#### CITY COUNCIL WORK SESSION

I.A Castle Creek Bridge and Entrance to Aspen

Appendix A Feasibility Assessment.pdf

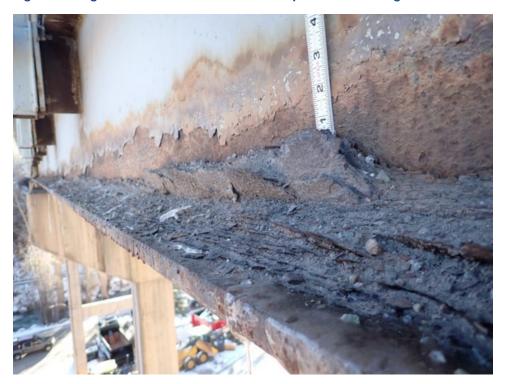
Figure 14. Significant Corrosion in Web and Top of Bottom Flange of North Exterior Girder A

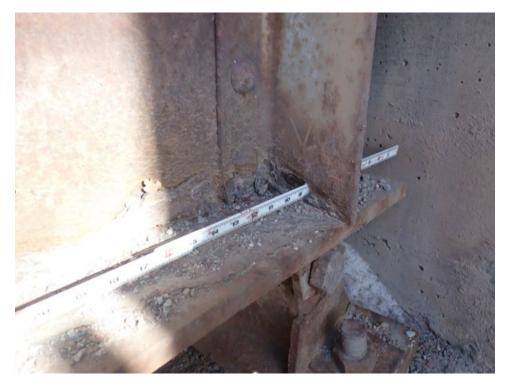
Figure 19. Pack Rust Between Bearing Stiffeners of Interior Girder at Abutment 1

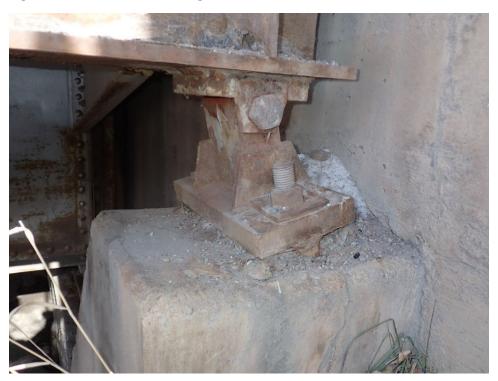
Figure 23. Impending Spall in the Bearing Pedestal at Bearing 6A at Abutment 6

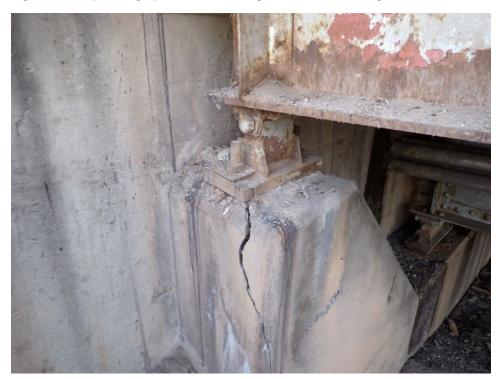
Figure 24. Loose Anchor Bolt Nuts – Typical at All Bearings

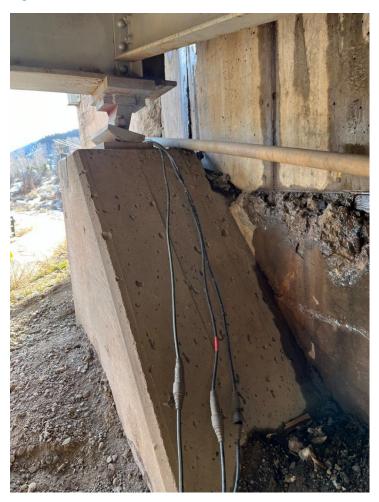
Figure 28. A Portion of Abutment 1 Backwall Was Removed During Previous Construction

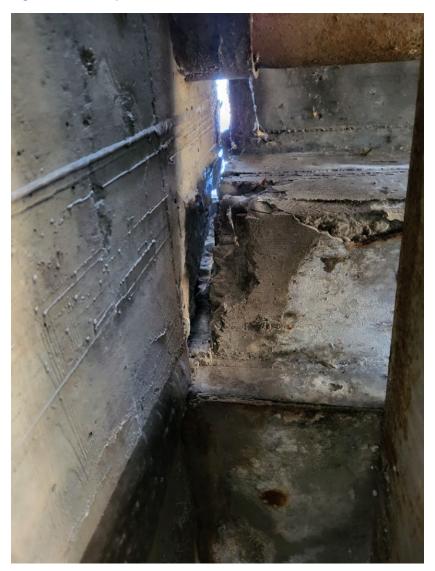
The bearings at the abutments need to be replaced, and bearings at the piers need additional rehab. Inadequate joint sealing at Abutment 6 raises concerns about the bridge's structural performance, and notable movement of the bridge was observed through the existing conditions of the bearings. The bridge's concrete substructure shows significant signs of deterioration and in several locations requires immediate attention to prevent further overall damage or load carrying capacity.

Figure 30. Inadequate Joint Seal at Abutment 6

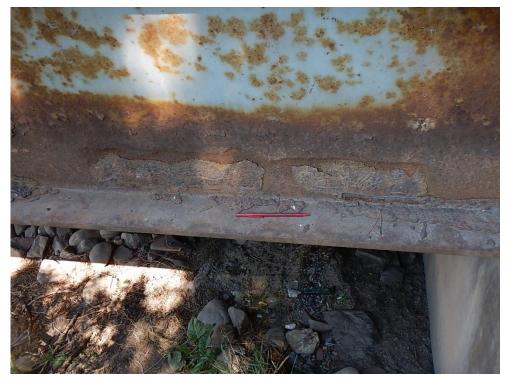
R3 - R4 Corrosion of Girder 5F near Abutment 6

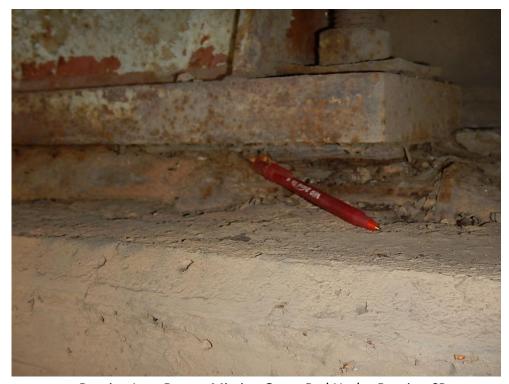
Bearing Loss Due to Missing Grout Pad Under Bearing 6B

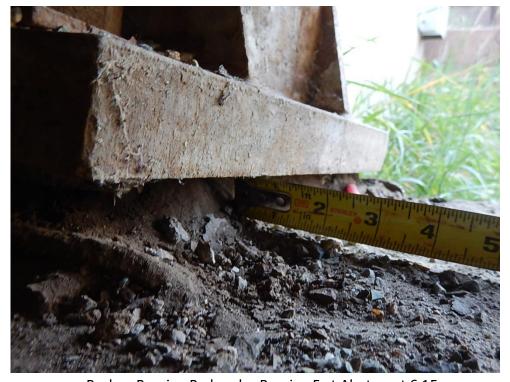
Broken Bearing Pad under Bearing F at Abutment 6 15
Percent Bearing Loss

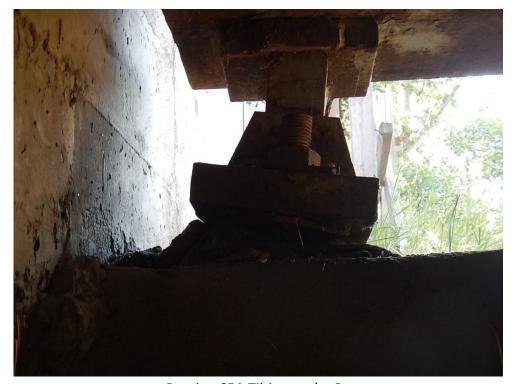
Bearing 6F isTilting to the Rear

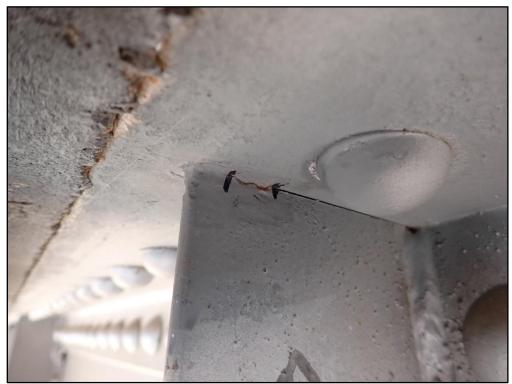
Figure 10: NSA Cracked Tack Weld – Girder B South Face – Stiffener 19 to Horizontal Leg of Top Flange Angle

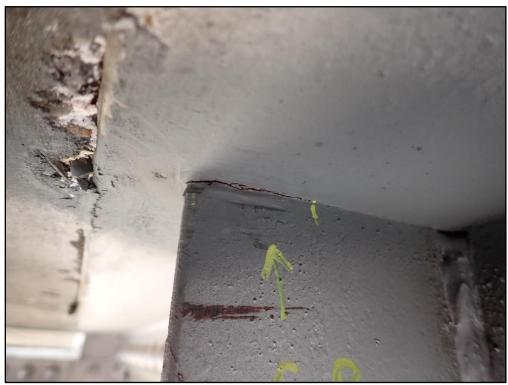
Figure 11: SA Cracked Tack Weld – Girder B South Face – Stiffener 17 to Horizontal Leg of Top Flange Angle

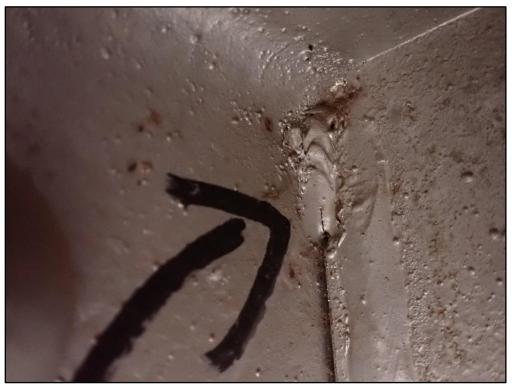
Figure 12: NSA Cracked Tack Weld – Girder C North Face – Stiffener 105 to Vertical Leg of Top Flange Angle

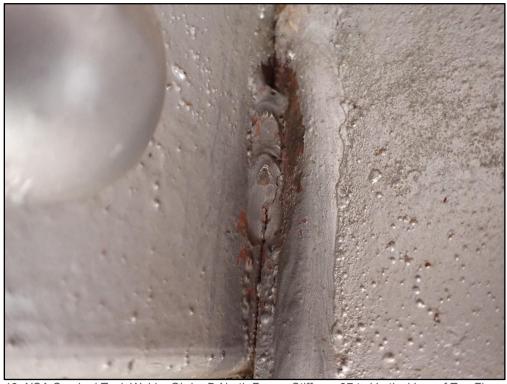
Figure 13: NSA Cracked Tack Weld – Girder D North Face – Stiffener 97 to Vertical Leg of Top Flange Angle

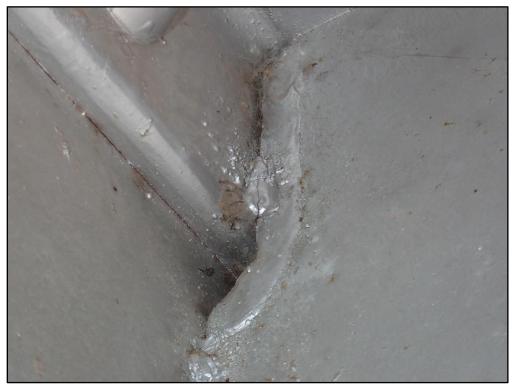
Figure 14: NSA Cracked Tack Weld – Girder E North Face – Stiffener 107 to Vertical Leg of Top Flange Angle

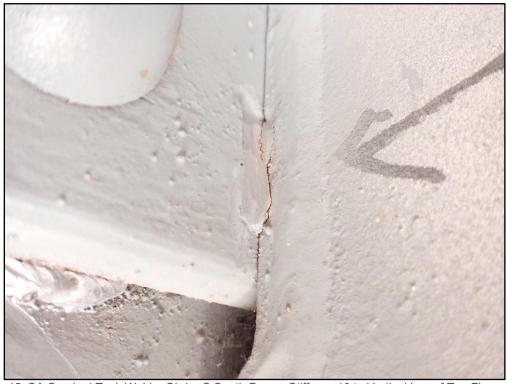
Figure 15: SA Cracked Tack Weld – Girder C South Face – Stiffener 16 to Vertical Leg of Top Flange Angle

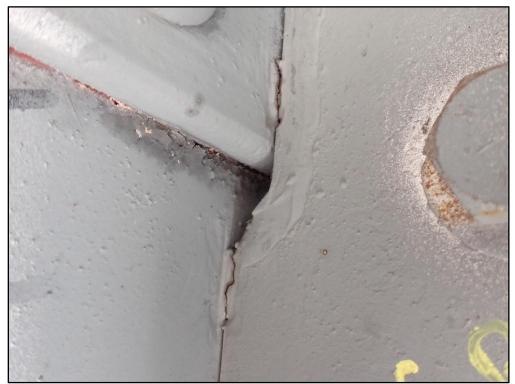
Figure 16: SA Cracked Tack Welds – Girder B South Face – Stiffener 41 to Vertical Leg of TF Angle and Web

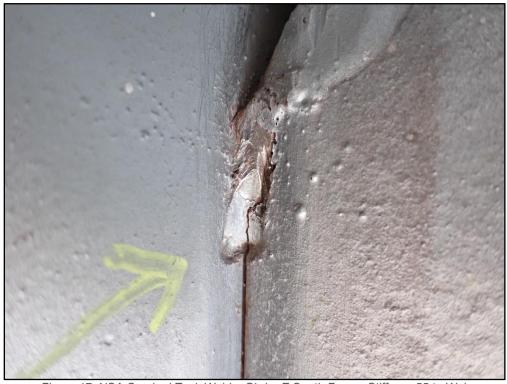
Figure 17: NSA Cracked Tack Weld - Girder E South Face - Stiffener 55 to Web

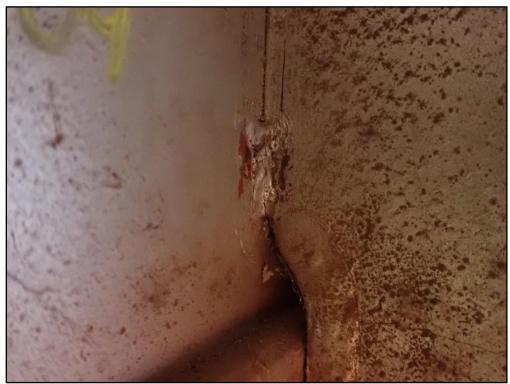
Figure 18: NSA Cracked Tack Weld – Girder C North Face – Stiffener 109 to Web

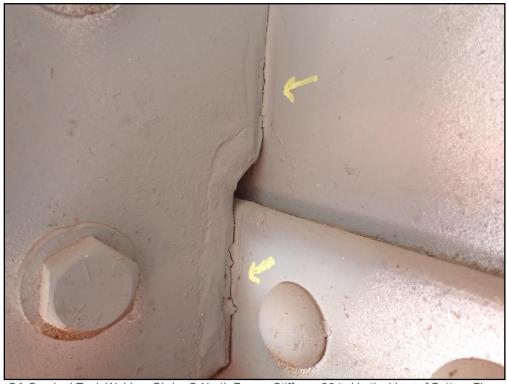
Figure 19: SA Cracked Tack Welds – Girder C North Face – Stiffener 26 to Vertical Leg of Bottom Flange and Web

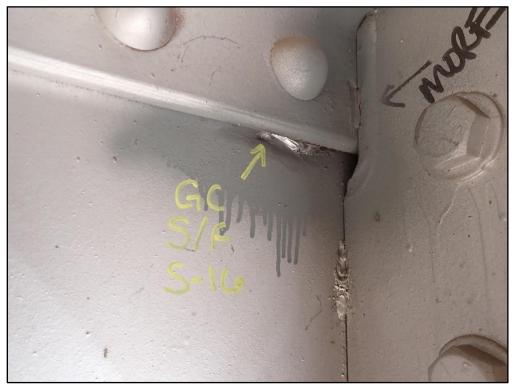
Figure 20: Partially Ground Out Tack Weld – Girder C South Face – Girder Top Flange to Web At Stiffener 16

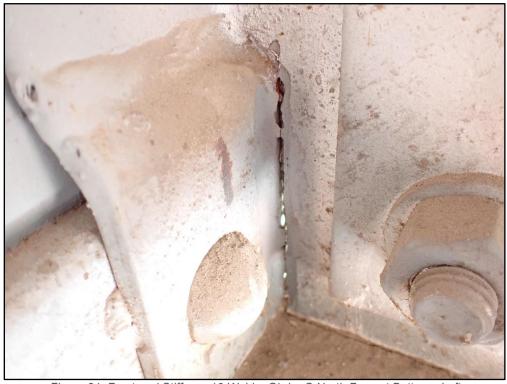
Figure 21: Fractured Stiffener 16 Weld - Girder C North Face at Bottom - Left

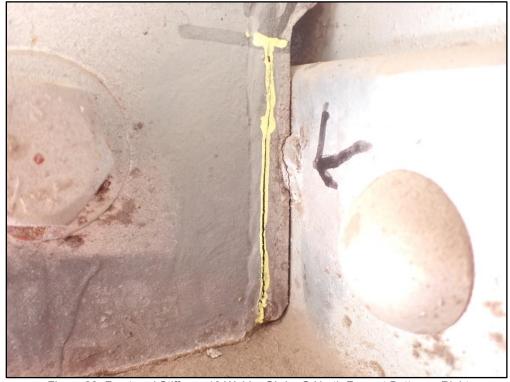
Figure 22: Fractured Stiffener 16 Weld – Girder C North Face at Bottom – Right

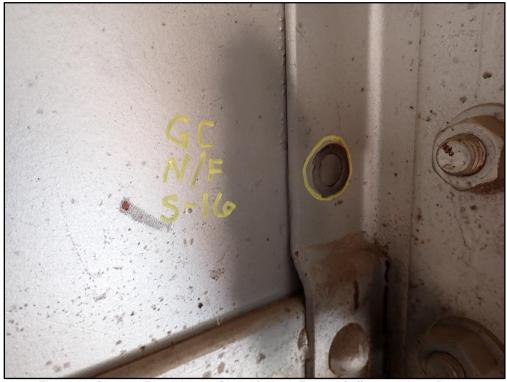
Figure 23: Sheared Rivet Head – Girder C North Face at Stiffener 16 Near Bottom

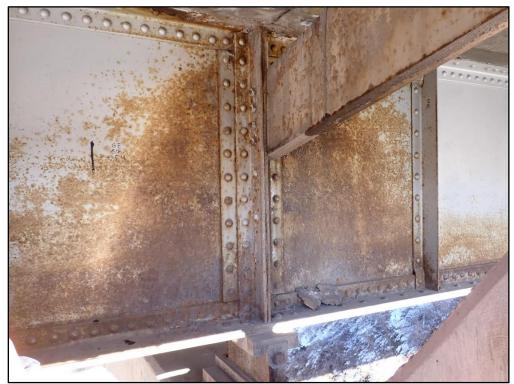
Figure 24: Typical Surface Corrosion of Interior Girder at Pier – Girder E South Face at Pier 4

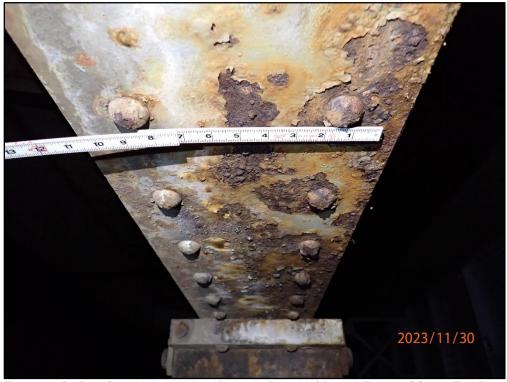
Figure 25: Surface Corrosion and Minor Pitting in Bottom of Bottom Flange of Girder E at Pier 4

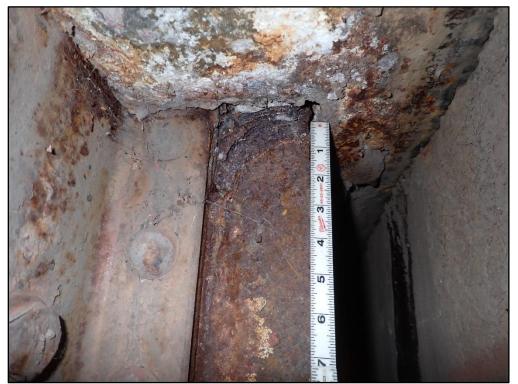
Figure 26: Laminar Corrosion of Girder E End at Abutment 6

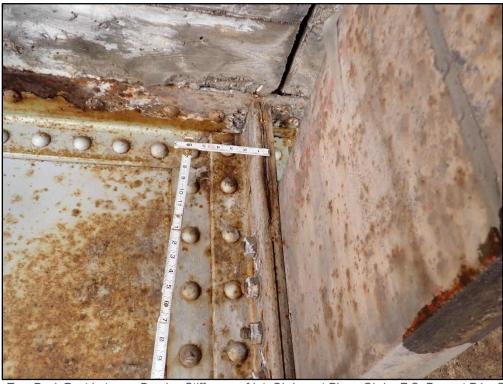
Figure 27: Typ. Pack Rust between Bearing Stiffeners of Int. Girders at Pier – Girder E S. Face at P4 – Stiffener 69

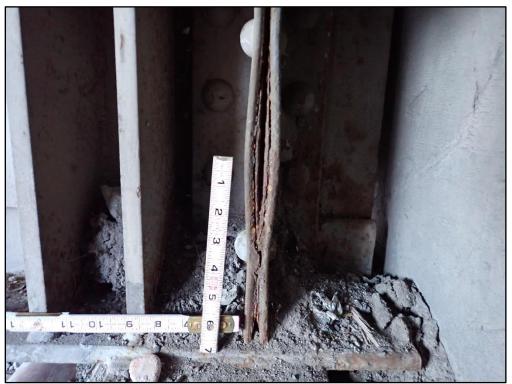
Figure 28: Typ. Pack Rust between Bearing Stiffeners of Int. Girders at Abut. – Girder B N. Face at A1 – Stiffener 1

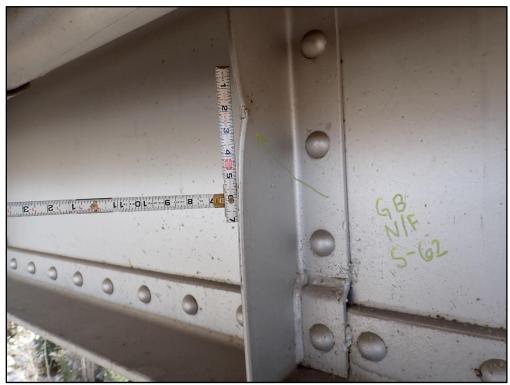
Figure 29: Deflection of Stiffener 62 at North Face of Girder B

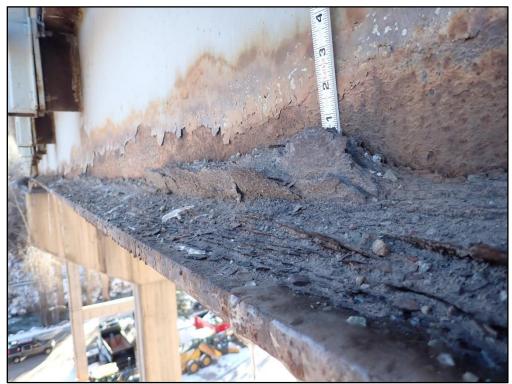
Figure 30: Laminar Corrosion in Web and Top of Bottom Flange of North Exterior Girder A

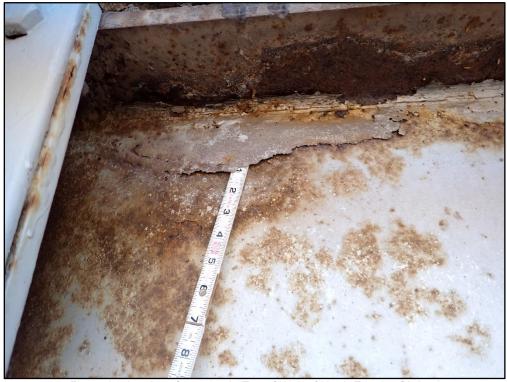
Figure 31: Laminar Corrosion in Top of Web of North Exterior Girder A

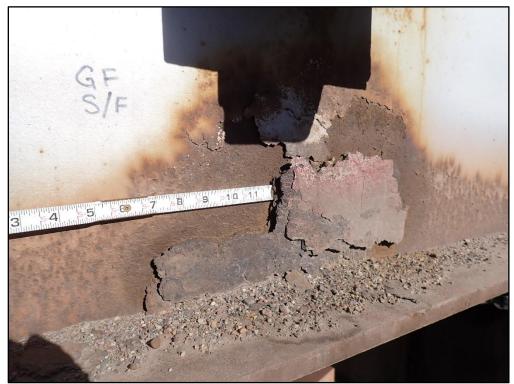
Figure 32: Laminar Corrosion in Web of South Exterior Girder F

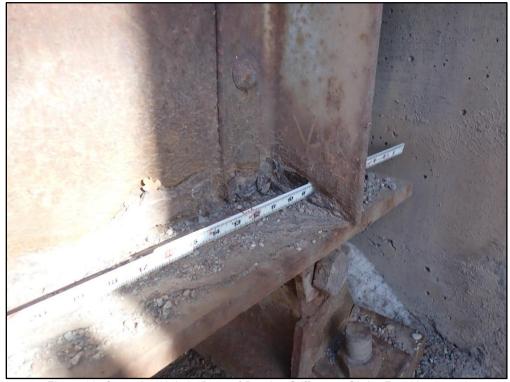
Figure 33: Corrosion Hole in Base of Bearing Stiffener - Girder F at Abutment 6

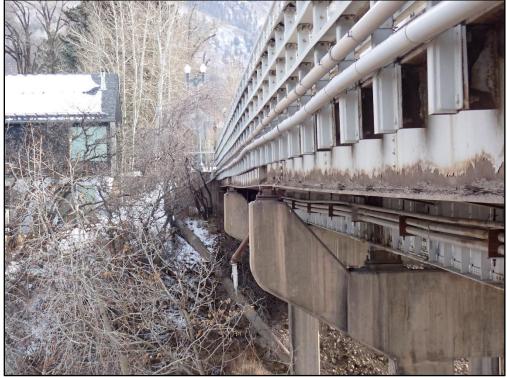
Figure 34: Load Sag of North Exterior Girder A

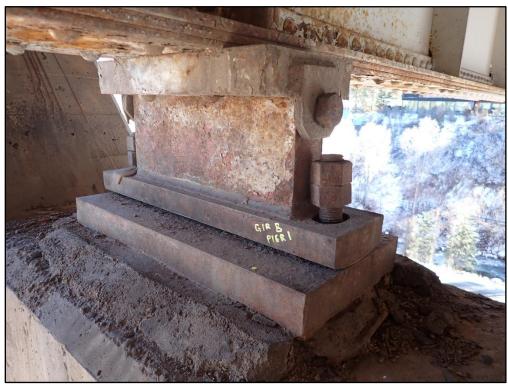
Figure 35: Typical Surface Corrosion of Bearing at Pier - Girder B at Pier 1

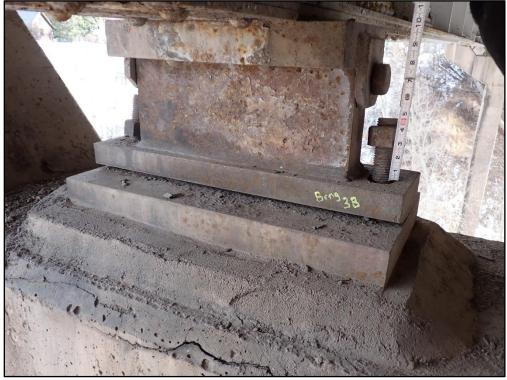
Figure 36: Typical Anchor Bolt Nut Backed Out and Missing Lock Nut – Girder B at Pier 2

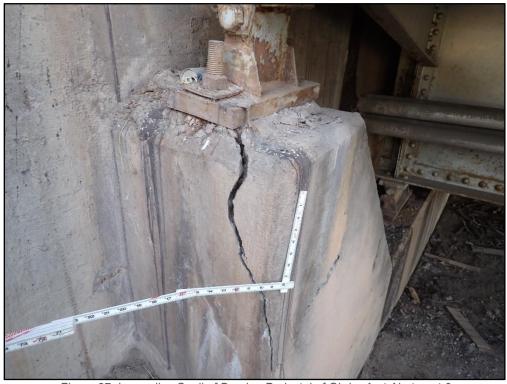
Figure 37: Impending Spall of Bearing Pedestal of Girder A at Abutment 6

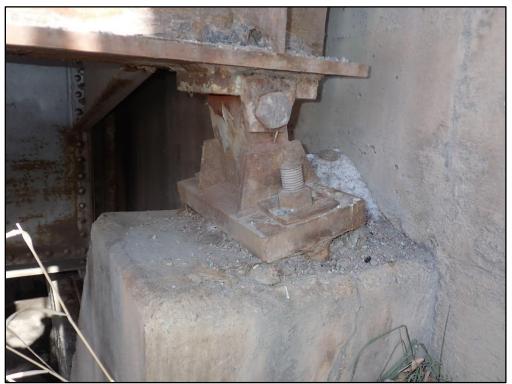
Figure 38: Tilted Bearing of Girder F at Abutment 6
