# **Notice of Meeting of the Main Street Advisory Board of the City of Georgetown, Texas September 17, 2026**

- 1.A **Call to order**  
Call to order - Evan Cuyler, Board Chair
- 1.B **Main Street Facade Grant request for 102 E University Ave**  
Consideration and possible action on a Main Street Facade Grant request for 102 E University Ave – Rachel White, Downtown Development Manager

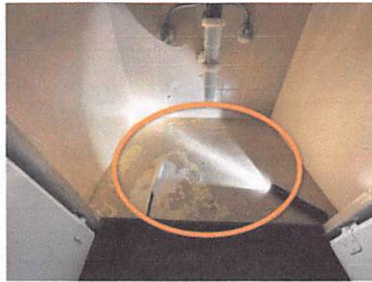
Bathroom

Fungal growth and elevated moisture levels under kitchen sink

Evidence of previous moisture. At time of the inspection no moisture was observed while using moisture meter

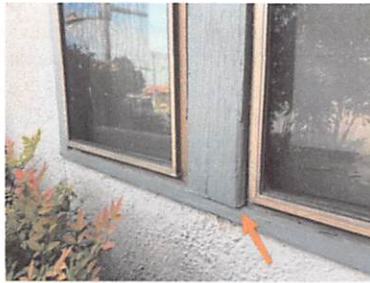
Loose and damaged exterior cladding components were observed, including sections of window trim, soffit areas, crawlspace vent trim, and other wood trim elements showing signs of deterioration and moisture-related damage. These conditions are consistent with deferred maintenance and may allow further moisture intrusion if not addressed. Repair and ongoing maintenance is recommended to help preserve the exterior envelope.

Loose and deteriorating trim

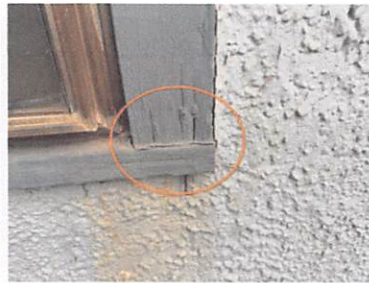
Wood rot and potential water entry points

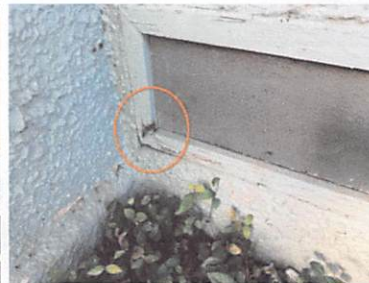
Various trim damage

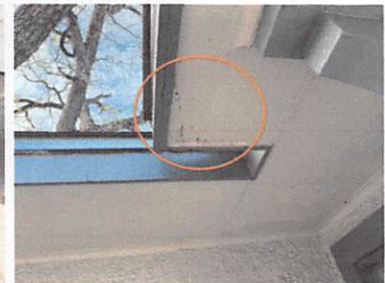
Soffit damage due to previous water penetration

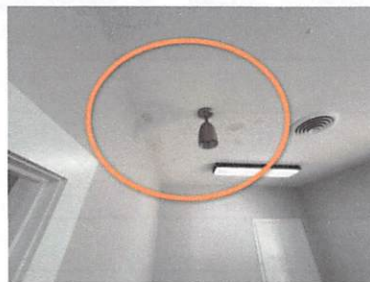
The source of moisture in the right rear room appears to be from a previous condensation leak at the HVAC system above. The moisture at the attic stair unit is likely associated with a previous roof leak. No active moisture was observed at the inspection. Further evaluation and repair is recommended as necessary.

Back bedroom. Appears to be below HVAC unit in attic

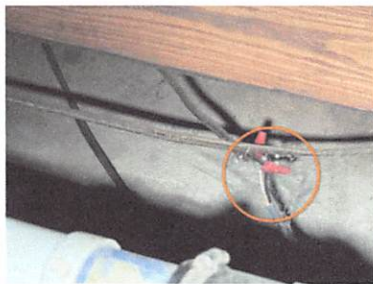
Exposed wiring connections within crawlspace

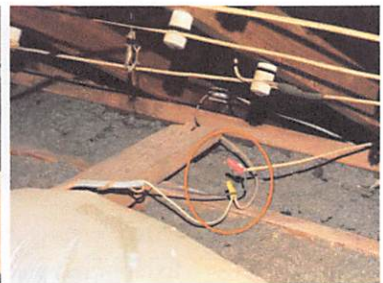
Exposed wiring connections in attic

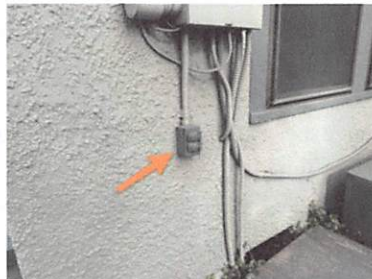
Exterior receptacle covers in wet locations should ideally be changed out to newer "bubble covers". These covers keep the receptacles covered, even while in use (cords plugged in).

Missing appropriate wet location cover

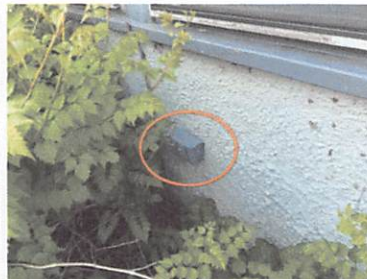
Missing appropriate wet location cover

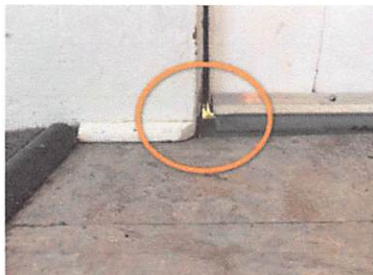
Left side exterior door

Damaged / missing weatherstripping materials can result in energy loss, pest intrusion and / or moisture intrusion. For garage pedestrian doors, this can also result in possible garage fumes within the living space.

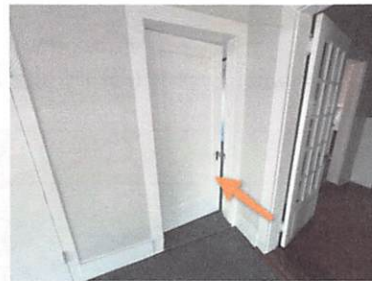
Unable to latch

Adjustment / repair is recommended as necessary for improved door operation.

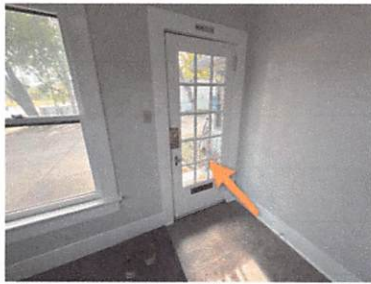
Tempered safety glass is required for all glass in doors that will allow the passage of a 3 inch sphere, and is generally identified by an etching in the corner of the glass pane. Glass replacement, with the appropriate safety glass, is generally recommended as a repair to prevent potentially injury, should the door glass break.

No tempered glass etching observed at left side exterior door

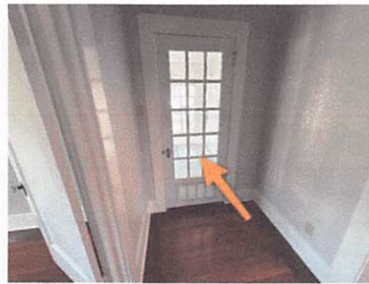
No tempered glass etching observed at right side bedroom door

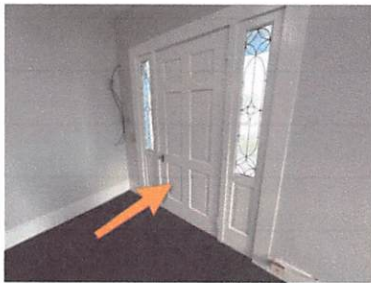
Front door

The front entry door exhibited multiple deficiencies at the time of inspection. The door appeared to be painted shut and could not be opened or operated, which may impact proper egress and functionality. Additionally, the door handle was observed to be loose, and a deadbolt lock was not present. These conditions may affect both safety and security. It is recommended that the door be made fully operable, the handle be properly secured, and a deadbolt be installed for improved safety and functionality.

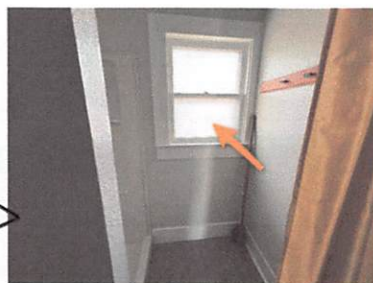
Missing tempered glass next to shower in bathroom

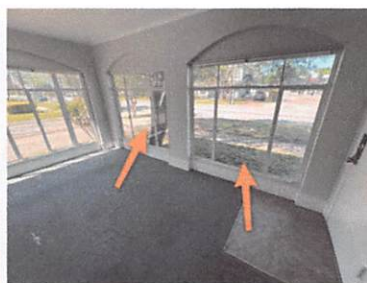
Window panes over 9 square feet missing tempered glass. Right side room

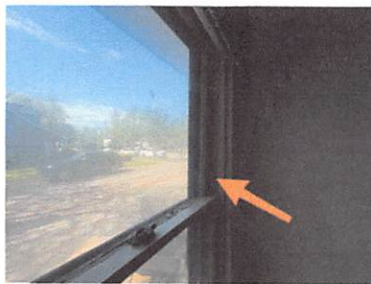
Damaged lift support. Back left side room.

Counterbalance repair or replacement is recommended as necessary for improved operation.

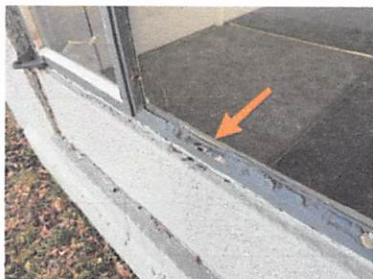
The older windows at the right side of the house were observed to have deteriorated and previously repaired glazing compound. These conditions may allow moisture intrusion and were consistent with evidence of past moisture penetration at interior areas. Repair and ongoing maintenance is recommended to help reduce the potential for continued water intrusion.

poor window glazing compound

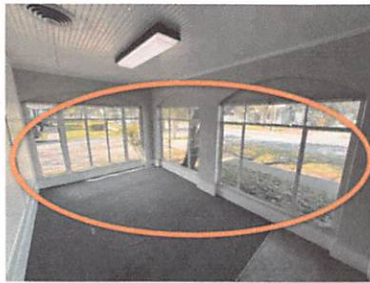
Affected windows would not operate or open using normal force. Repair is recommended for improved operation; particularly in bedroom areas where window emergency egress is required.

Windows appear to be painted shut.  
Back right side room.

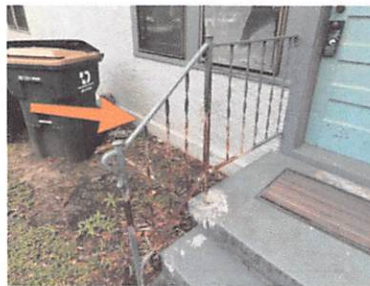
Rear - substantially loose handrail

Adjustment / repair is recommended as necessary for improved safety.

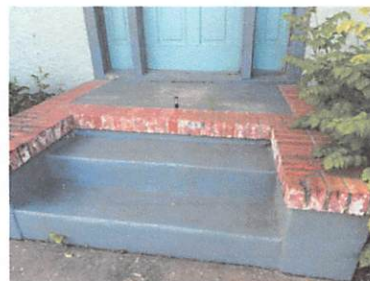
The greatest riser height within any flight of stairs shall not exceed the smallest by more than 3/8 inch. This condition can pose a trip hazard. It is recommended to have a qualified contractor evaluate and correct the stairway to meet safety standards.

riser variance exceeds 3/8"

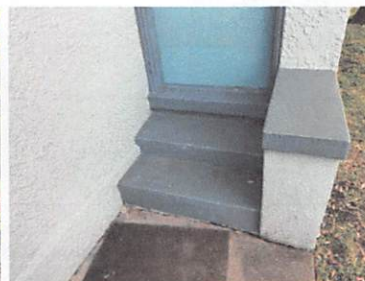
riser variance exceeds 3/8"

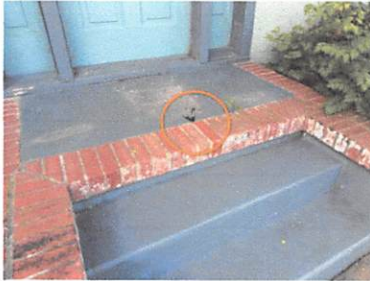
A metal bracket was observed bolted to the front porch, likely a remnant from previous signage. This created a potential trip hazard at the entry. Removal is recommended to reduce the risk of injury.

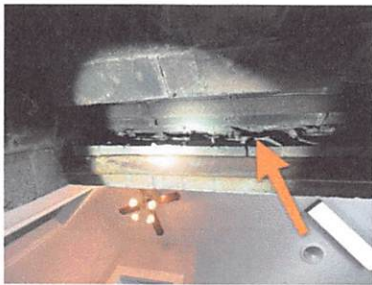
The gap between the fire box and the masonry lintel is required to be sealed with an approved high temperature sealant material in order to prevent possible flame spread between the masonry and the framed wall or space behind the masonry.

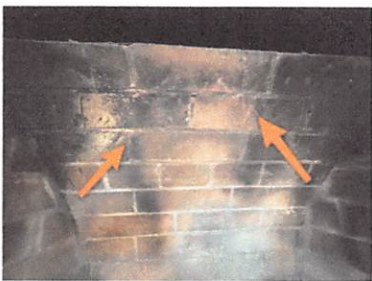
This condition can be somewhat common and typically results from the repeated expansion and contraction of materials as they are heated from room temperature to several hundred degrees Fahrenheit and then cooled. Repairs can often be made using refractory caulk, a special high-heat material containing silica. Consultation with a qualified fireplace contractor is recommended to assess repair options and ensure the firebox is restored to safe and functional condition.

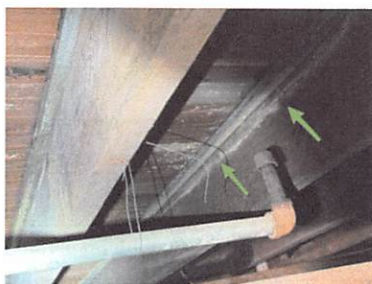
Fungal (biological) growth was observed within the crawlspace. This is a common condition in areas with elevated moisture, often influenced by limited or ineffective ventilation. While typically minor, it indicates moisture presence. Monitoring and improving ventilation and moisture control may help limit further growth. Further evaluation may be considered if conditions worsen or concerns arise.

Visible fungal growth within crawl space

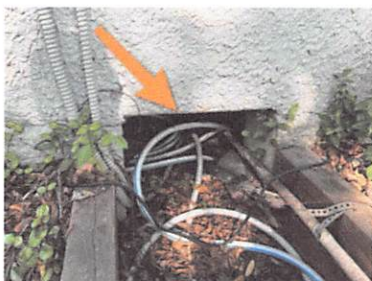
The crawl space access opening was missing, undersized, or otherwise inadequate. Access openings through the floor should be at least 18 x 24 inches, and through a perimeter wall should be at least 16 x 24 inches. Where below-grade access exists, a window well or areaway of not less than 16 x 24 inches should be provided. Correction is recommended for proper accessibility.

Exterior crawlspace access undersized (18" x 14")

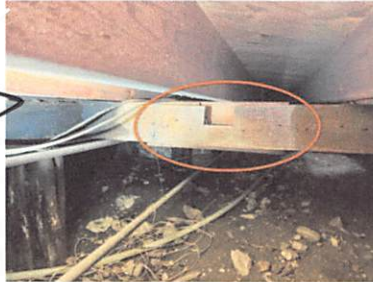
One or more structural beams were observed to have been previously cut and repaired in a non-standard manner. The repair did not appear to have been engineered or documented; however, no significant distress was observed at the time of inspection. Additionally, several beams were bearing on the foundation wall with approximately 1.5 inches of contact, which is less than current standards, though this may have been typical

notched and subsequently repaired beam

at the time of construction. The beams appeared to be performing adequately overall. Further evaluation by a qualified contractor or structural engineer is recommended to assess the adequacy of the repairs and bearing conditions.

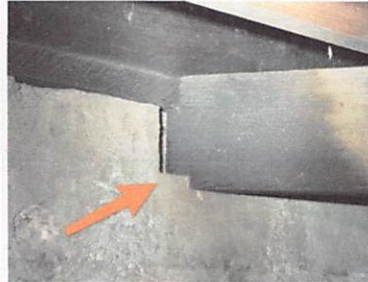
undersized bearing onto concrete

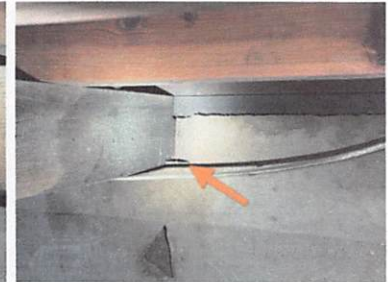
undersized bearing onto concrete

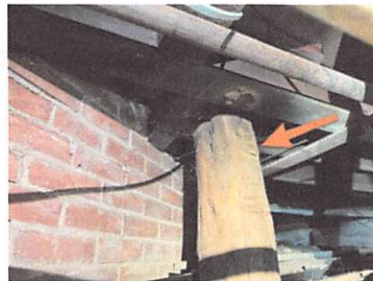
One or more foundation piers were observed to be tilted, leaning, or unstable. This can affect the overall long-term stability and load transfer of the foundation system. Further evaluation and repair are recommended by a qualified foundation specialist or engineer.

pier tilted and not supporting beam near fireplace

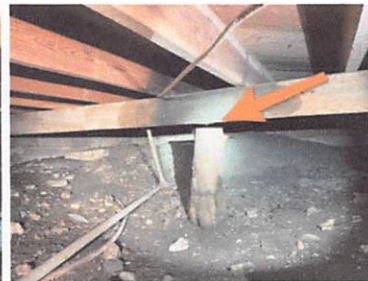
pier no longer supporting beam

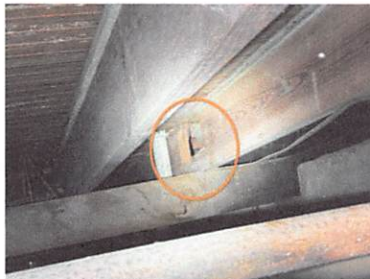
One floor joist was observed to be over-notched above a supporting beam beneath the shower area.

Improper joist notch and bearing under shower

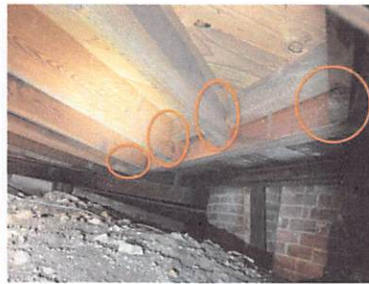
Additionally, several joist ends at the framing in front of the fireplace lacked approved joist hangers or ledger support, which is common in homes of this age. Although these conditions do not meet current standards, no significant movement or distress was observed at these locations at the time of inspection. Further evaluation by a qualified contractor may be considered to assess long-term performance.

Missing joist hangers

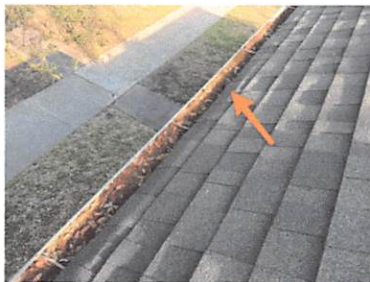
Accumulated debris or items were observed in the gutters. Cleaning is recommended to ensure proper drainage and to prevent possible gutter overflow. Ongoing maintenance (typically annual) is advised, and installing leaf guards may help minimize future buildup.

Clear debris from gutters

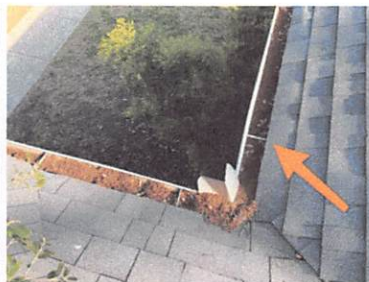
Clear debris from gutters

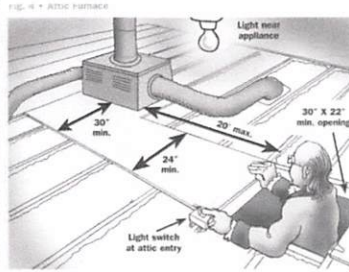
Walkway segmented and service platform less than 30 inches in front of HVAC equipment

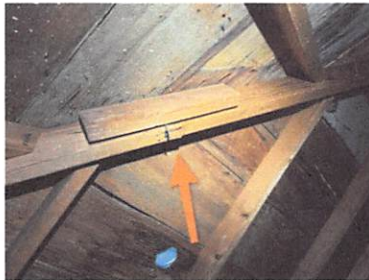
Several hip rafter ends were observed to be adequately fastened but lacked direct bearing support at their endpoints. Additionally, multiple hip rafters were spliced near mid-span without support beneath the splice locations. While no significant movement or structural distress was observed at the time of inspection, these conditions do not align with typical framing practices. Further evaluation by a qualified contractor is recommended to assess long-term adequacy.

Unsupported hip rafter splice

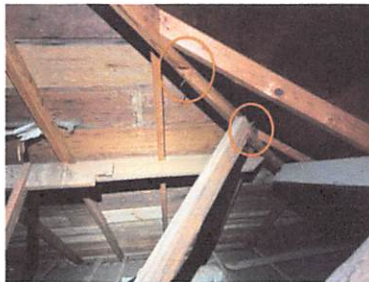
Previous splice support detached
