CITY OF
BAINBRIDGE ISLAND

**CITY COUNCIL STUDY SESSION
TUESDAY, MARCH 15, 2022**

AGENDA ITEM: (6:10 PM) Review Current and Recommended Practices for Funding and Maintaining City Facilities and Streets - Public Works,

City of Bainbridge Island

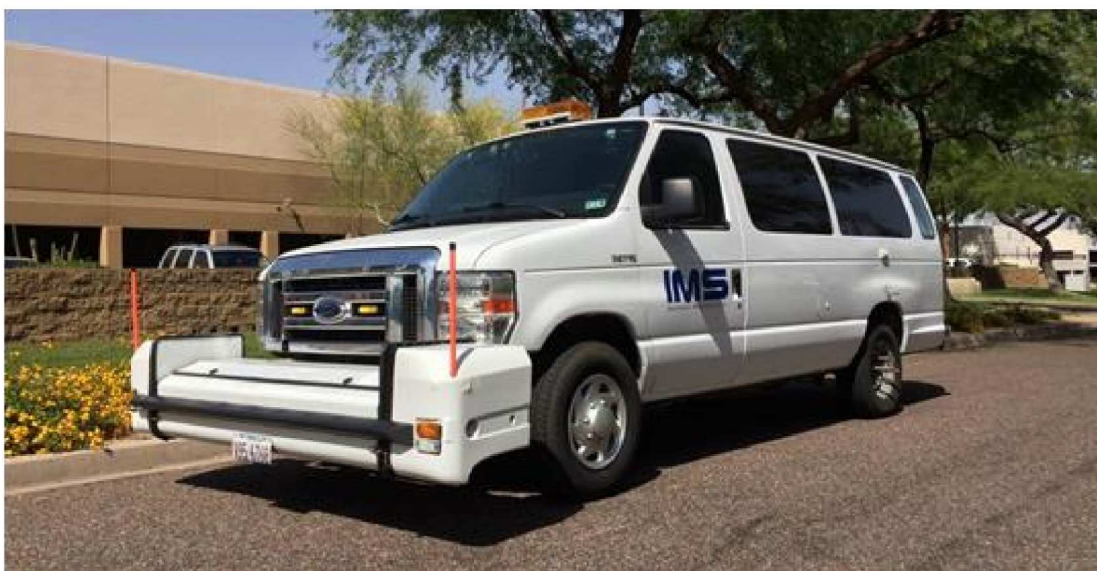
Figure 4 – Laser Road Surface Tester (RST)

Conversely, deterioration of roads can have adverse effects on a community and may bring about important and unanticipated welfare effects that the governments should be aware of when cutting transportation budgets. Poor road conditions increase fuel and tire consumption while shortening intervals between vehicle repair and maintenance. In turn, these roads result in delayed or more expensive deliveries for businesses and consumers. Economic effects of poor road networks, such as time consuming and costly rehabilitation, can be reduced if a proactive maintenance approach is successfully implemented. To accomplish this, a pavement assessment and analysis should be completed every few years in an effort update the budget models and rehabilitation plans. The IMS Laser Road Surface Tester (featured in **Figure 4**) was mobilized to Bainbridge Island to conduct an objective survey.

IMS mobilized their Laser Road Surface Tester (RST) to conduct an objective assessment using industry standard pavement distress protocols such as those found in ASTM D6433-11. At that time, the City's network average Pavement Condition Index was found to be a 69 and the City's backlog (roads below a PCI of 40) was at 10%. *See section 4 for more information*

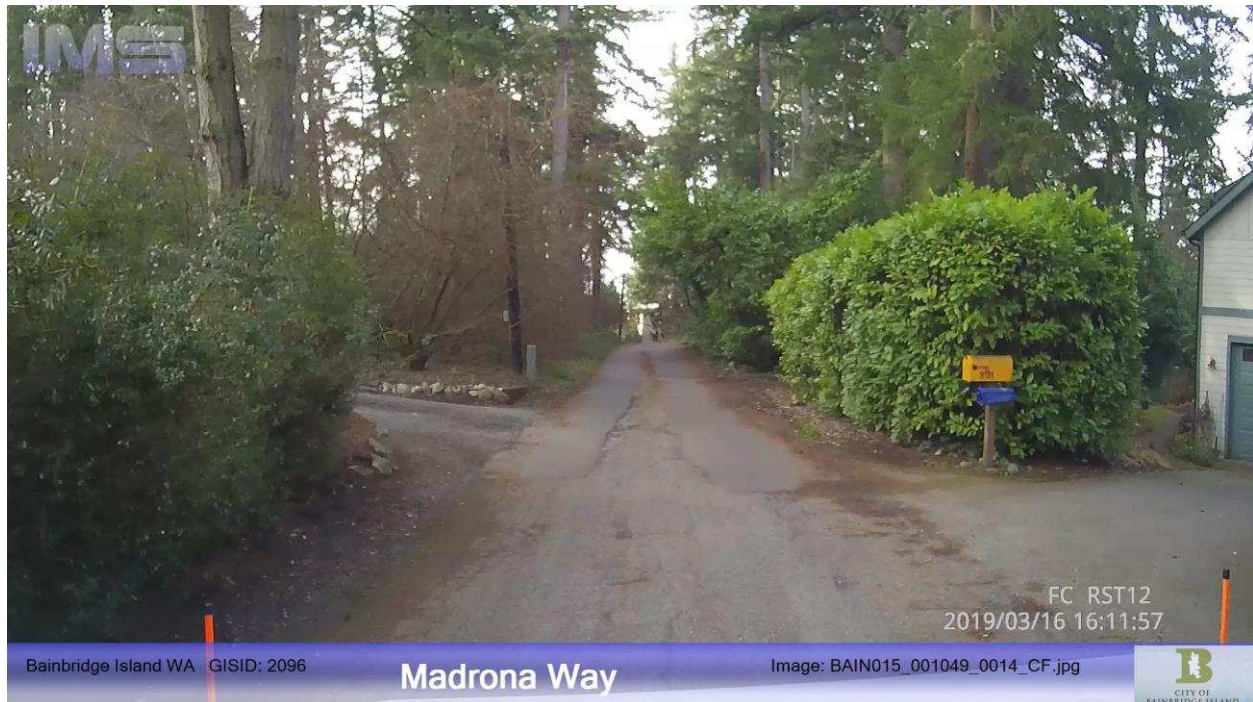
Very Poor (PCI = 0 to 25) – Complete Reconstruction

Madrona Way from South End to Olympus Beach Way (GISID 2096, PCI = 23) – Rated as Very Poor, this street displays spreading base failure as evidenced by the severe alligator cracking and patching. A mill and overlay on this street would not be suitable as the base has failed and would not meet an extended service life of at least 15 years. This street requires a full reconstruction and should be carefully monitored.

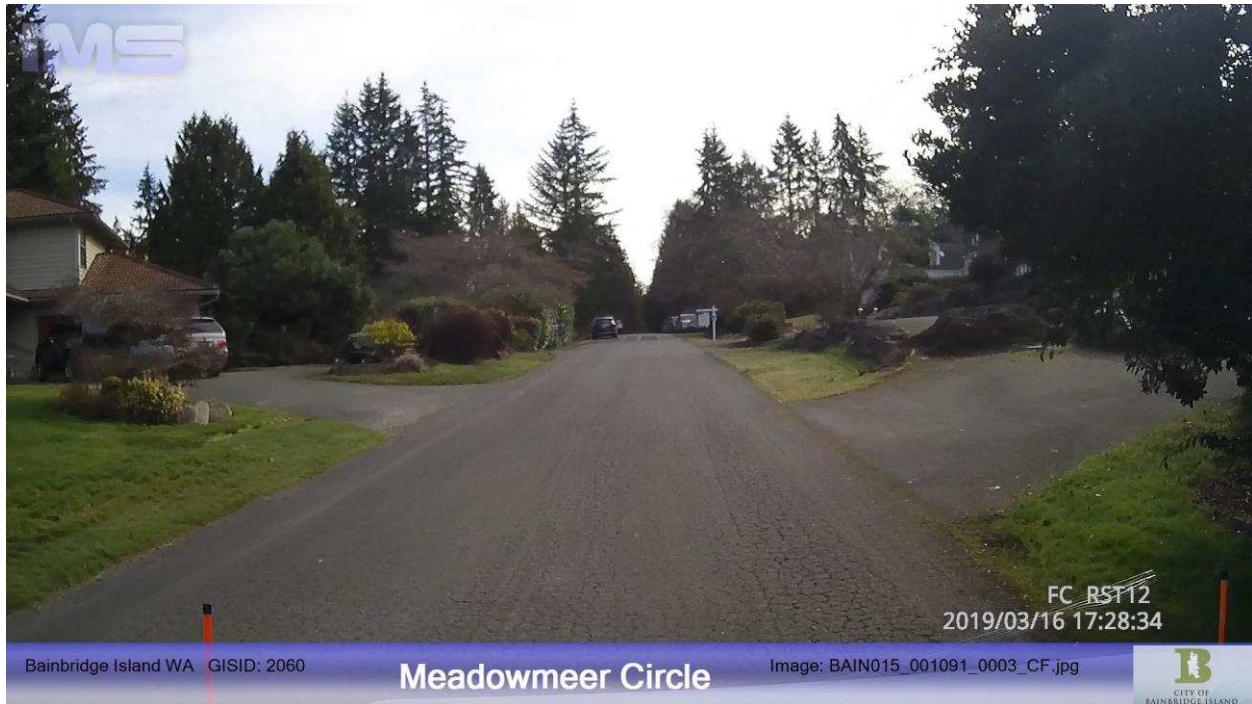
Poor (PCI = 25 to 40) – Last Opportunity for Surface Base Rehabilitation

Meadowmeer Circle from Chatham Place to Tyler Place (GISID 2060, PCI = 33) – Rated as Poor, this segment still has some remaining life before it becomes a critical reconstruction need. On this street, the base is showing signs of failure in areas exhibiting alligator/fatigue cracking. The severely cracked areas are isolated and do not persist throughout the entire segment length and cross section. These areas should be dug out and structurally patched to attain the maximum life from any potential rehabilitation efforts. If left untreated, within a short period of time, a full reconstruction would be required.

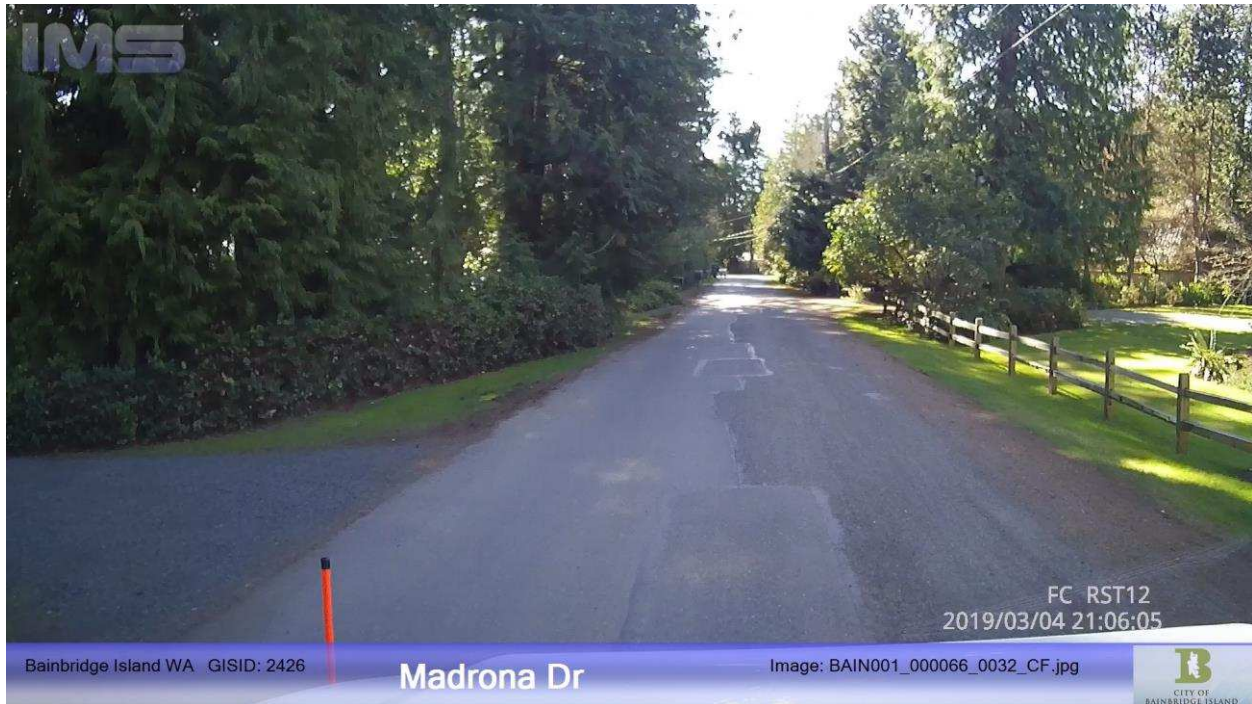
Fair (PCI = 50 to 60) – Thin to Moderate Overlays

Madrona Drive from South End to Olympus Beach Way (GISID 2426, PCI = 54) – Rated in the Fair category, these streets require thin to moderate overlays for asphalt when they enter their need year (generally within 2-3 points of the lower PCI in the defined range). Several distresses are present, but tend to be more localized and moderate in severity, and non-load related (primarily longitudinal and transverse cracking and raveling). On this segment of road, the signs of deterioration are evident in the left hand travel lane of the pavement and are moderate in severity indicating the base has not yet failed along the entire length of roadway.

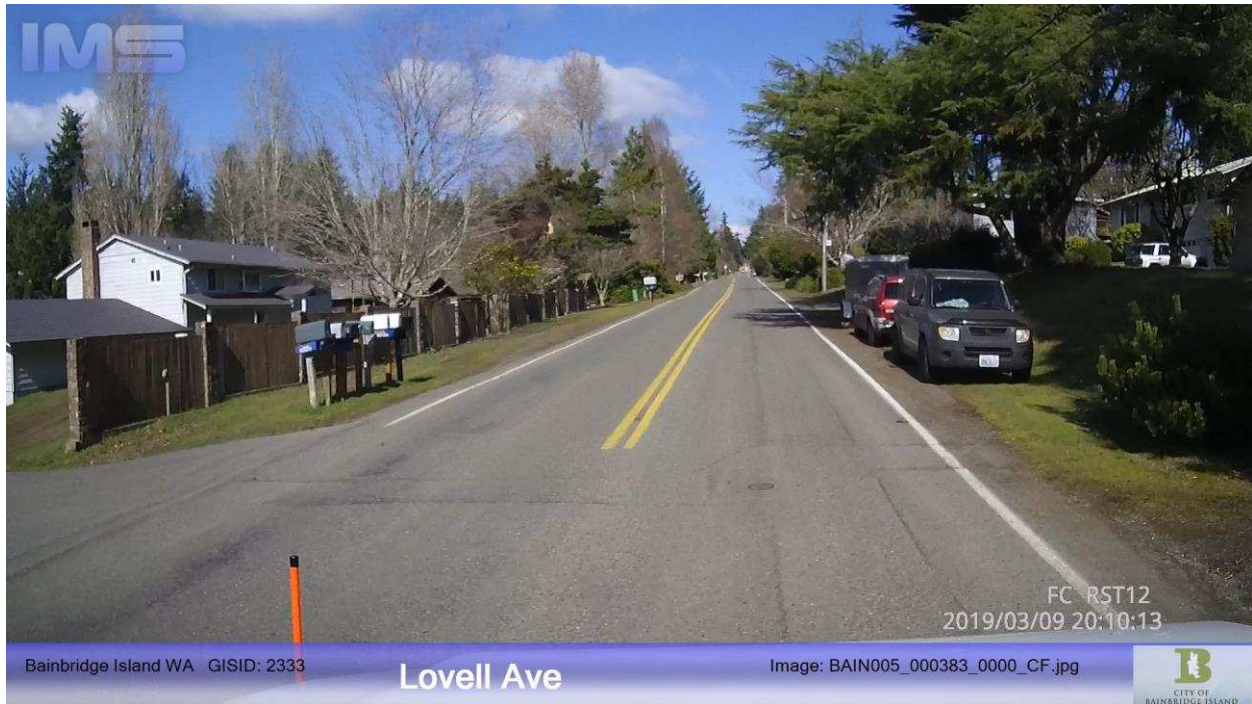
Good (PCI = 60 to 70) – Surface Treatments to Thin Overlays

Lovell Avenue from Pierce Court to Annie Rose (GISID 2333, PCI = 60) – Rated as Good with the primary cause of deterioration the transverse and longitudinal cracking, as well as patching. It also displays small amounts of load associated distresses that can easily be removed to restore the visual appearance of the roadway. The existing cracks should be sealed and the pavement surface restored, with a heavier surface treatment such as microsurfacing or double slurry to fully waterproof the pavement and cover the crack sealant. The occasional dig out and replacement may be required to correct localized deficiencies. Alternatively, depending on the extent of the distressed areas, base strength and drainage, a thin overlay may be applied.

Asphalt streets rated as Good are ideal candidates for thinner surface-based rehabilitations and local repairs. Depending on the amount of localized failures, a thin edge mill and overlay, or possibly a surface treatment, would be a suitable rehabilitation strategy for streets rated as Good. Streets that fall in the high

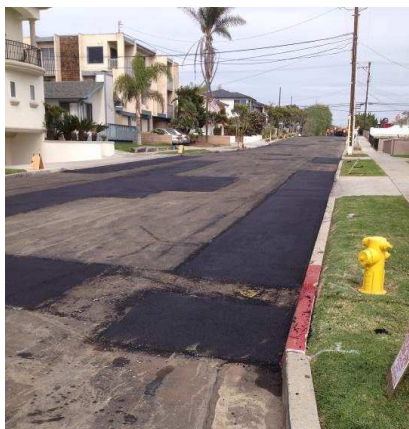
60 - low 70 PCI range provide the greatest opportunity for extending pavement life at the lowest possible cost, thus applying the principles of the perpetual life cycle approach to pavement maintenance. The adjacent photo is a great example of a street segment (not a Bainbridge Island Road) that displayed low load associated distresses and thus, high structural characteristics, and once the distressed areas were replaced, a slurry seal was applied. The patching accounted for less than 5 to 10% of the total area and resulted in a good looking, watertight final surface at a much lower cost than an overlay with less disruption to the neighborhood and curb line. The patches were paver laid and roller compacted.

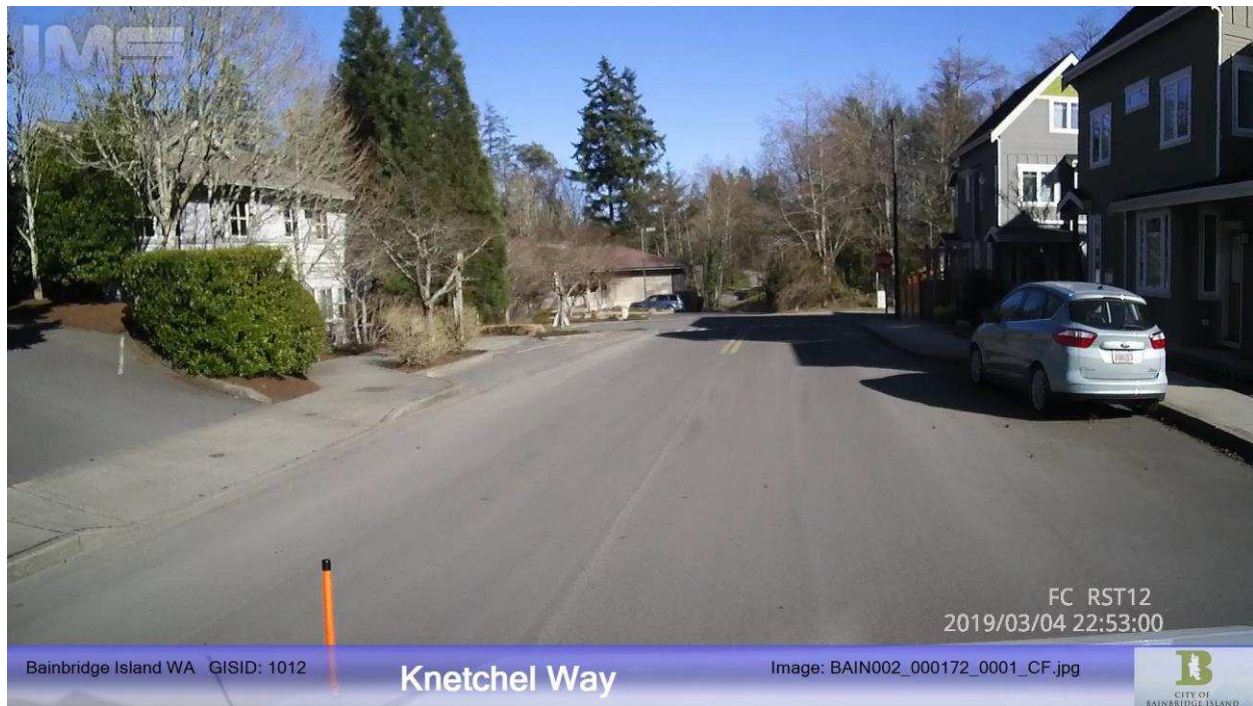
Excellent (PCI = 85 to 100)

Knetchel Way from Wintersweet Road to Ericksen Avenue (GISID 1012, PCI = 94) – Rated as Excellent, displaying little to no surface distresses. The ride is smooth and the surface is non-weathered and the base is strong. In a couple of years, this street segment would be an ideal candidate for routine maintenance activities such as crack sealant rehabilitation.
