# **Notice of Meeting of the Historic and Architectural Review Commission of the City of Georgetown, Texas March 4, 2026**

### **1.A 205 E University Avenue (2026-4-COA)**

205 E University Avenue (2026-4-COA)

**Re: Letter of Intent  
HARC Demolition Certificate of Appropriateness (COA)  
205 E. University Ave.,  
Georgetown, TX 78626**

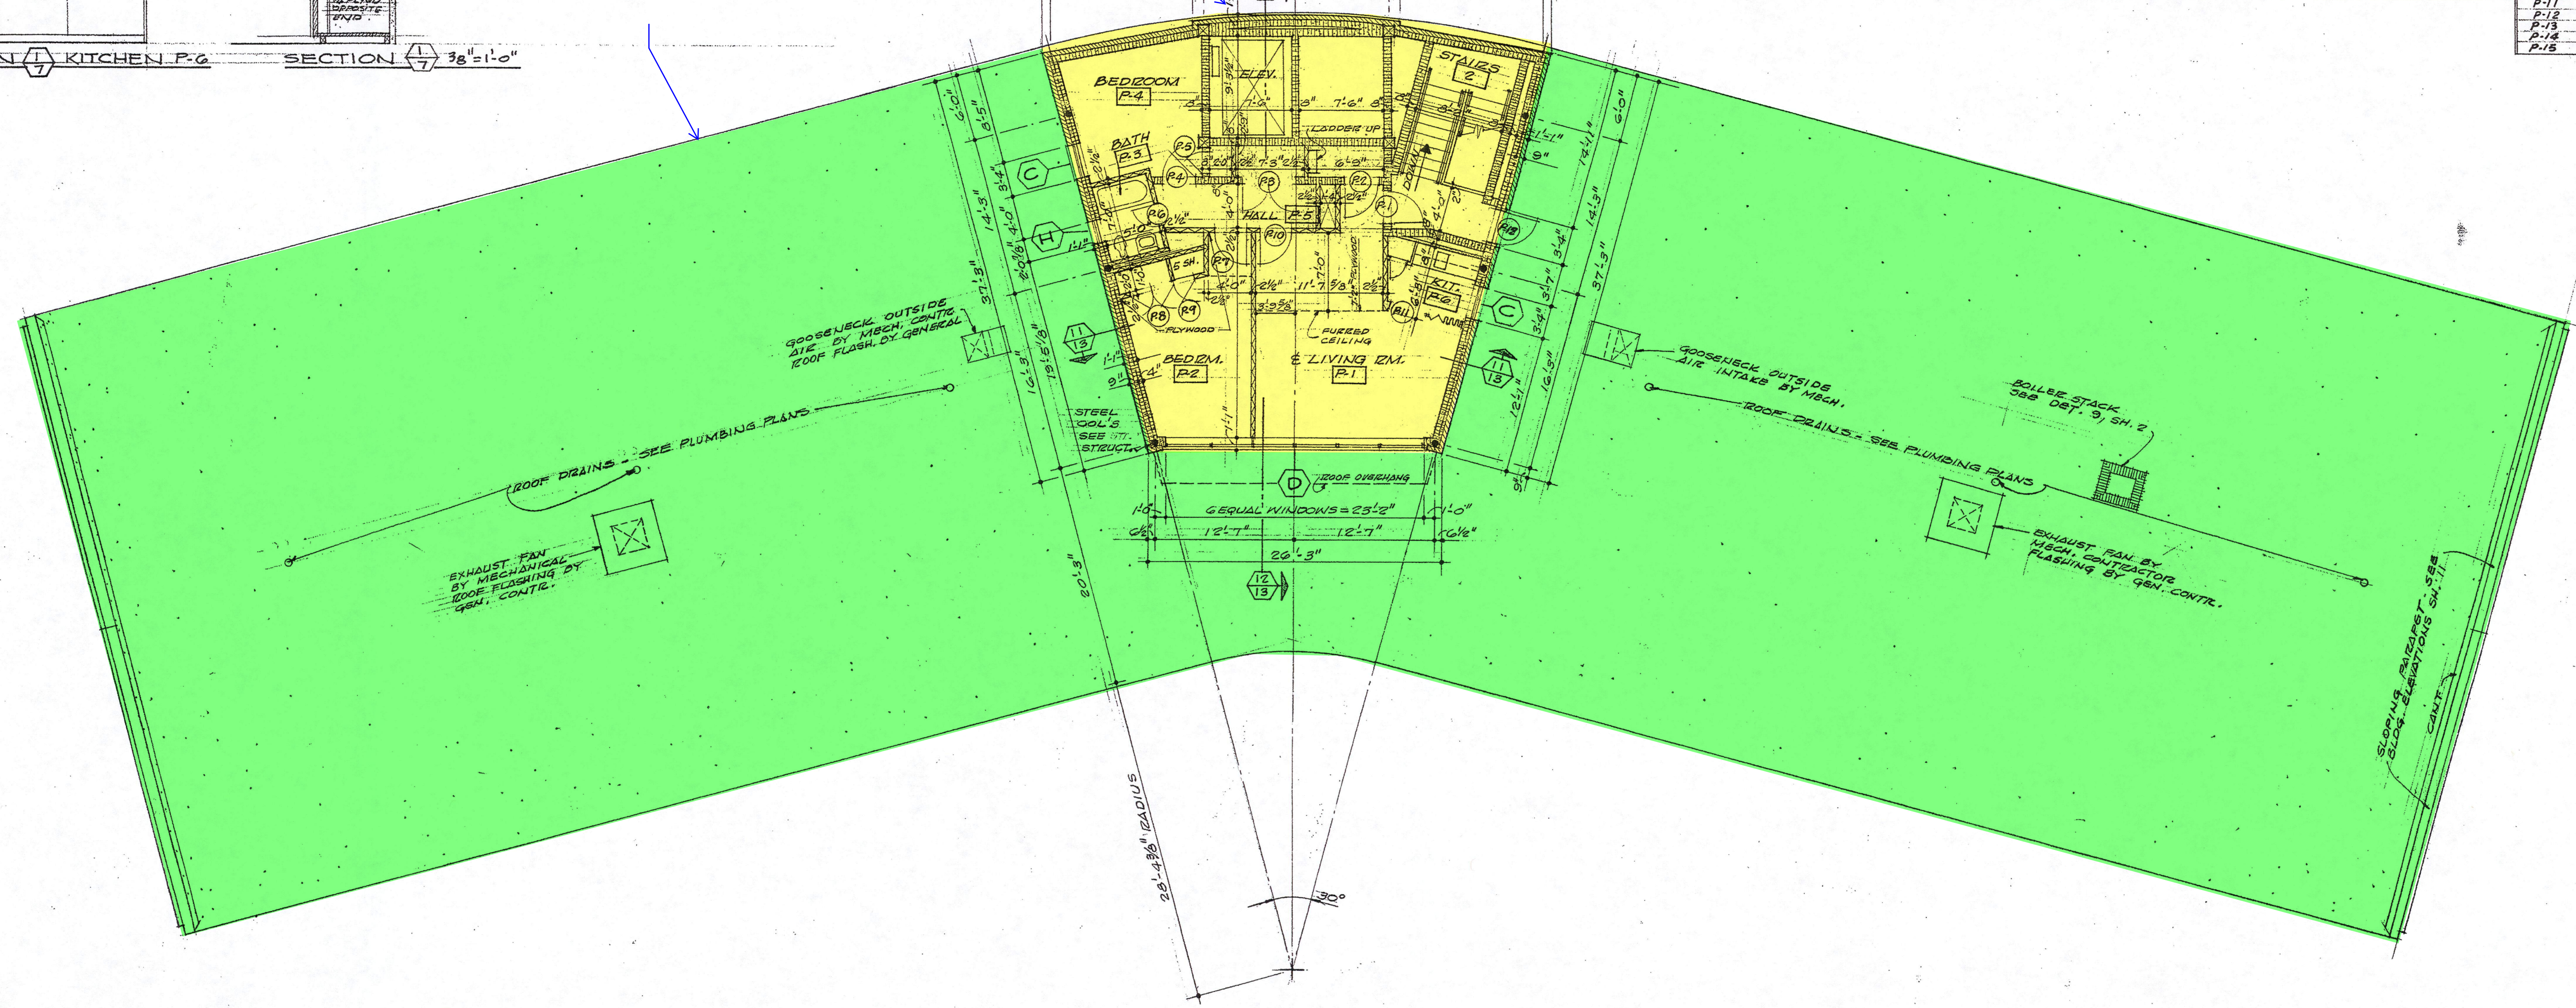
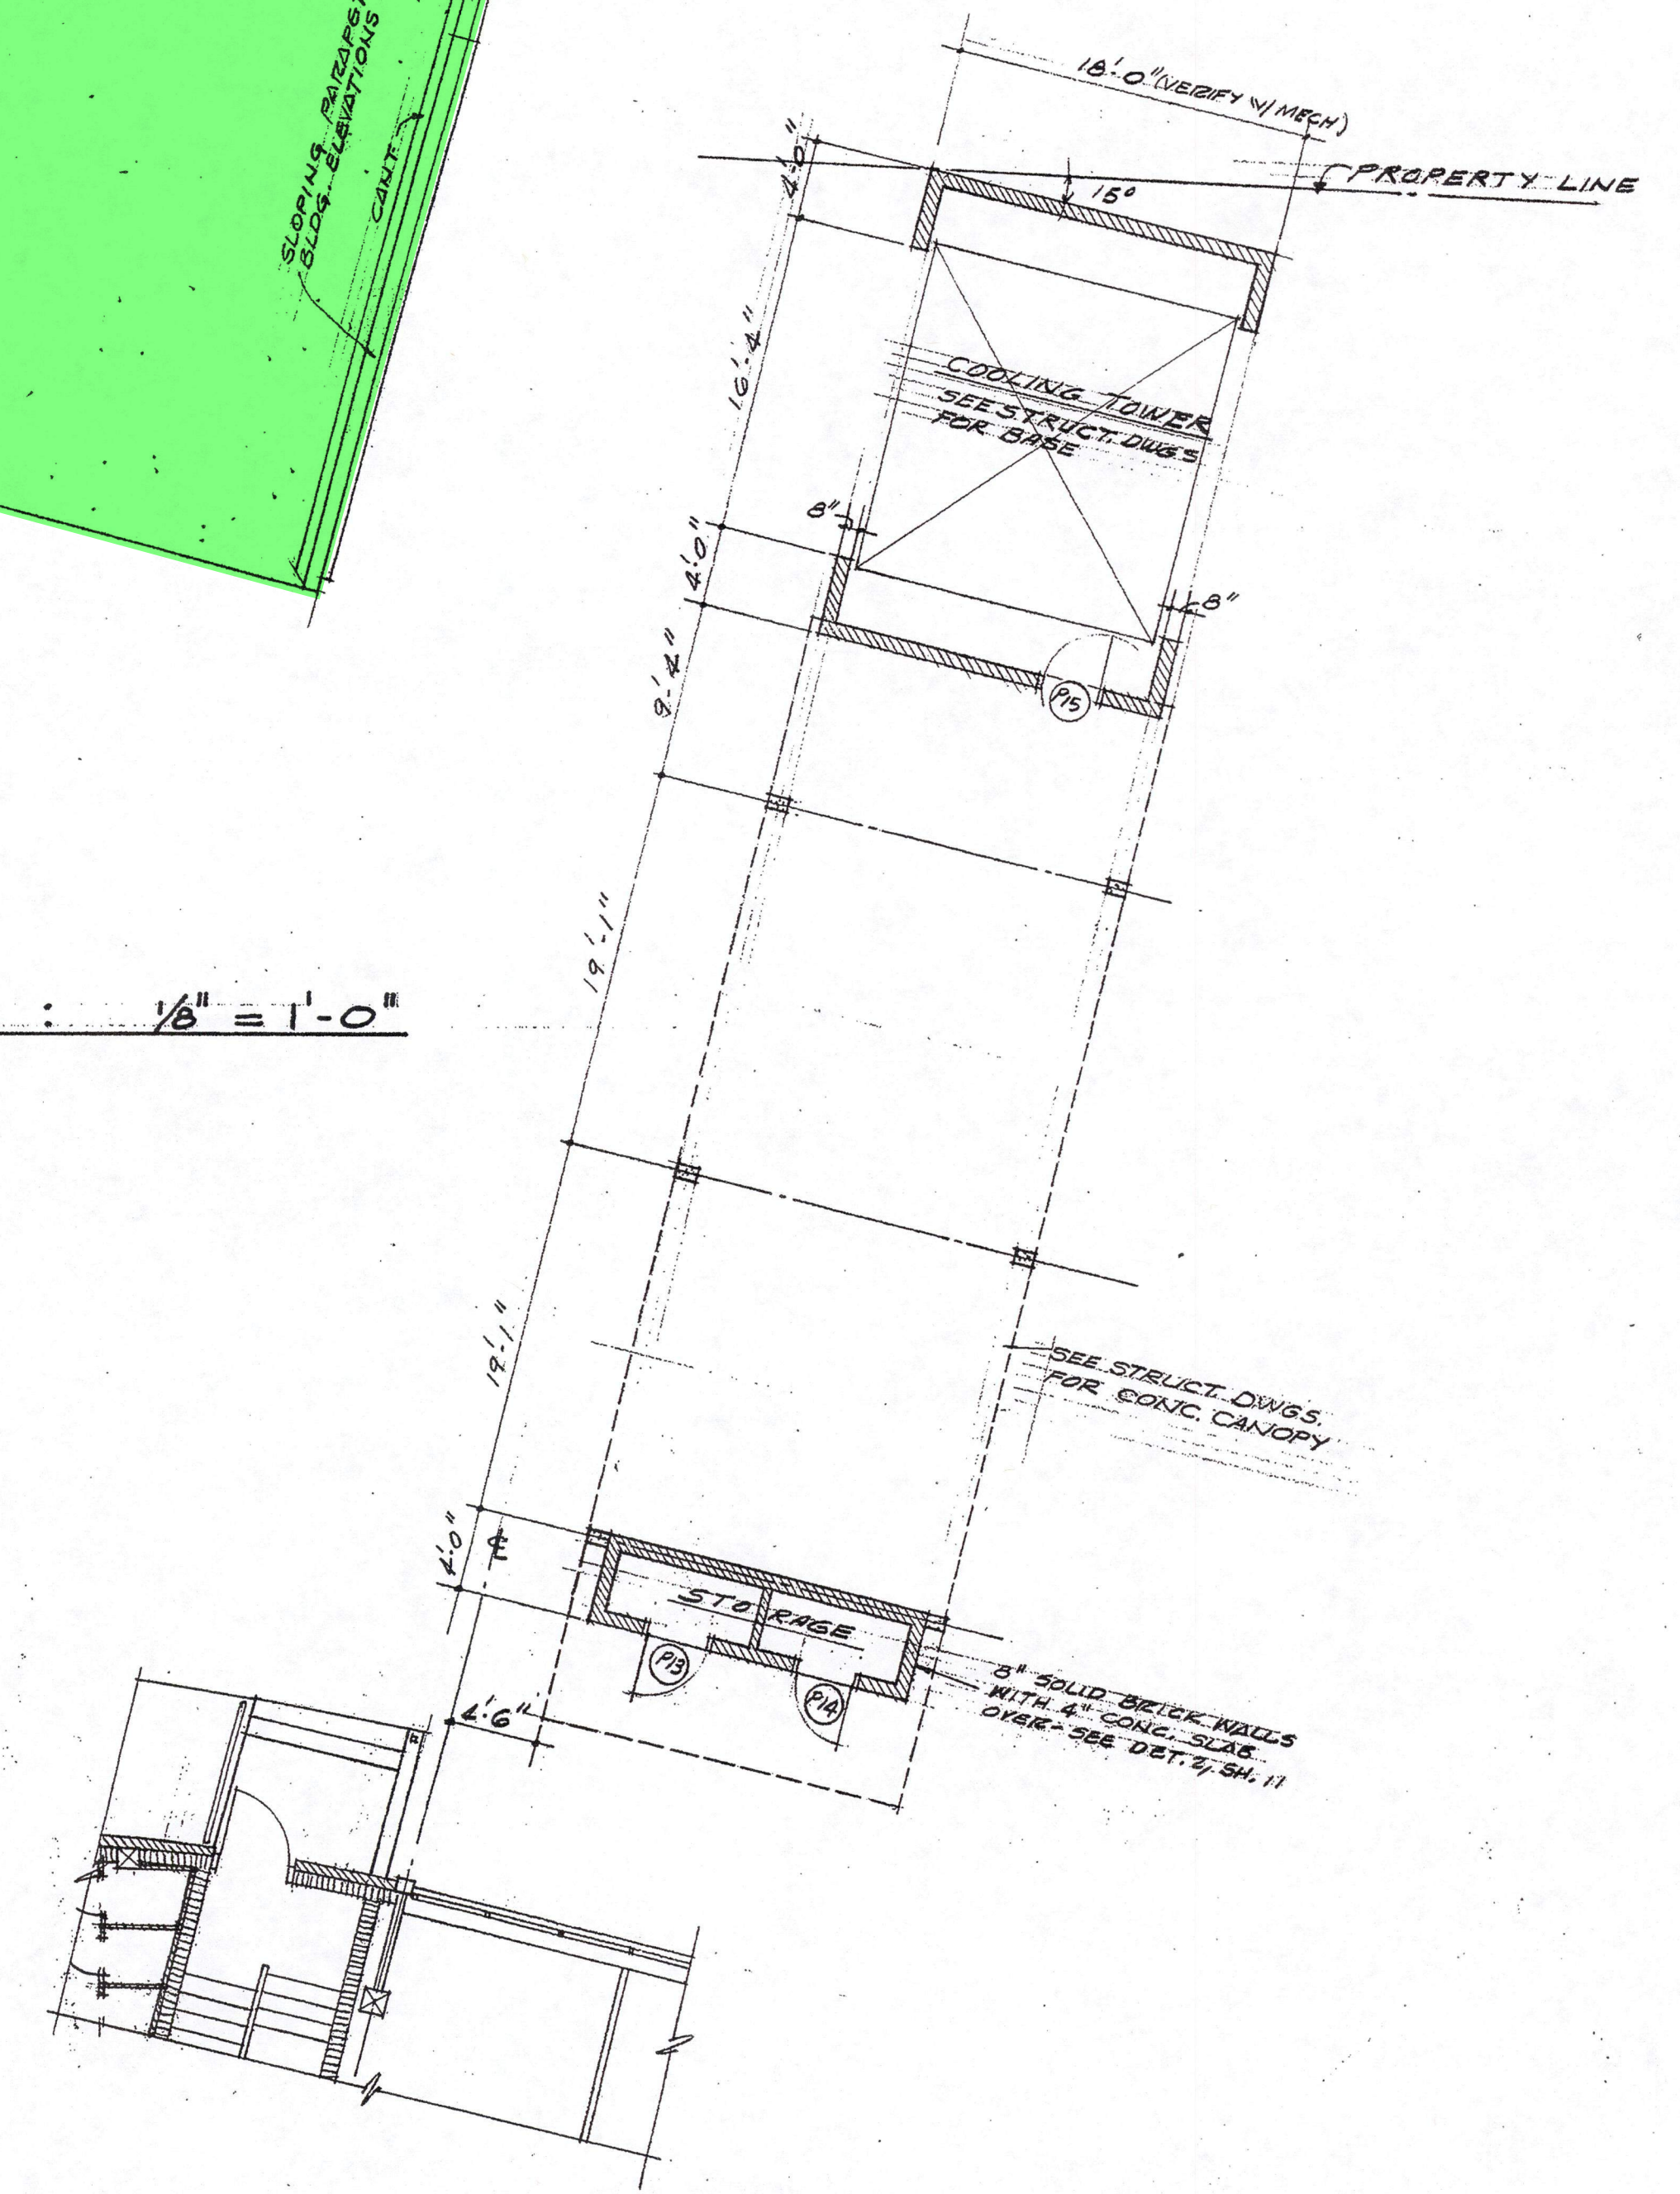
PENTHOUSE AND CARPORT PLANS

PENTHOUSE AND ROOF PLAN

PLAN OF CARPORT 1/8" = 1'-0"

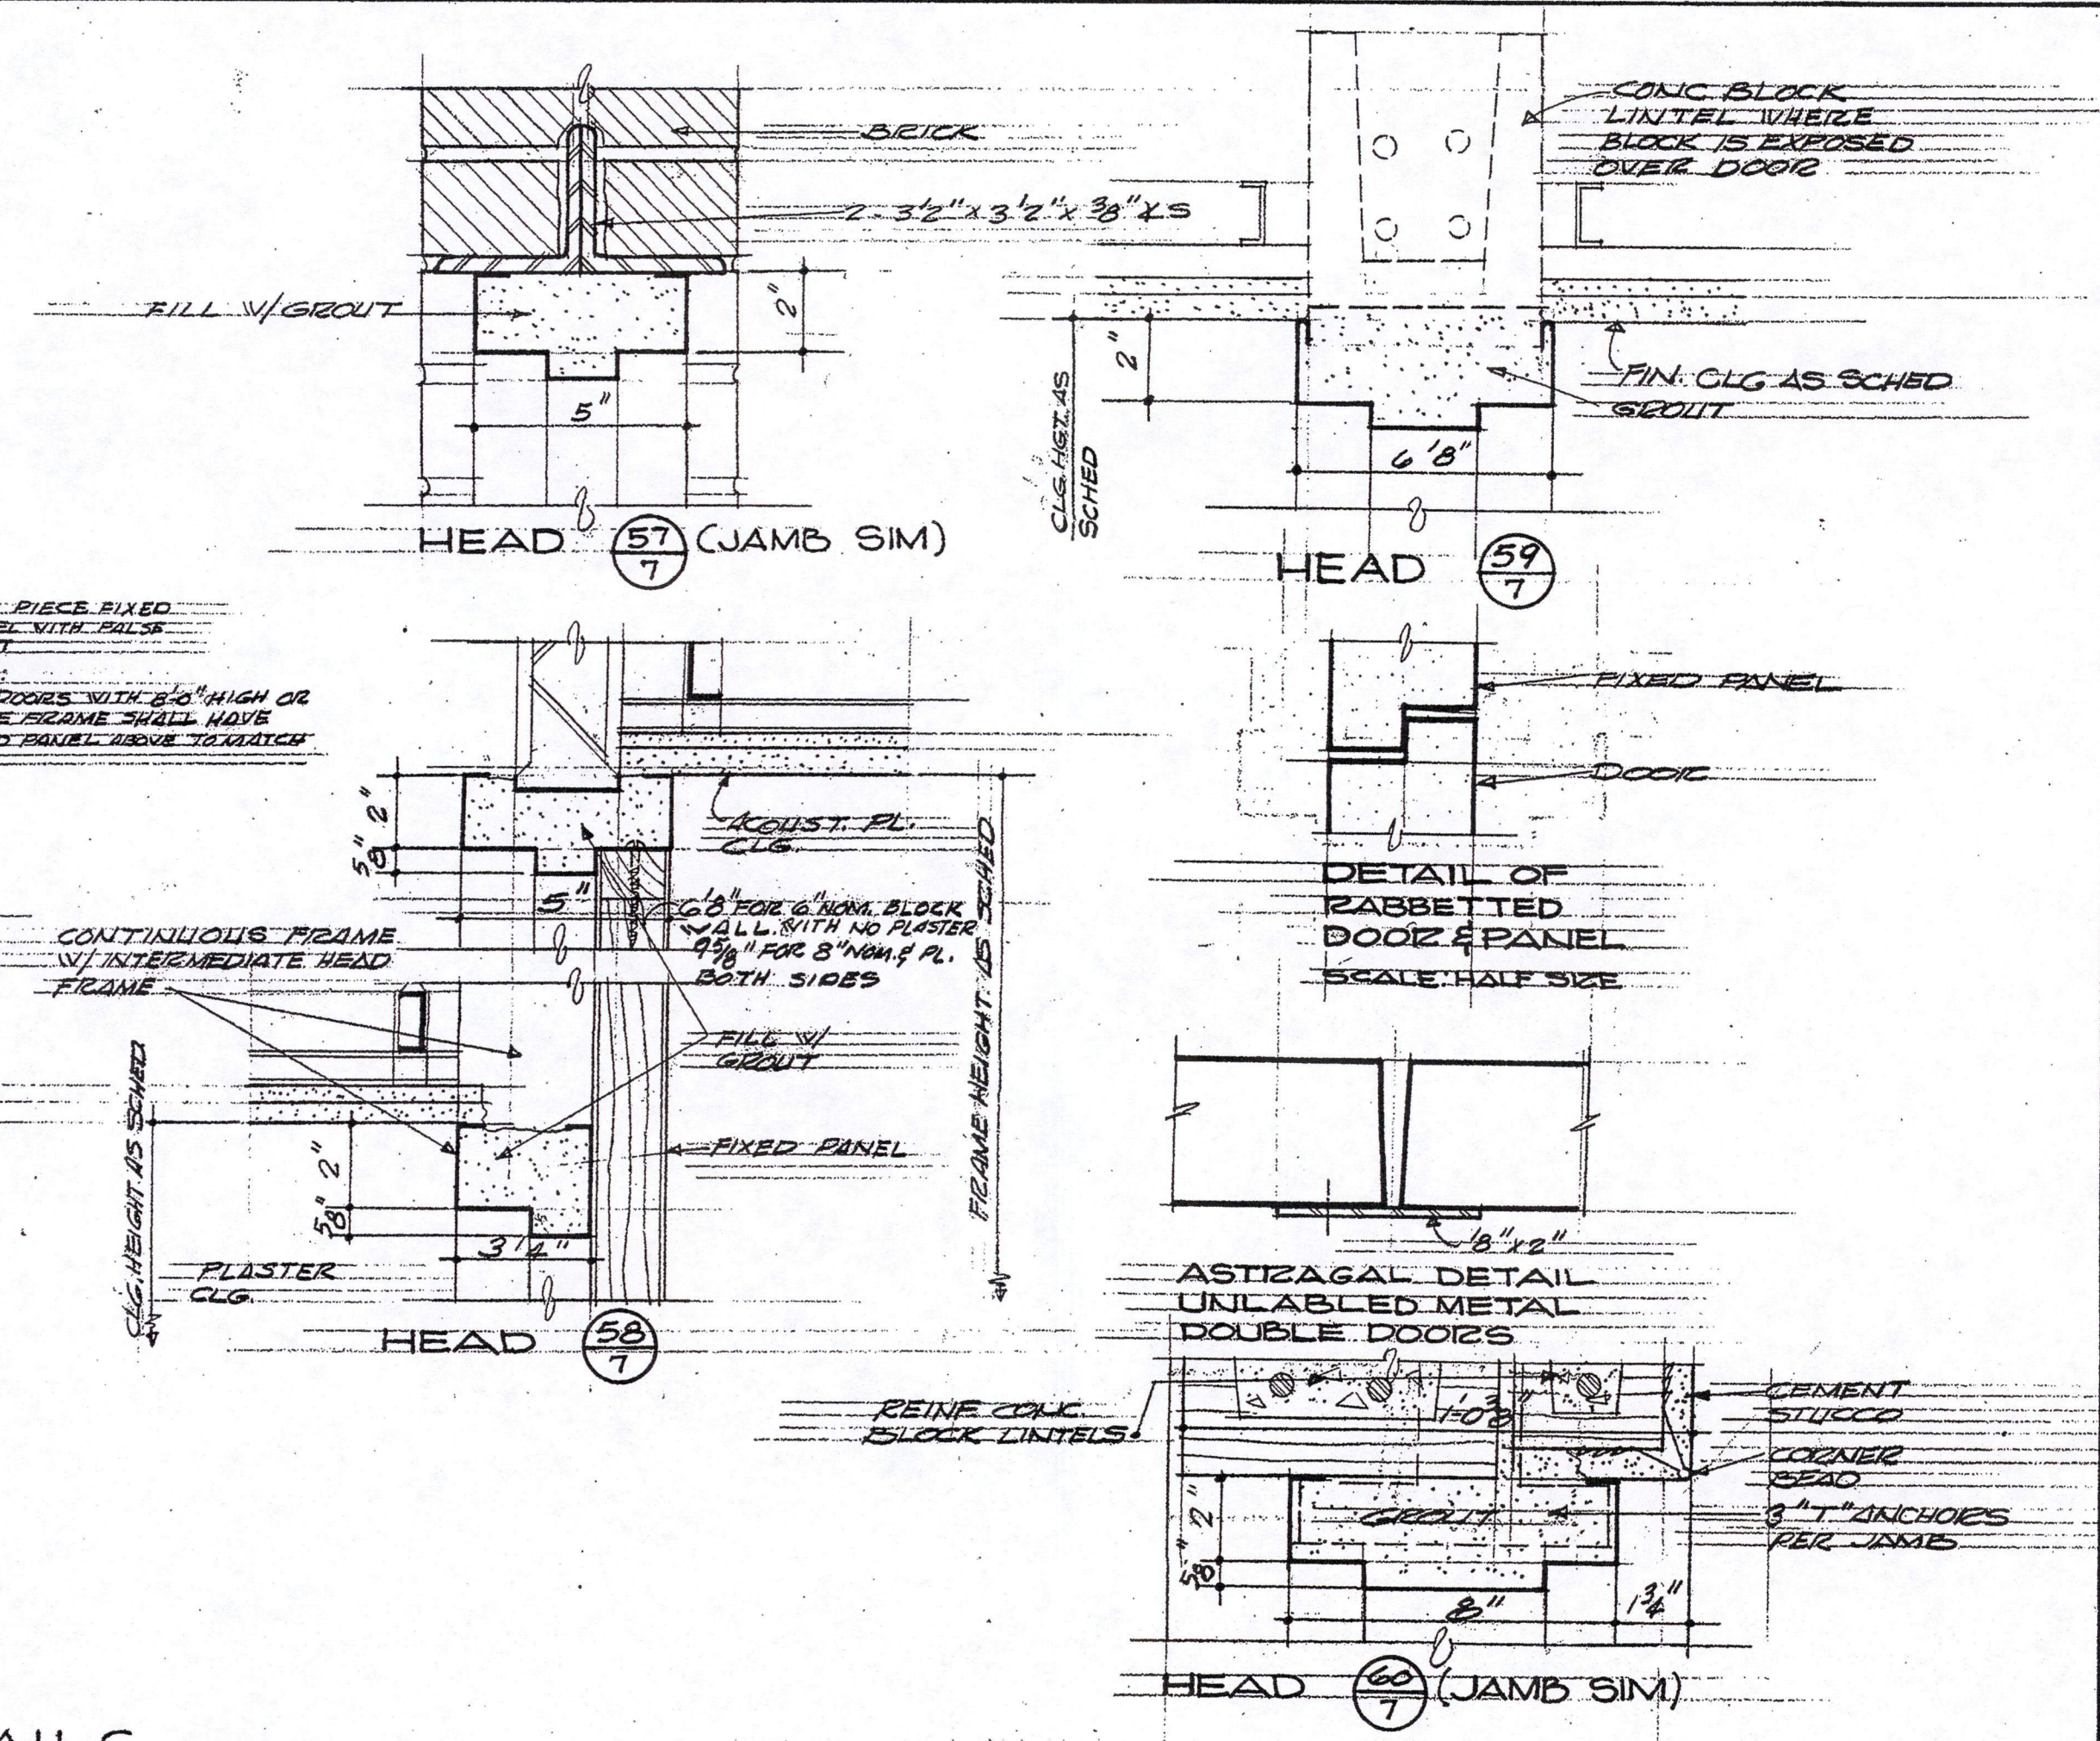
DOOR TYPES, NOTES AND DETAILS  
SEE SHEET 8 FOR ADDITIONAL DETAILS

- DOOR CONSTRUCTION TYPES**
1. WOOD SOLID CORE (WHITE OAK)
  2. WOOD SOLID CORE (RED OAK)
  3. WOOD METAL (UNLABELED)
  4. WOOD METAL (2. FLOOR LABEL)
  5. METAL COVERED PLANK AND INSULATED COLD STORAGE DOOR AS SPEC.
  6. EXTENDED ALUM. STYLES AND GLASS AS SPEC.
  7. ACCORDIAN TYPE FOLDING AS SPEC.
  8. WOOD HOLLOW CORE (WHITE OAK)
  9. WOOD HOLLOW CORE (RED OAK)
- DOOR GLASS TYPES**
1. 3/8" HEAVY SHEET
  2. 1/2" POLISHED PLATE
  3. 1/4" WIDE
- GENERAL NOTES**
1. WOOD ASTRAGAL AS DETAILER SHALL BE USED ON ALL WOOD DBL DOORS.
  2. WOOD SHALL MATCH VENEER.
  3. SEE ASTRAGAL DETAIL SHEET 9 FOR ALL METAL DBL DOORS.
- LOUVER SIZES**
1. 24" x 24" LOUVER AS SPEC.
  2. 36" x 24" " " "
  3. 24" x 36" " " "
  4. 12" x 24" " " "
- 3. LINTELS OVER DOORS ADJACENT TO COLUMNS SHALL BE SUPPORTED AT THE COLUMN WITH A 4"x4"x16" & 1/4" SHORTER THAN THE THICKNESS OF THE LINTEL BOLT & TO COL.**

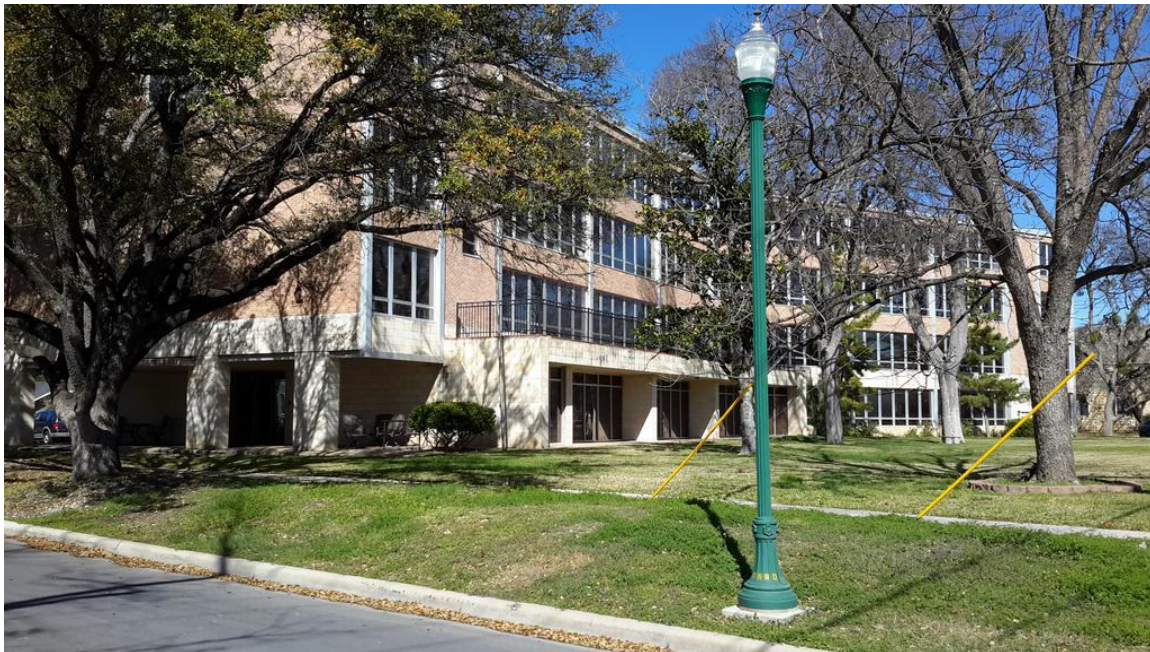
Photo direction: Northeast

Four-story commercial building with a rectilinear, open-V shape and a flat roof. It has a concrete block base, and ribbon windows, which are separated by bands of brick, line the exterior. There is a balcony off the second level spanning from the center of the building to the western end. The primary entry is at the rear of the building off the parking lot.

☒ Additions, modifications: Primary entrance relocated from the western elevation to the rear of the building; circle drive at western elevation removed; lower level wing at rear of building demolished; slatted wall screens located on brick bays between 2nd and 4th floors removed; folding plate wall canopy removed from rear of building. Alterations date to c.2010.
