Consider Resolution #21-01 for the approval of the Prairie Shores Coastal Resource Management & Restoration Study

Prairie Shores Coastal Resource Management and Restoration Study

Prepared for: Village of Pleasant Prairie, WI

Prepared by: Clark Dietz, Inc.
Date: February 2021

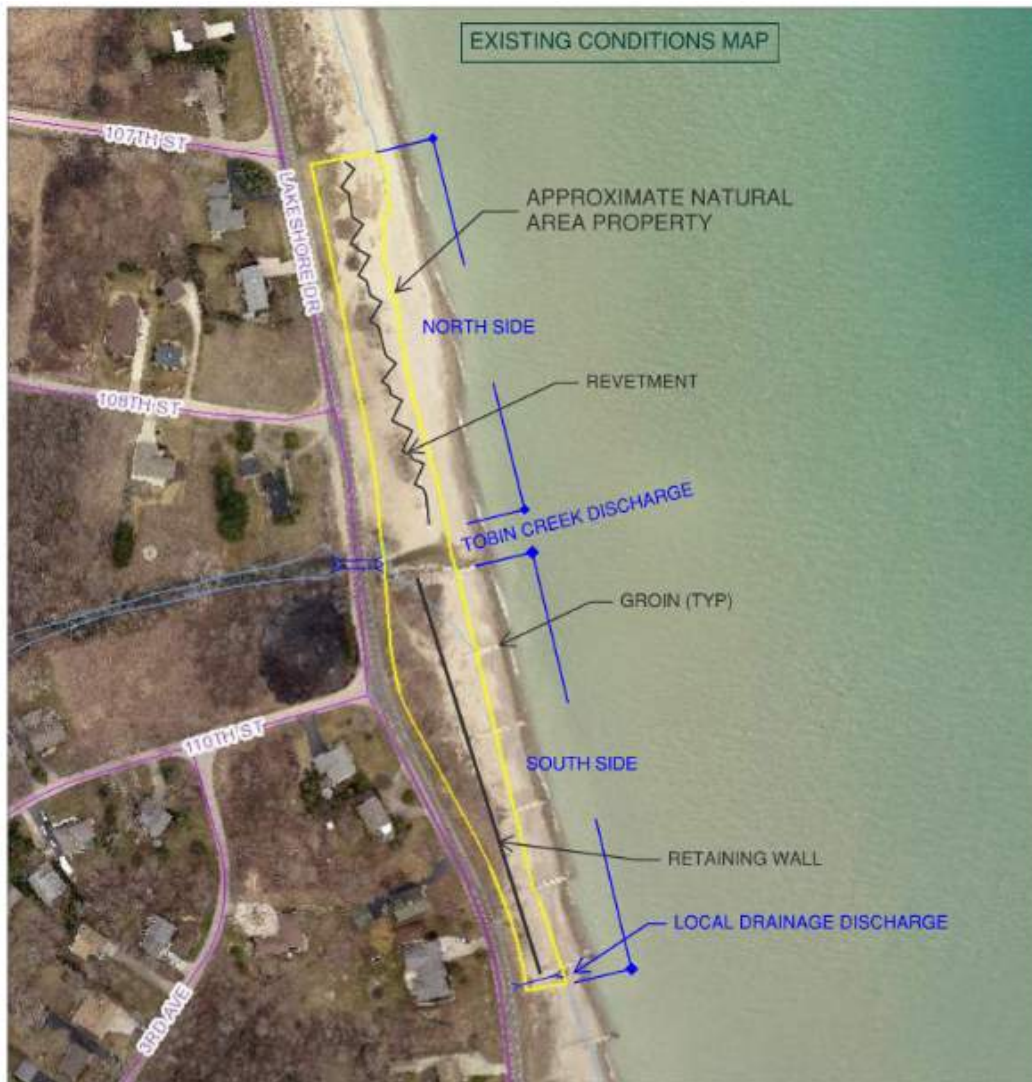
As stated above, the Prairie Shores Natural Area (Prairie Shores) covers approximately 2.64 acres of waterfront east of Lake Shore Drive between 107th Street on the north and 113th Street on the south. The overall length of lakeshore is approximately 1,300 feet. The follow provides an overview of the current status of the natural area along with observations taken during a site visit conducted in mid-summer 2020. Figure 1: Prairie Shores Natural Area Existing Condition below provides a visual reference for the descriptions noted.

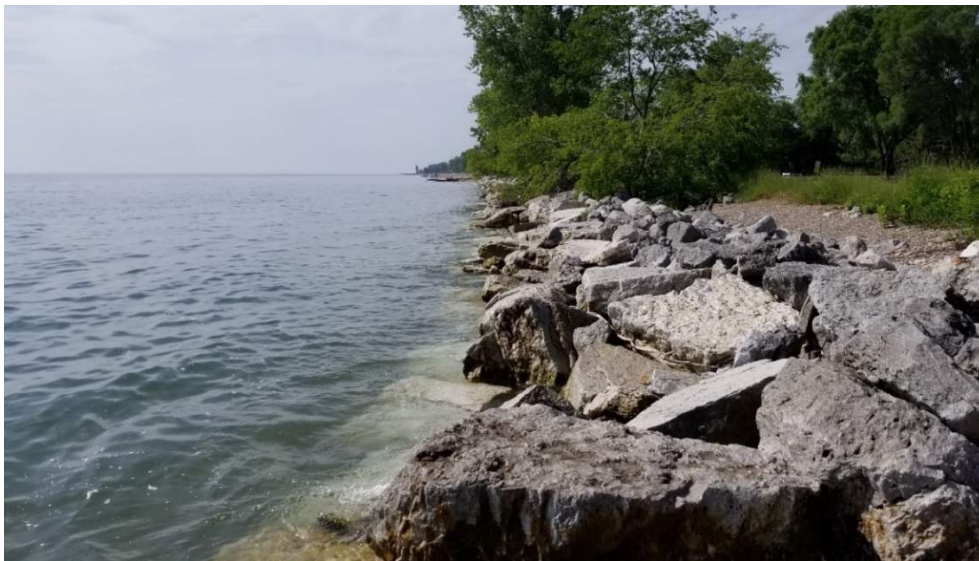
Figure 2: Existing Revetment Looking South below is a photo of the existing revetment looking south.

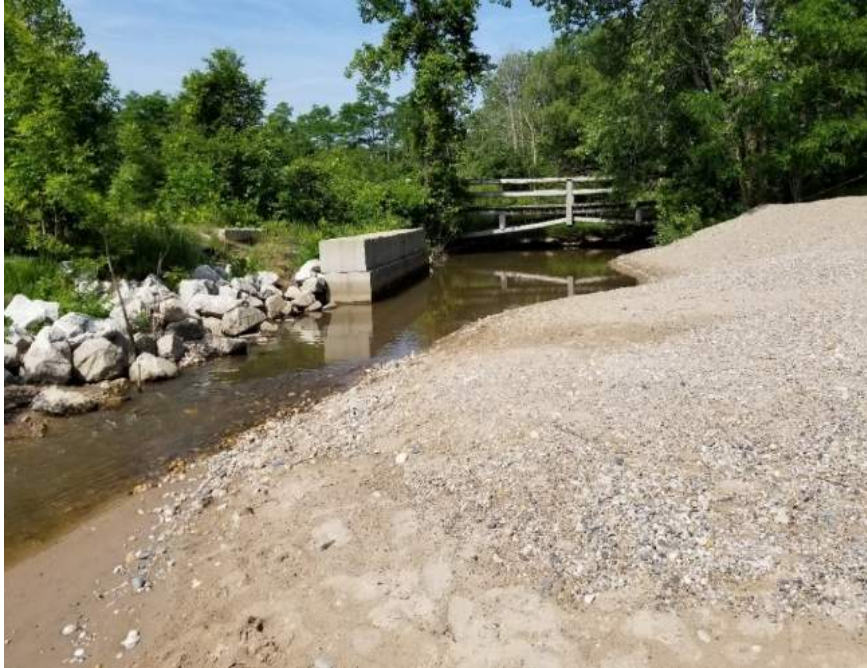
Between the 108th St and 110th St intersections the Tobin Creek discharges to Lake Michigan. Tobin creek flows through two large culverts under Lakeshore Drive and a wooden walking bridge that connects the current parking area and natural area to the south. Along the south side of the creek discharge there is a retaining wall constructed of “deadman” concrete blocks and rip rap. The concrete retaining wall ends at the west extent of a concrete block groin also constructed along the south side of the creek. Based on observation of historical aerial photos, the deadman concrete wall was installed between 2002 and 2005. On June 30, 2020, a site reconnaissance was completed, the water level in the creek was almost to the crown of the culverts. Furthermore, the water level noted during that visit was at the level of the end of the groin. Wave action was moving sand around the end of the groin. Figure 3: Tobin Creek Discharge Looking Southwest & Figure 4: Tobin Creek Discharge and Groin Looking East below are photos of the creek discharge looking west and east showing the treatments along the creek bank leading to Lake Michigan.

Storms between January 10 to January 12, 2020 caused significant damage to the natural area including the creek. As a result of this storm event, the mouth of Tobin Creek underwent emergency excavation to reestablish flow after sand and gravel had pushed into the creek outlet during the storm surge. The excavated material was moved to the north side of the creek and graded as a temporary measure. The Figure 3 photo shows the graded material on the right side of the creek.

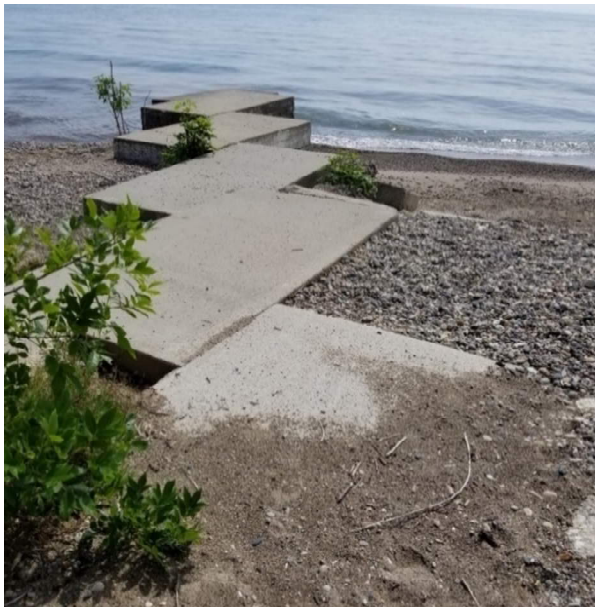
As discussed, the groins have an ability to retain some sand, however they have no effect on reduction of wave action, retention of the dune, or establishment of habitat. Furthermore, the sand has filled in beyond the end of the groins thereby making the groins ineffective at reducing or further mitigating littoral transport of sand.

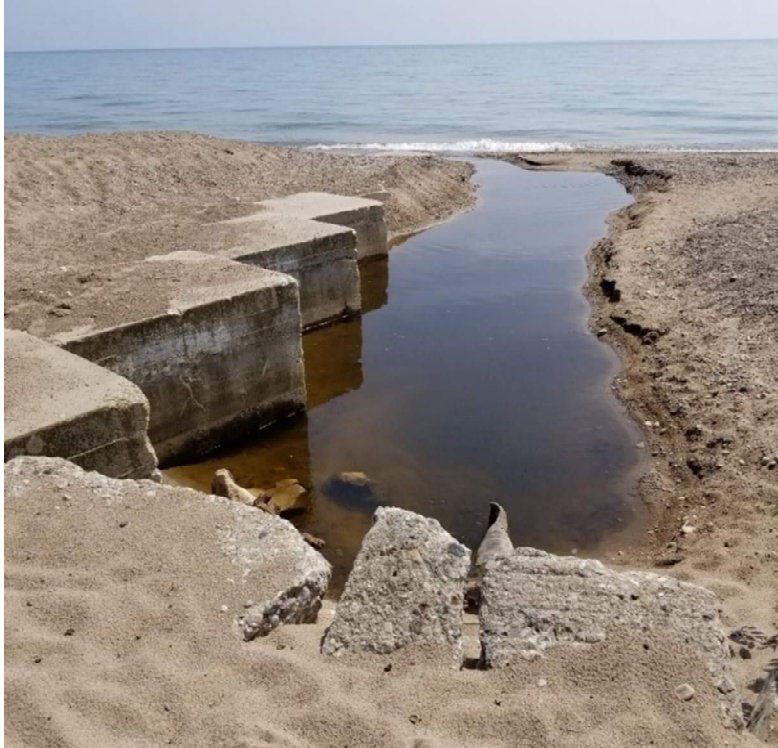
Figure 7: Local Drainage Discharge Looking East

Along Lakeshore Drive south of Tobin Creek there is a storm sewer system that discharges to the lake approximately 650 feet south of the creek culverts. The discharge of the local storm sewer system is a corrugated metal pipe with a Tideflex™ check valve over the end section. It was observed during the site investigation that the discharge of this culvert area appeared to have been excavated leading up to the waterline. Since then, wave action has pushed sand onto the backshore area partially closing off this drainage way creating a pool between the culvert outlet and the waterline. Figure 7 shows the Tideflex™ valve at the bottom of the photo and the pool which has formed looking toward the lake. The drainage way is located just south of southern most concrete groin in the Prairie Shores Natural Area.

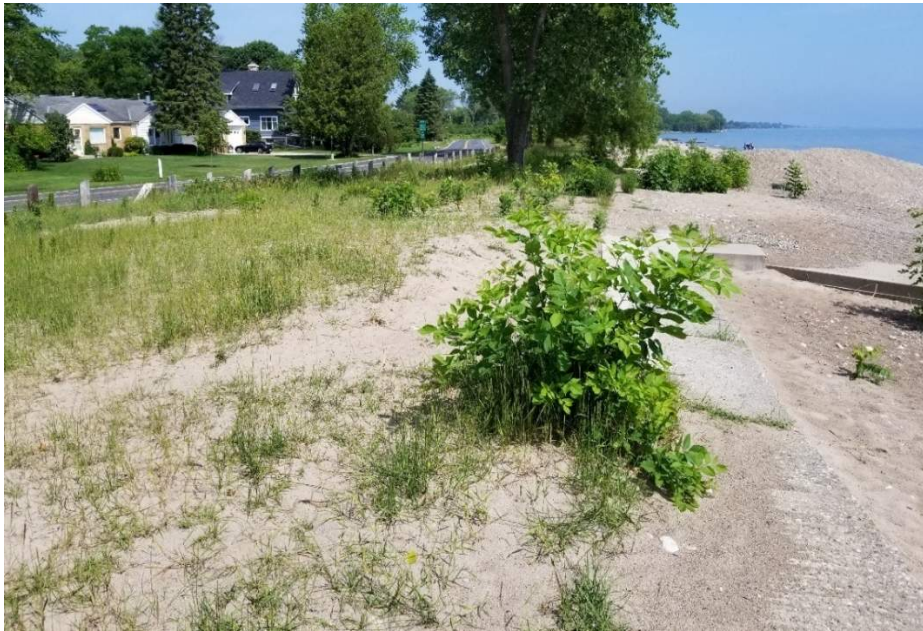
A concrete wall was installed parallel to the water line and is currently between 80 to 100 feet from the water. The concrete wall is more visible to the south with some areas projecting out of the existing dune. Proceeding north, the wall has been obscured by the sand. The wall appears to begin south of Tobin Creek and extend beyond the public property to the south, roughly 850 feet as measured off historic aerial photos. The wall itself has little effect on maintaining the dune other than creating a

solid barrier for collection of windblown sand. Dune grasses and vegetation appear to be taking hold on the west side of the wall away from the lake while the east side toward the lake is mostly sand with little vegetation. Figure 8 is a photo of the existing retaining wall buried in the remnant of the dune looking north.

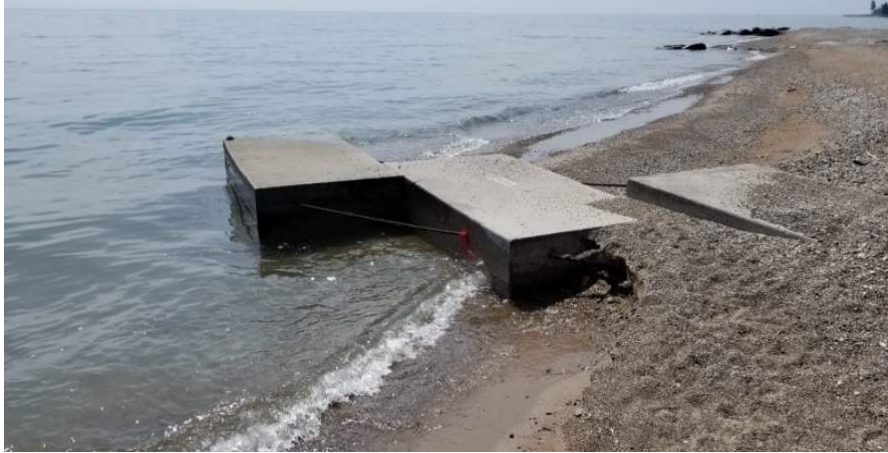
The existing groins as described earlier extend to the waterline and act in some minimal fashion to maintain the sandy shoreline. There are a total of 8 concrete block groins extending approximately 90 feet from the concrete retaining wall. The short comings of the groins are clear in that they are no longer effective to protect against continuing littoral transport of sand due to longshore flow. As a result, the groins have reached their potential for retention of shoreline sands. More importantly, the

groins do not provide protection to the backshore area in a manner that will mitigate wave action or continue growth of a natural dune, associated vegetation, and habitat. Figure 9 is a photo of an existing groin looking south.

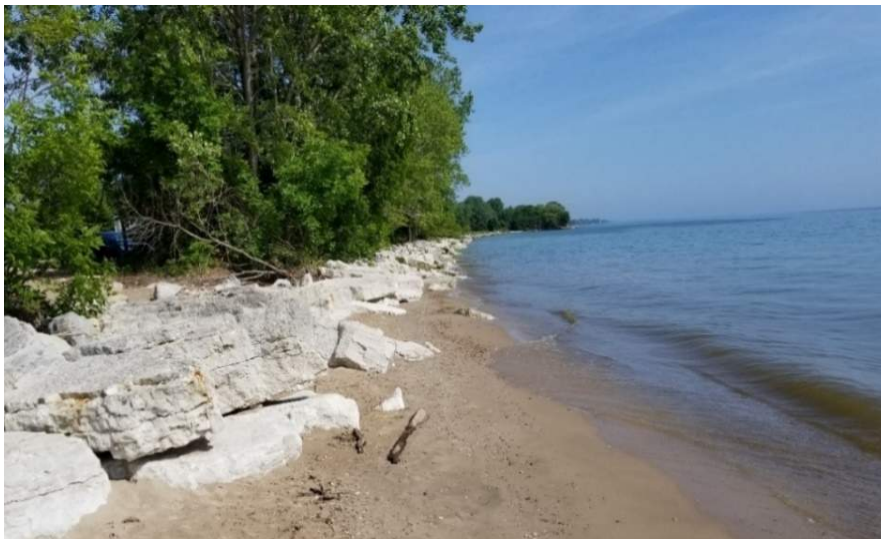
The existing revetment to the north consisting of heavy rock rip rap (4 to 5ft size) which has the effect of armoring the northern shoreline against wave action. The existing revetment extends approximately 1,500 feet from Tobin Creek well beyond the northern extent of the public property. The revetment, as

it is installed, does not encourage creation and growth of a sand dune structure at the rear of the shoreline area nor does it assist with maintenance of dune vegetation. The vegetation behind the revetment is generally grasses and weeds, however some trees have taken root and have been allowed to grow and mature over the years. Figure 10 is a photo of the existing revetment looking north.

As seen in this picture, the rock revetment can act as an accelerator to erosion of the shoreline sand. The revetment will armor the foredune area of the shoreline but will not protect the beach itself. The revetment does not dissipate energy from incoming waves but instead will cause waves to reflect off the rocks thereby moving sand back into the lake. Studies targeting sand movements have been

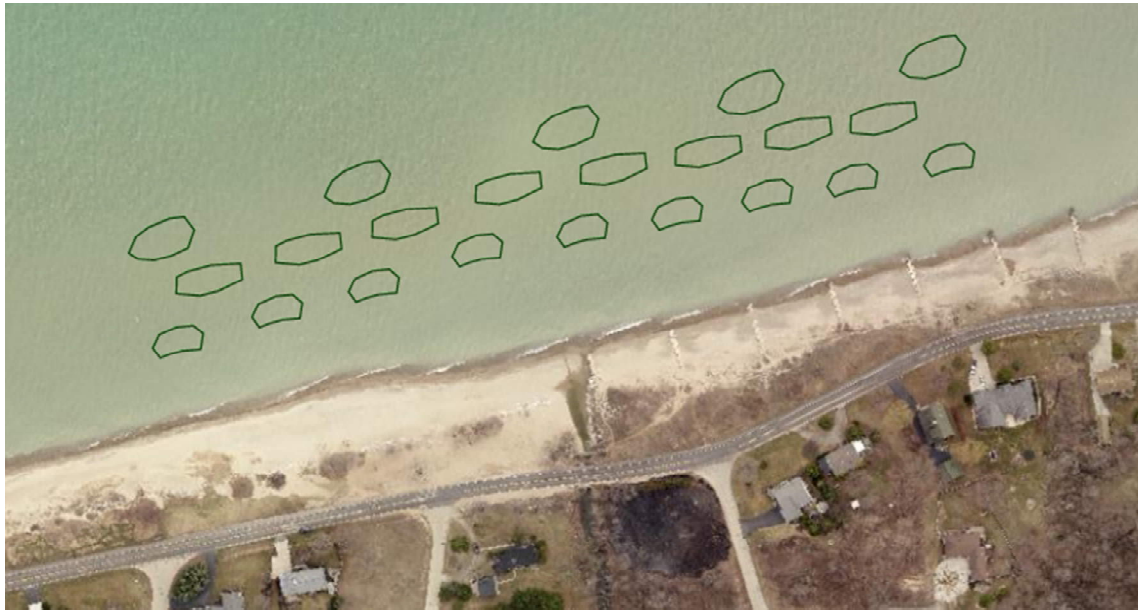
Figure 35: Layout of Offshore Breakwaters

Studies performed around the world on both artificial and natural reefs suggest that an artificial reef designed close to shore (less than 200 feet) can cause currents between the reef and the shore that

would promote erosion while reefs further from the shore are best at protecting and promoting shoreline maintenance and dune growth. A series of reefs as shown in Figure 35 would mitigate wave reflection and interrupt longshore flows.
