Village Board of Trustees Work Session Agenda

# Village of Scarsdale Flood Mitigation Projects

# PAVEMENT MANAGEMENT FINAL PROJECT REPORT

Scarsdale, NY - PATHWAYS

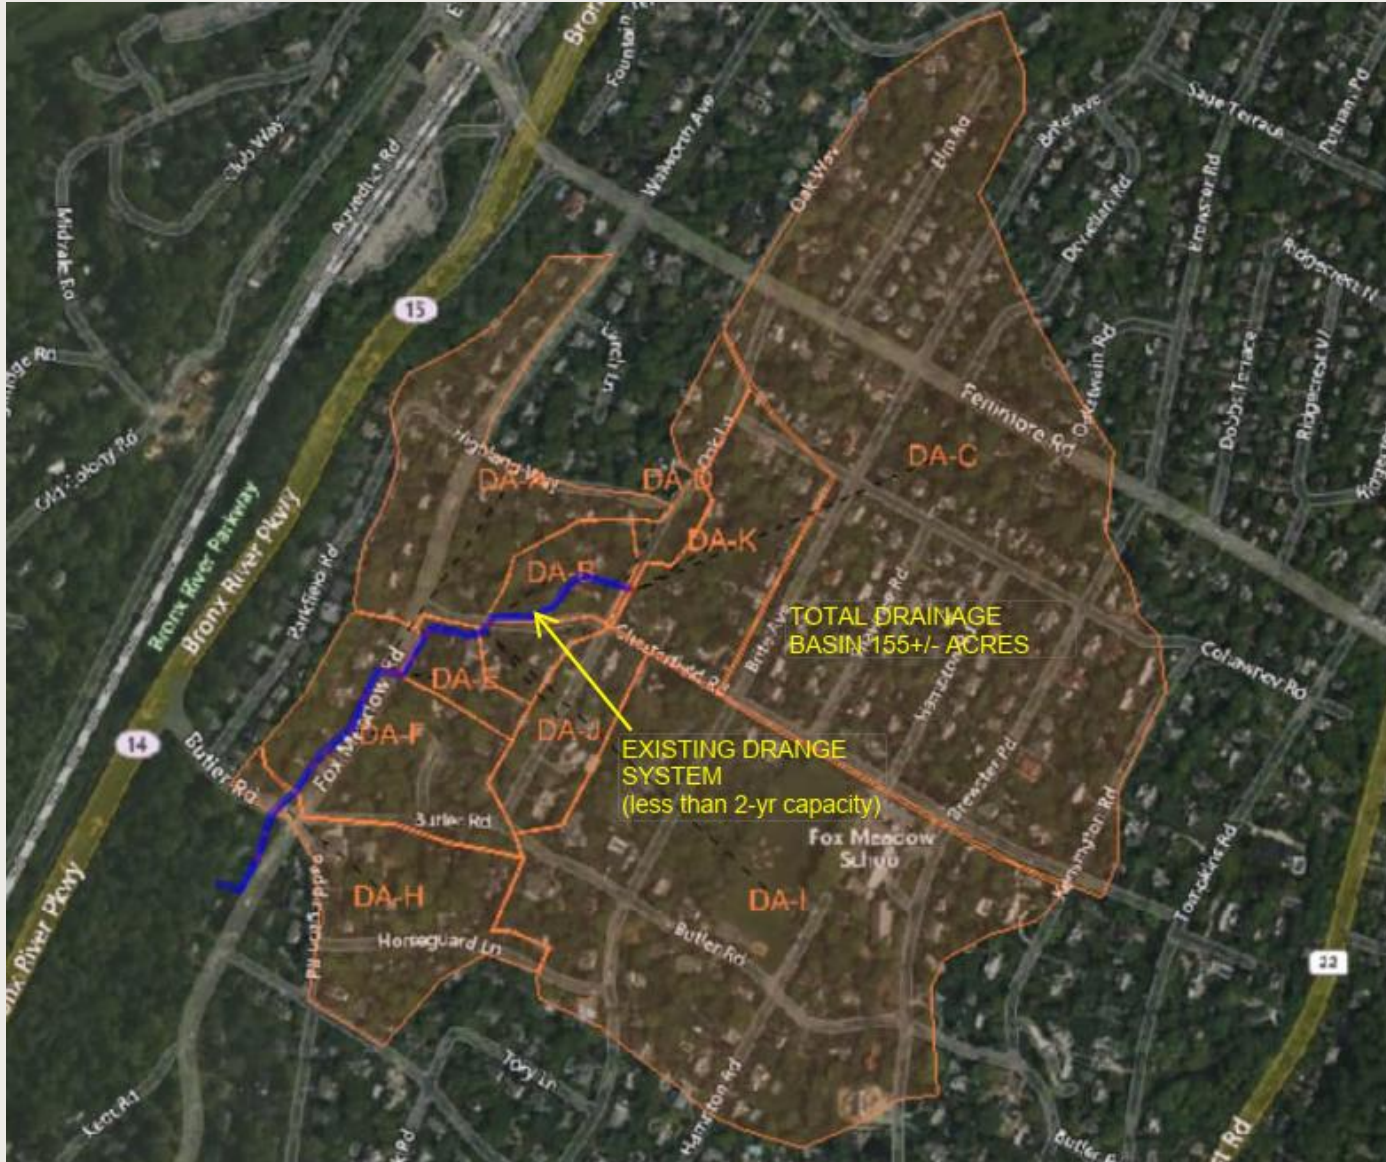
# Brite Avenue/Fox Meadow Road Project Area

- Total drainage basin for the project site is approximately 155 acres.
- Existing drainage system has less than a 2-year storm capacity.

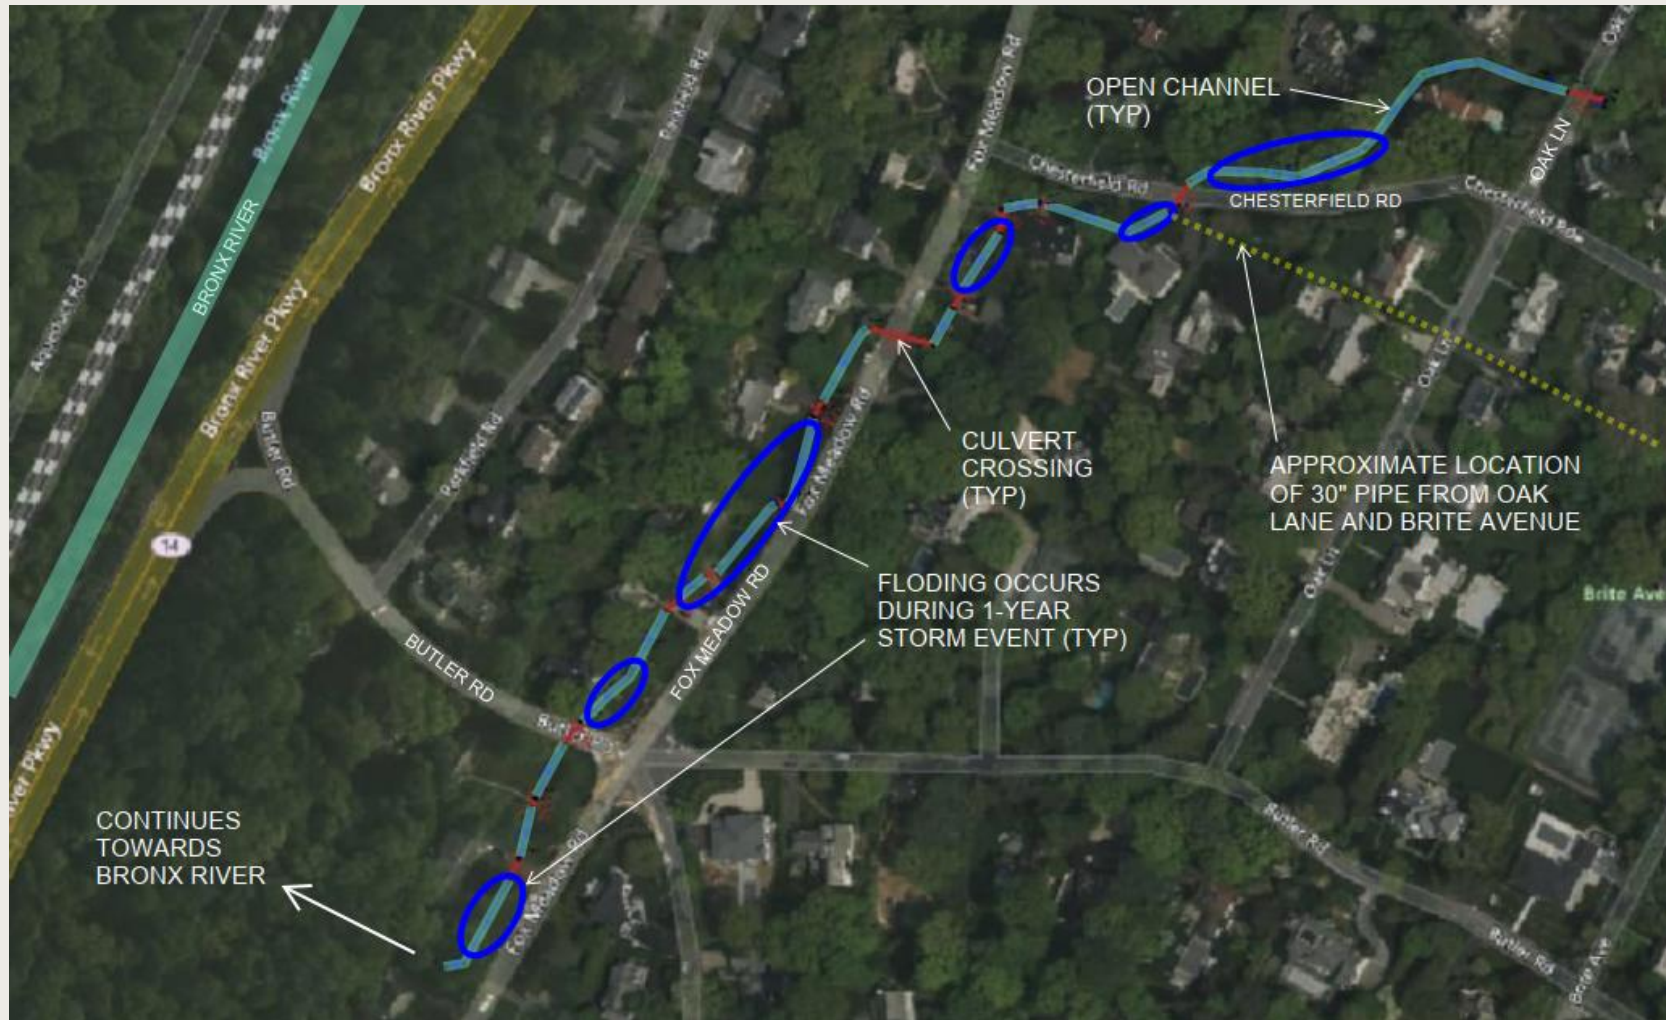
# Brite Avenue/Fox Meadow Road Project Area

- Existing drainage system consists of a combination of open channel and culverts that meander through residential properties.
- Existing drainage system has less than a 2-year storm capacity with flooding occurring at several locations during the 1-year storm event.
- Existing drainage system has less than a 2-year storm capacity.

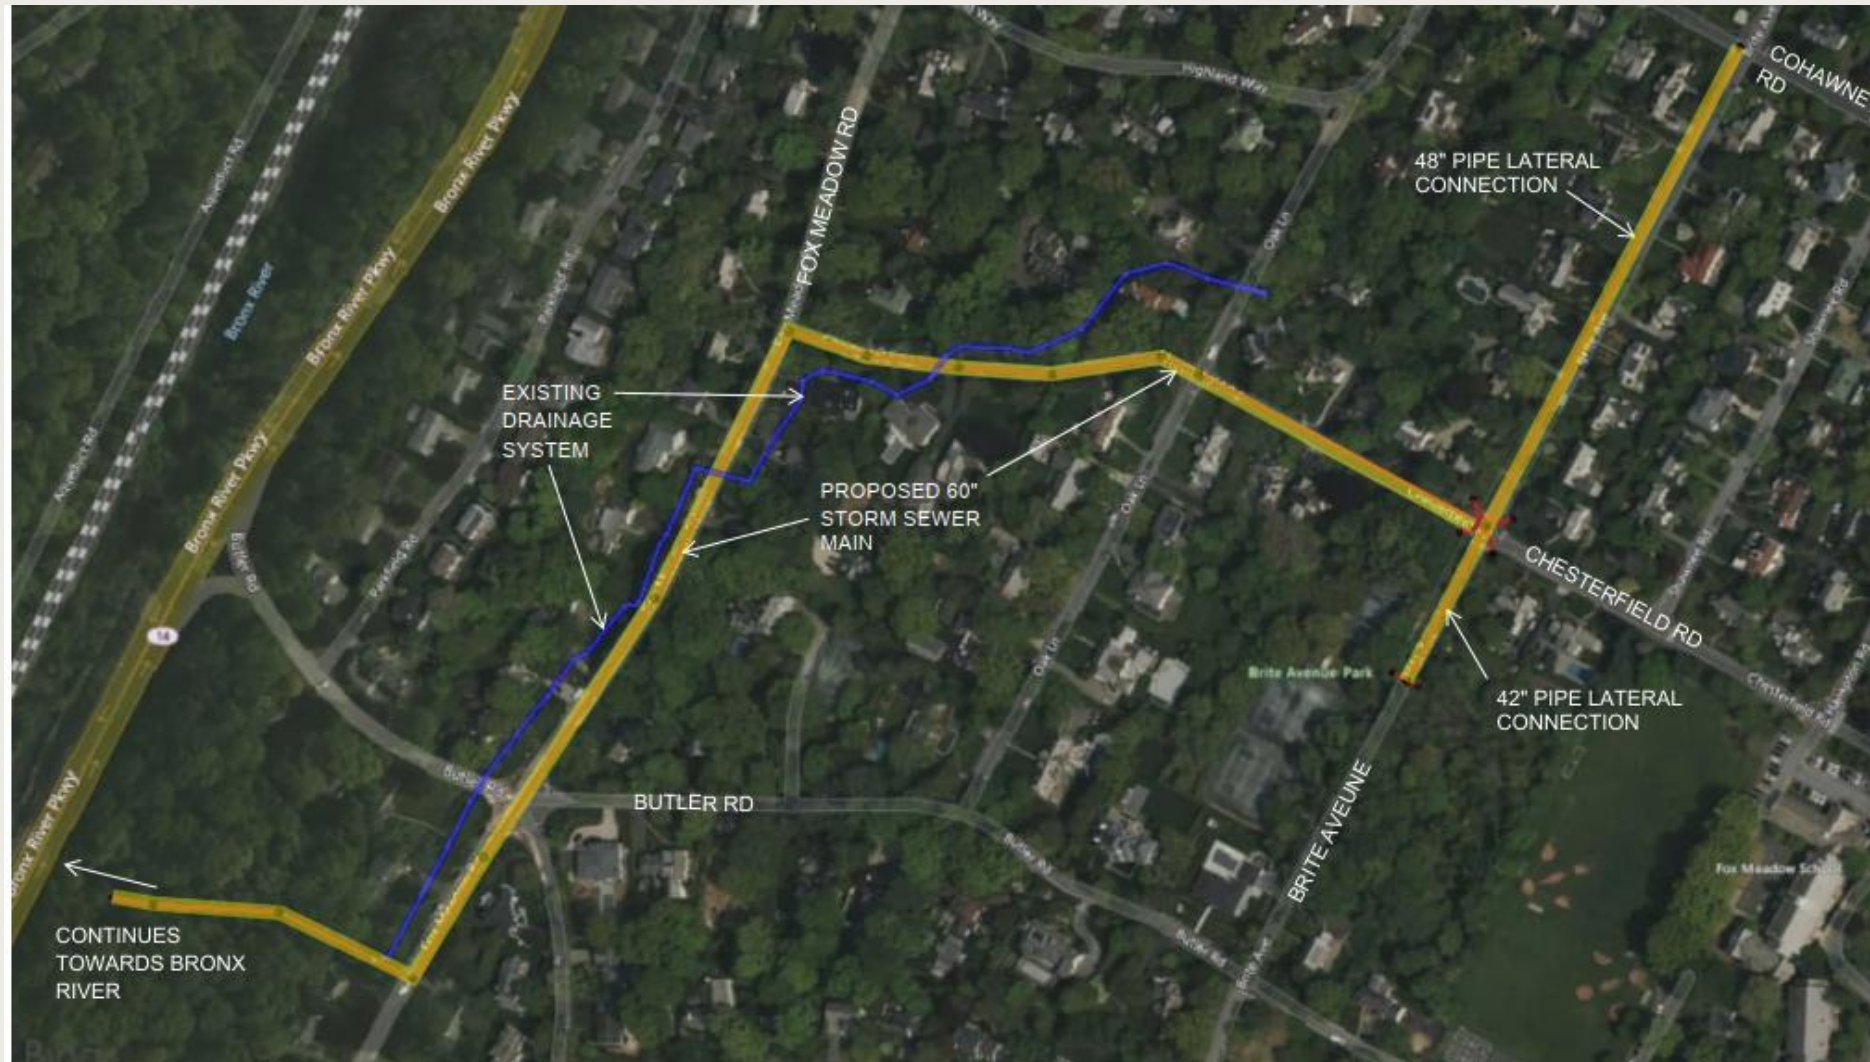
# Brite Avenue/Fox Meadow Road Project Area

### Improvements:

- Construct new supplemental storm drainage system along Fox Meadow Road, Chesterfield Road and Brite Avenue.
- New drainage system will consist of pipes ranging in size from 42-inch to 60-inch diameter.
- New drainage system will have 100-year storm capacity.
- Existing open channel will remain active.

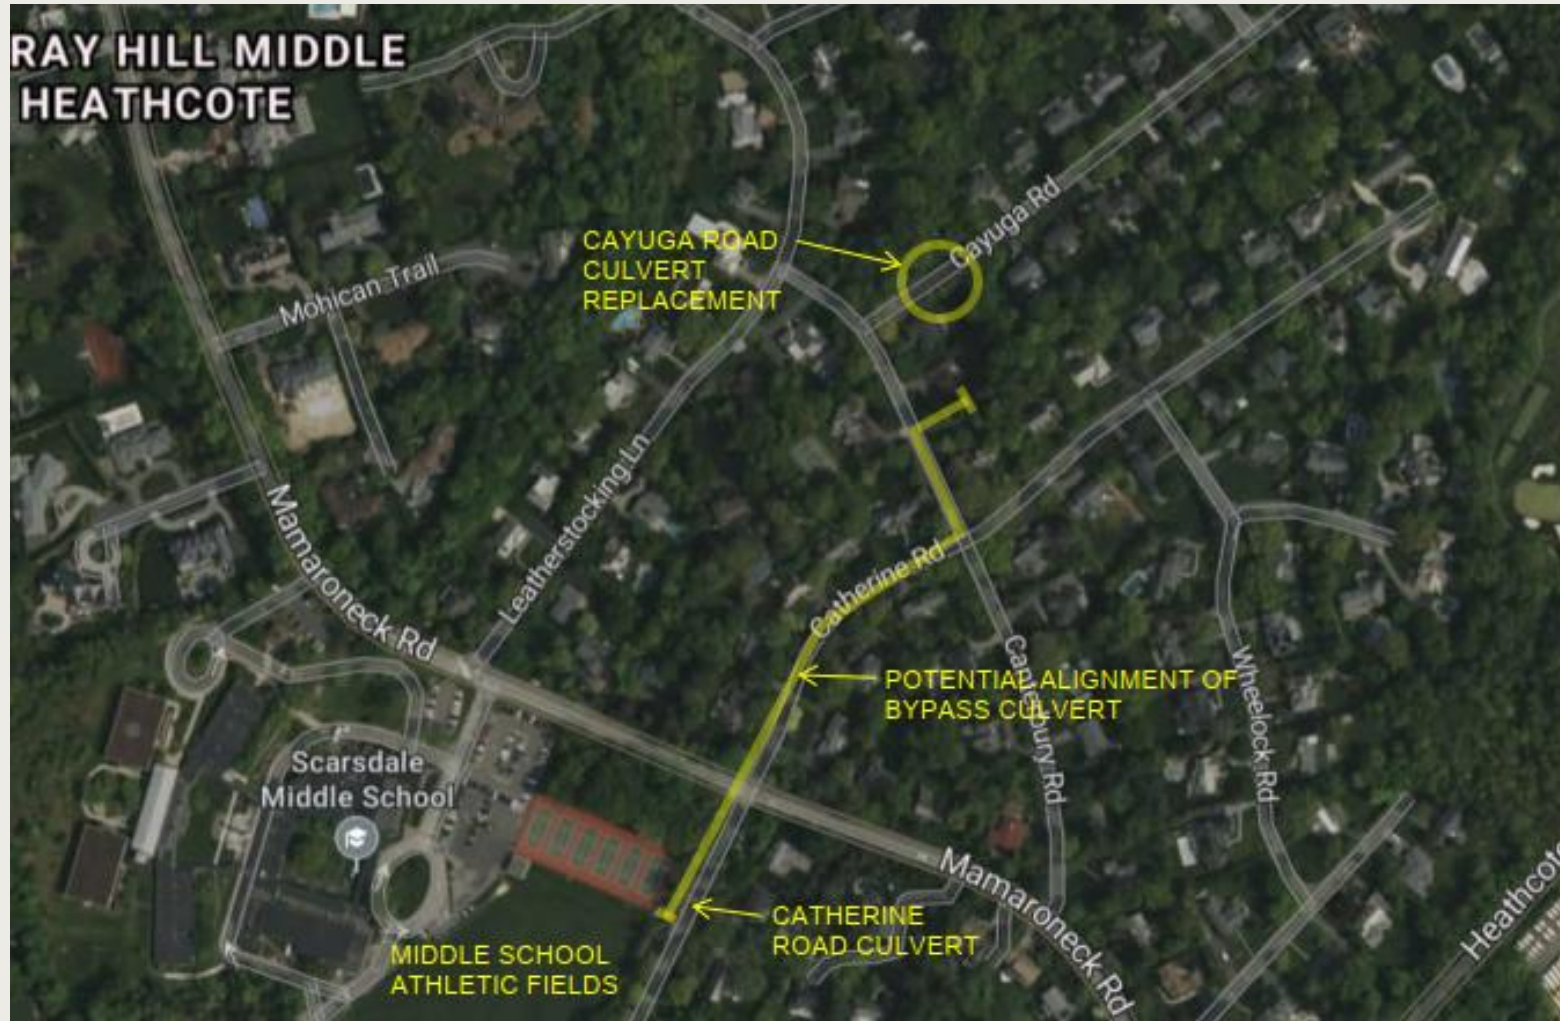
# Sheldrake River Flood Mitigation Project

## Proposed Improvements:

- Catherine Road Culvert Replacement: Replacement of the two Catherine Road culverts adjacent to the Scarsdale Middle School athletic fields.
- Cayuga Road Culvert Replacement: Enlarge Cayuga Road culvert to increase flow capacity.
- Bypass Culvert: Installation of approximately 1,400 feet of 10'x 4' box culvert to bypass flows from Cayuga Road area downstream to the Scarsdale Middle School athletic fields area.
- Middle School Detention Facility: Large underground detention structure below athletic field. Diversion structure in channel to control flow into detention structure and pumps required to regulate flow from detention structure.

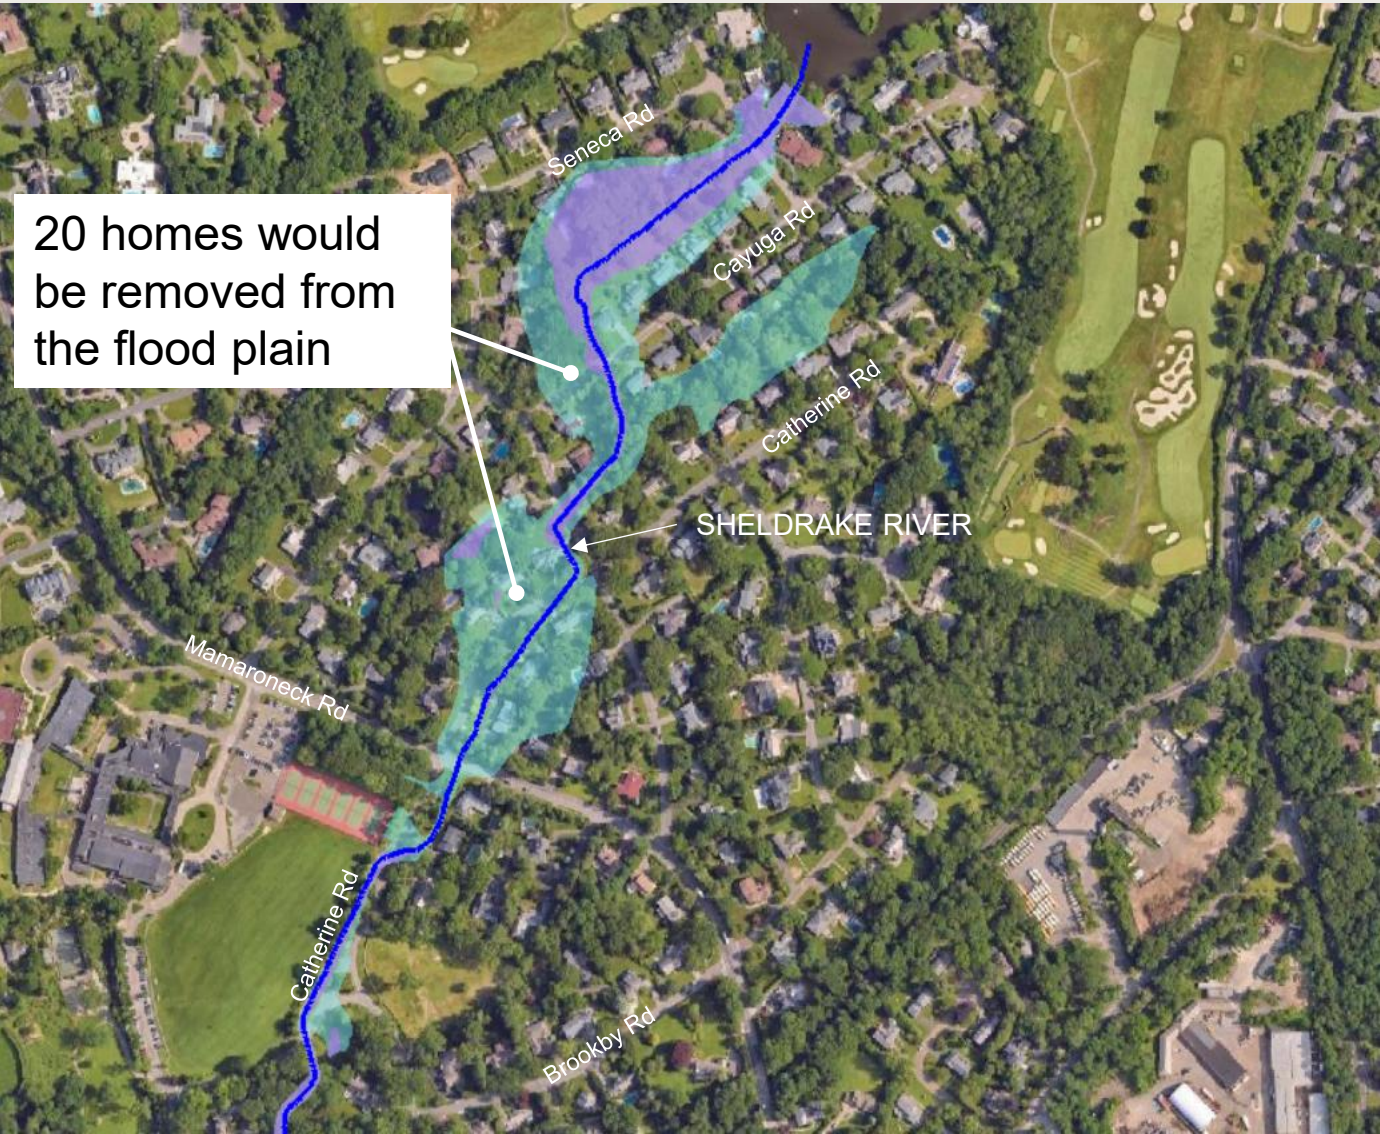
# Sheldrake River - Bypass Culvert and Cayuga Road Culvert

Storm Event		Existing Conditions	Proposed Improvements	Diff
		WSEL (ft)	WSEL (ft)	(ft)
Oneida Road				
100-Year	241.08	240.92	-0.16	
Cayuga Road				
100-Year	240.9	238.37	-2.53	
Canterbury Road				
100-Year	240.83	237.54	-3.29	
Catherine Road				
100-Year	240	236.41	-3.59	
Mamaroneck Road				
100-Year	239.95	234.06	-5.89	
Catherine Road				
100-Year	234.54	232.74	-1.8	
Catherine Road				
100-Year	231.86	230.78	-1.08

- Similar benefits for all storm events

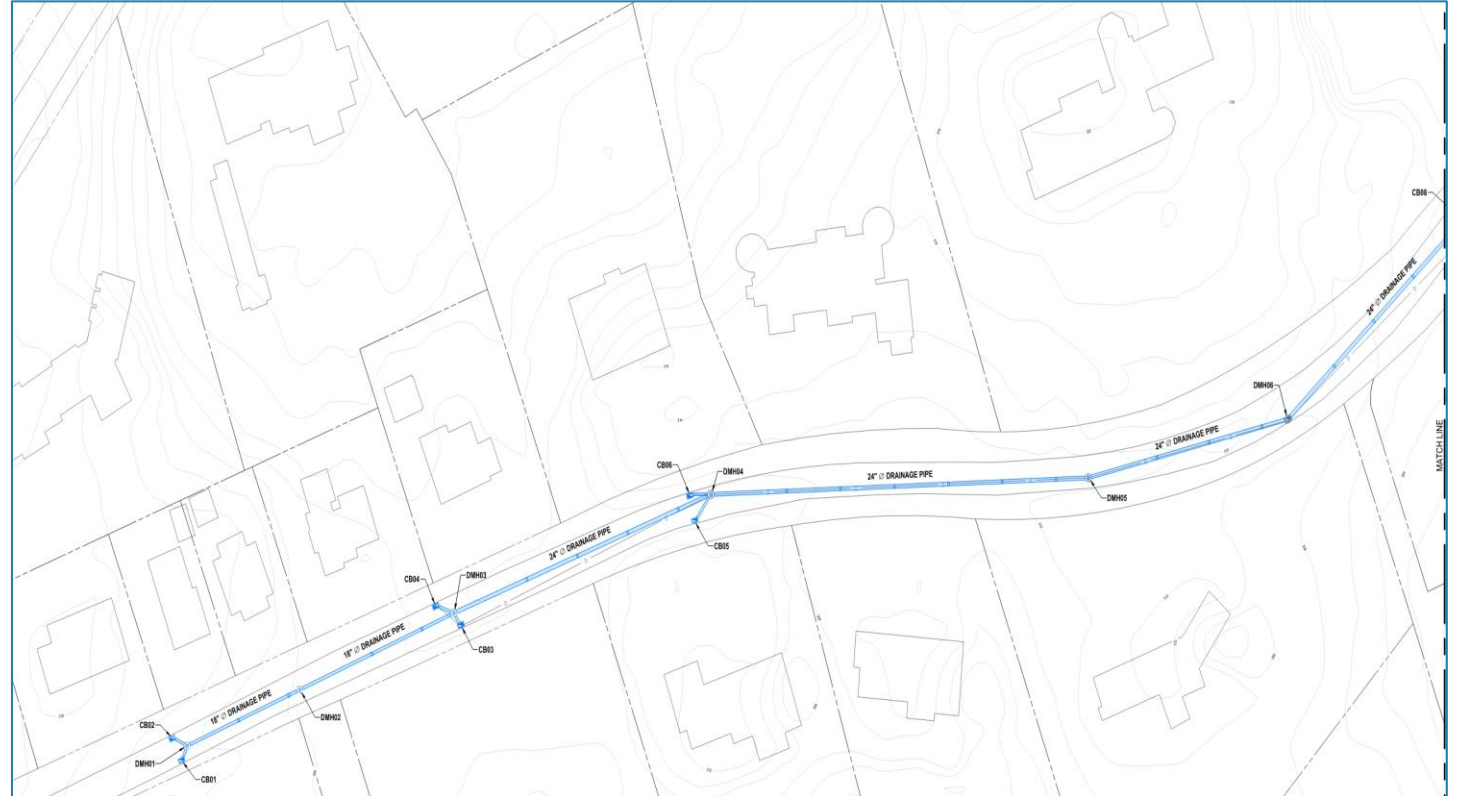
# Cushman, Willow, and Sheldrake – Drainage Area 1 (Cushman West)

## Proposed Improvements:

- Install approximately 2,040' of new drainage infrastructure within Cushman Road.
- It is recommended that 7 existing structures should be removed and replaced with NYSDOT standard catch basins.
- Install an additional 8 catch basins within Cushman Road to assist in runoff capture.

- Provide a higher level of collection and conveyance to reduce runoff bypassing the existing infrastructure.

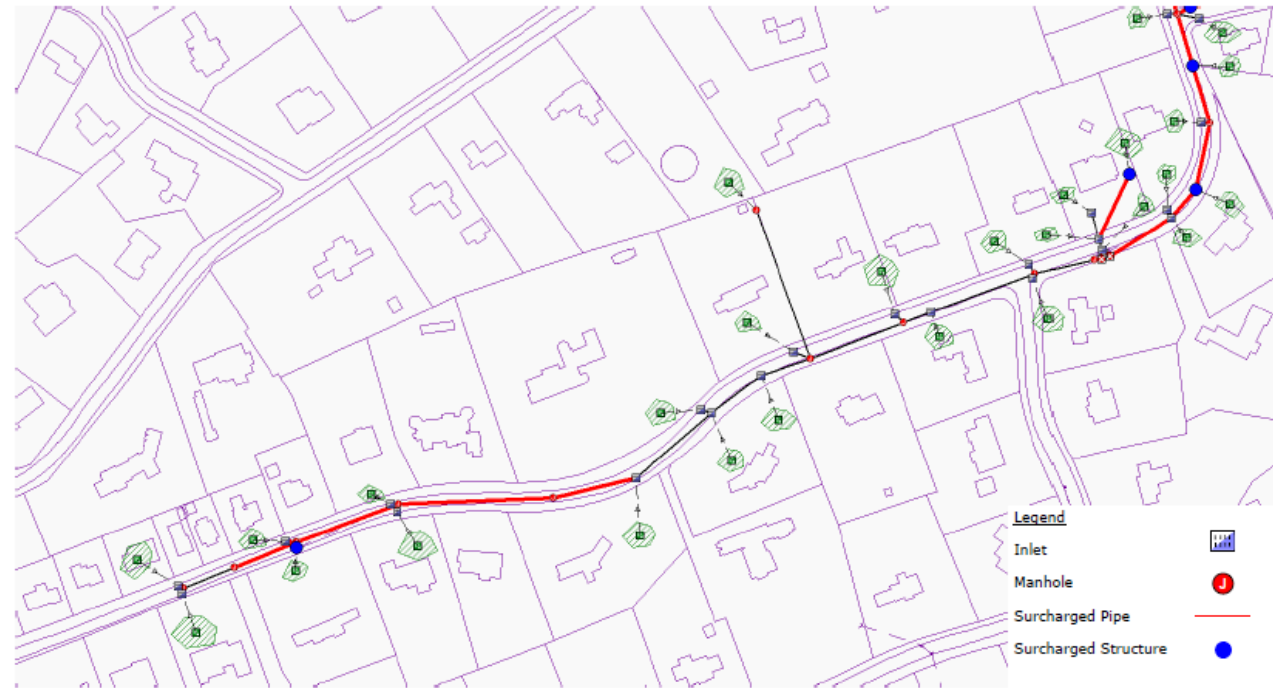
# 10 Year Storm Plan Plot

10 Year Storm Plan Plot  
DA-1 Cushman Rd West & DA-2 Cushman North

PROPOSED CONDITION

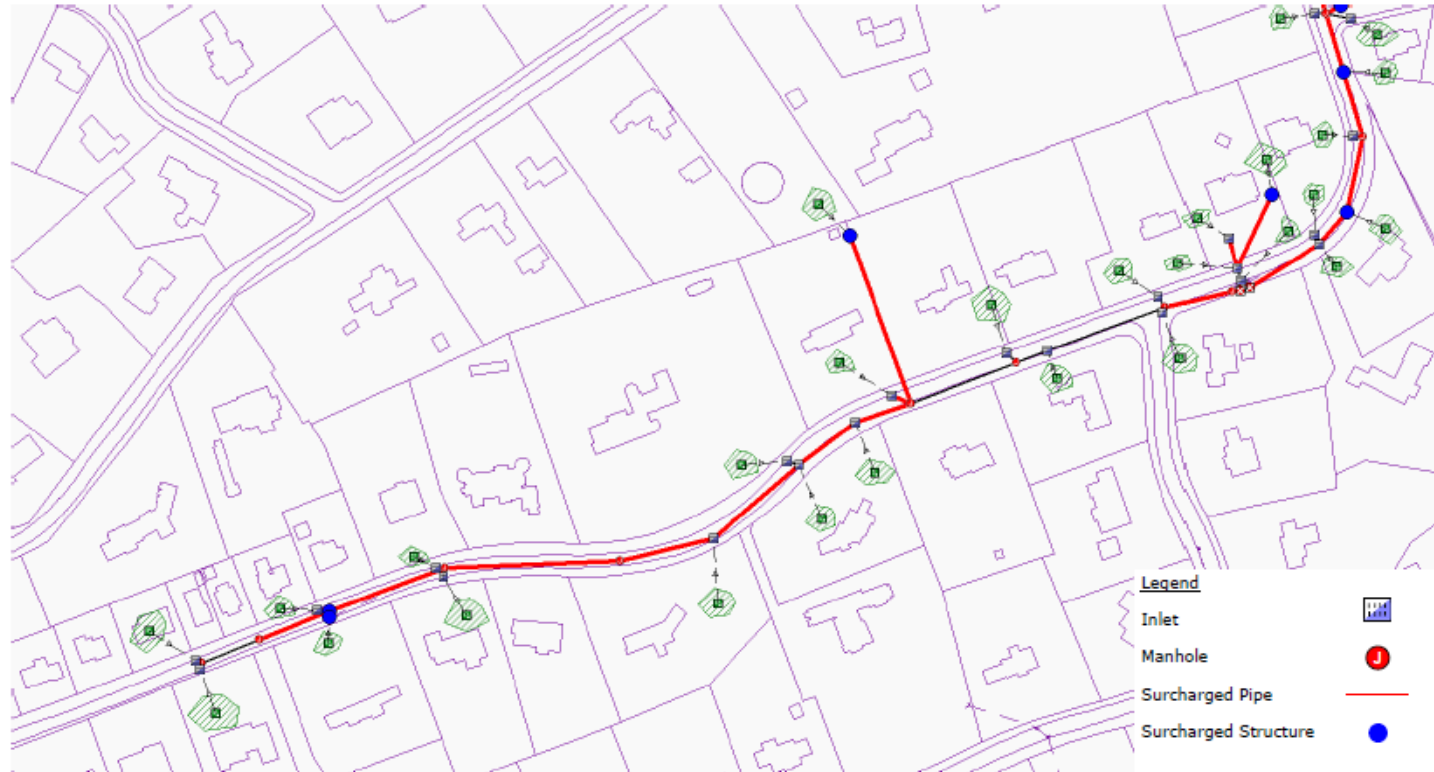
# 25 Year Storm Plan Plot

25 Year Storm Plan Plot  
DA-1 Cushman West & DA-2 Cushman North

PROPOSED CONDITION

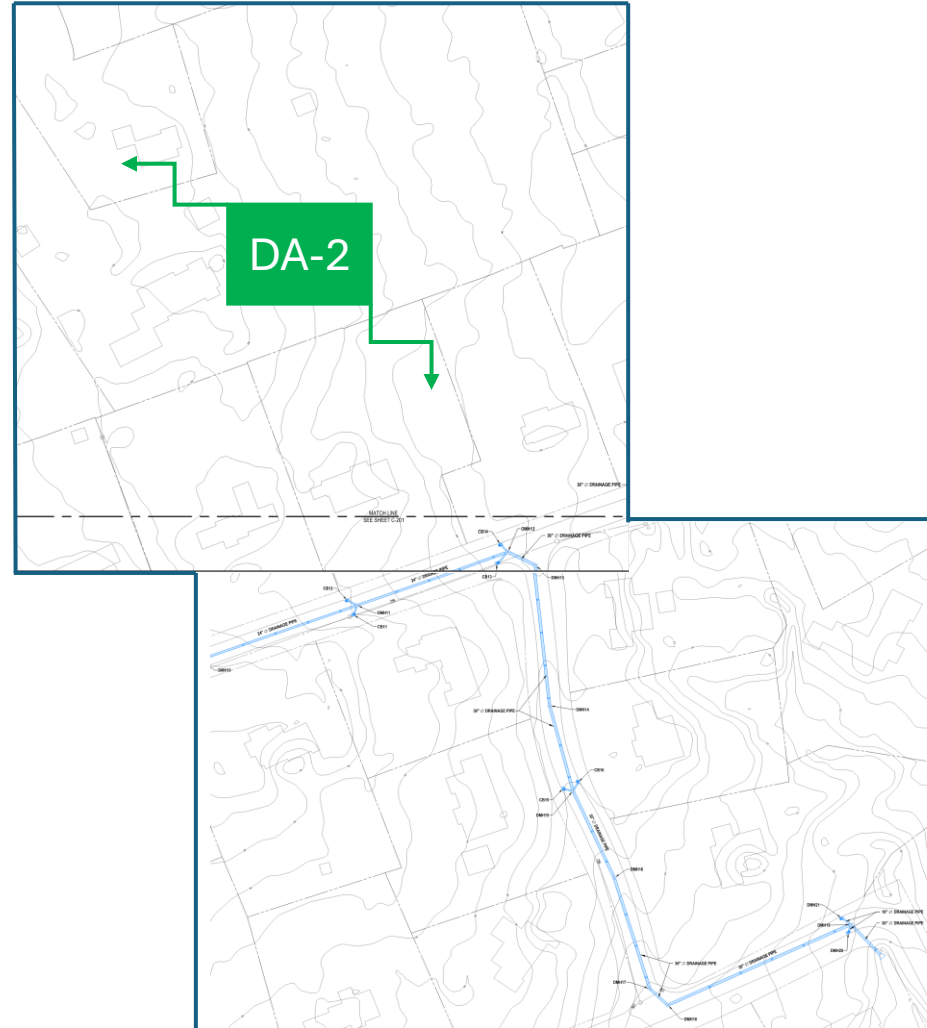
# Cushman, Willow, and Sheldrake – Drainage Area 2 (Cushman North)

## Proposed Improvements:

- Remove and replace the existing, damaged 18" pipe on 105 Cushman Road with a 24" pipe.
- Remove and replace 1 catch basin with a NYSDOT standard catch basin.

- Improve flow capacity and reduce stormwater backups.
- Reduced ponding and flooding impacts during heavy rain events.
- Address damaged pipe requiring repair or replacement in 5-10 years.

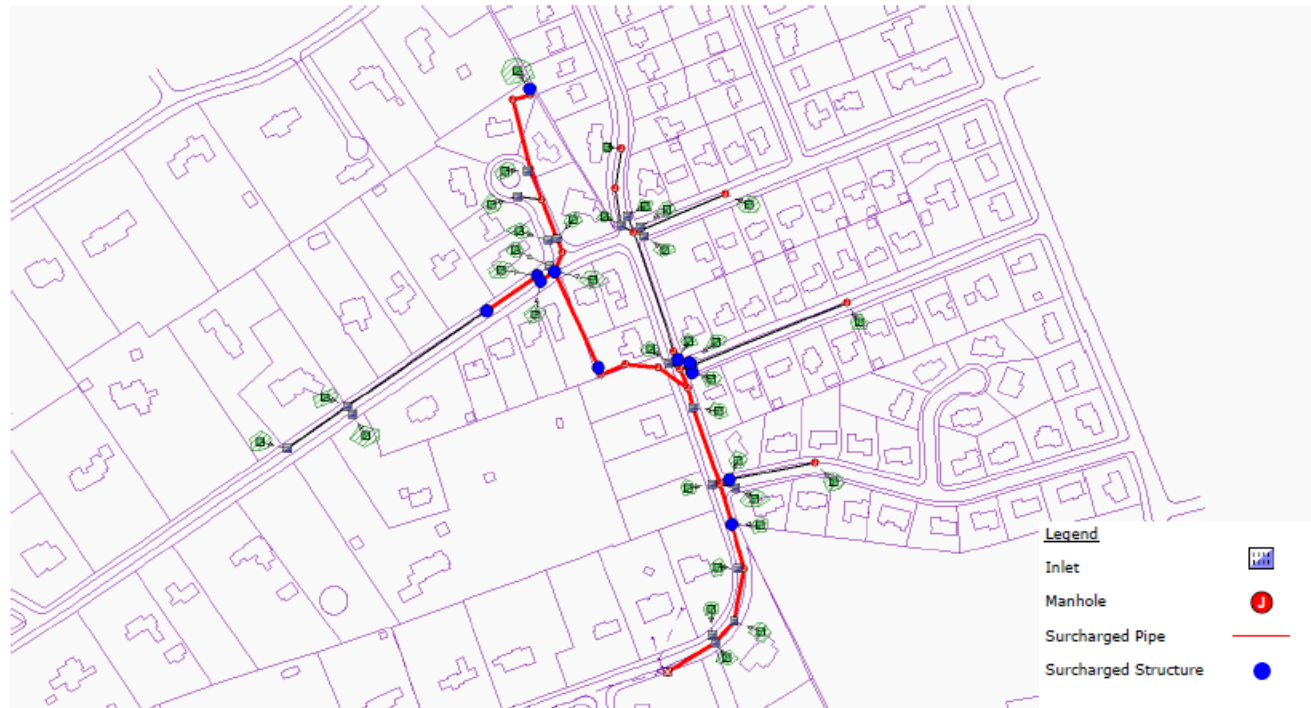
# 2 Year Storm Plan Plot

2 Year Storm Plan Plot  
DA-3 Cushman East - Immediate Improvements

PROPOSED CONDITION

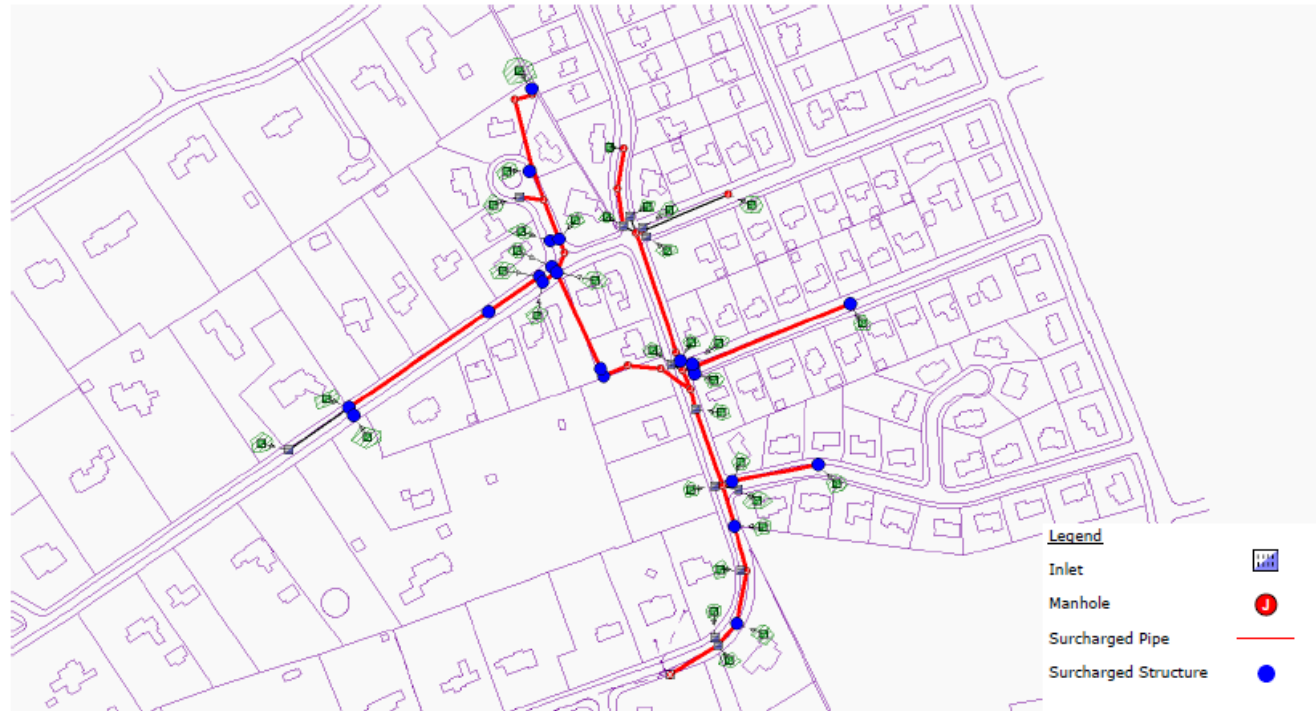
# 10 Year Storm Plan Plot

10 Year Storm Plan Plot  
DA-3 Cushman East - Immediate Improvements

**PROPOSED CONDITION**

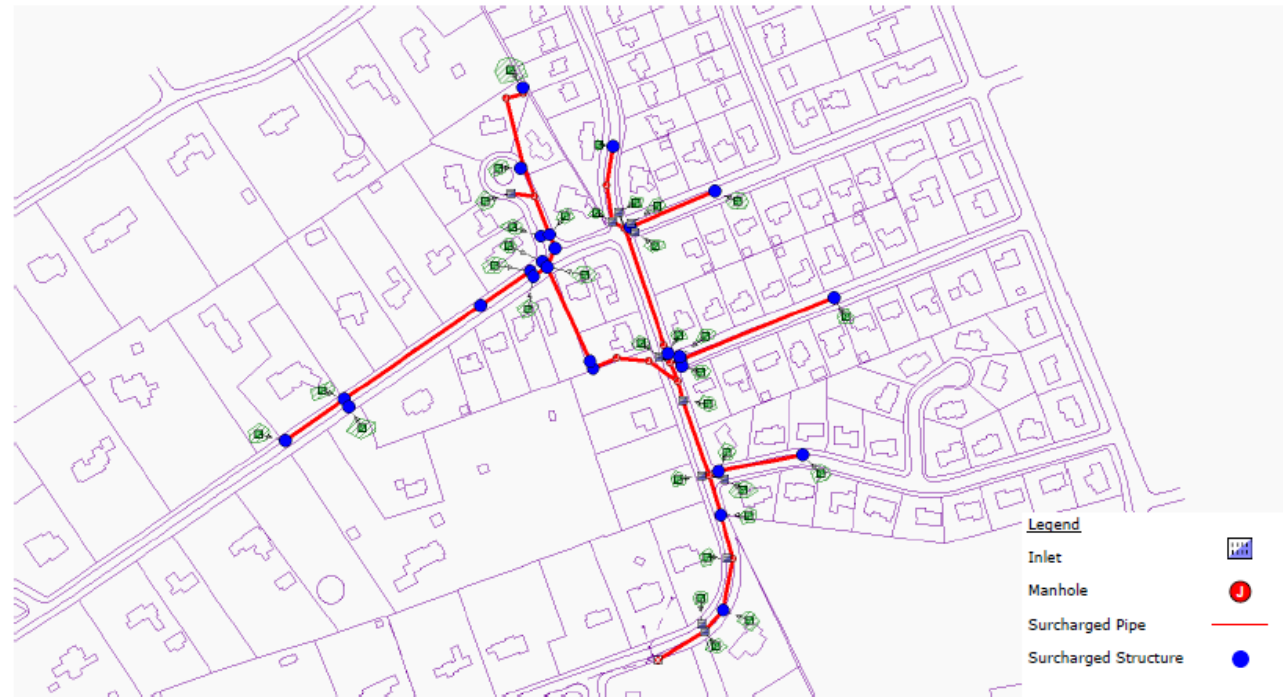
# 25 Year Storm Plan Plot

25 Year Storm Plan Plot  
DA-3 Cushman East - Immediate Improvements

**PROPOSED CONDITION**

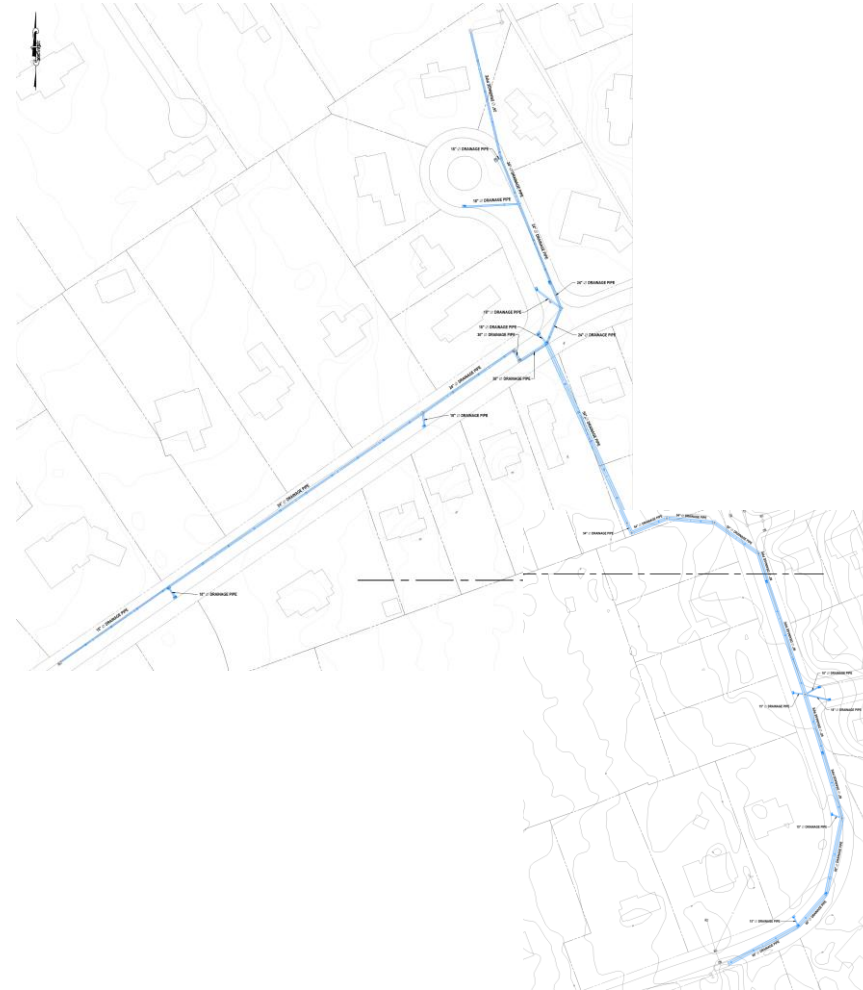
# Cushman, Willow, and Sheldrake – Drainage Area 3 (Cushman East – Future Improvements)

## Proposed Improvements:

- Increase the existing 35" pipe capacity from the intersection of Garden Road and Cushman Road to the intersection of Earlwoode Drive and Cushman Road to 54", approximately 515'.
- Increase the existing 35"-42" pipe capacity from the intersection of Earlwoode Drive to the existing sedimentation chamber to 60", approximately 800'.
- Increase the existing 12" capacity within Garden Road to 24", approximately 620'.
- Increase the existing 12" capacity within Varian Lane to 24", approximately 440'.

- The existing storm network cannot manage the peak discharge rates generated by the 2, 10, and 25-year storms.
- The proposed improvements will increase flow capacity in the storm network and mitigate surface flooding during heavy rainfall.

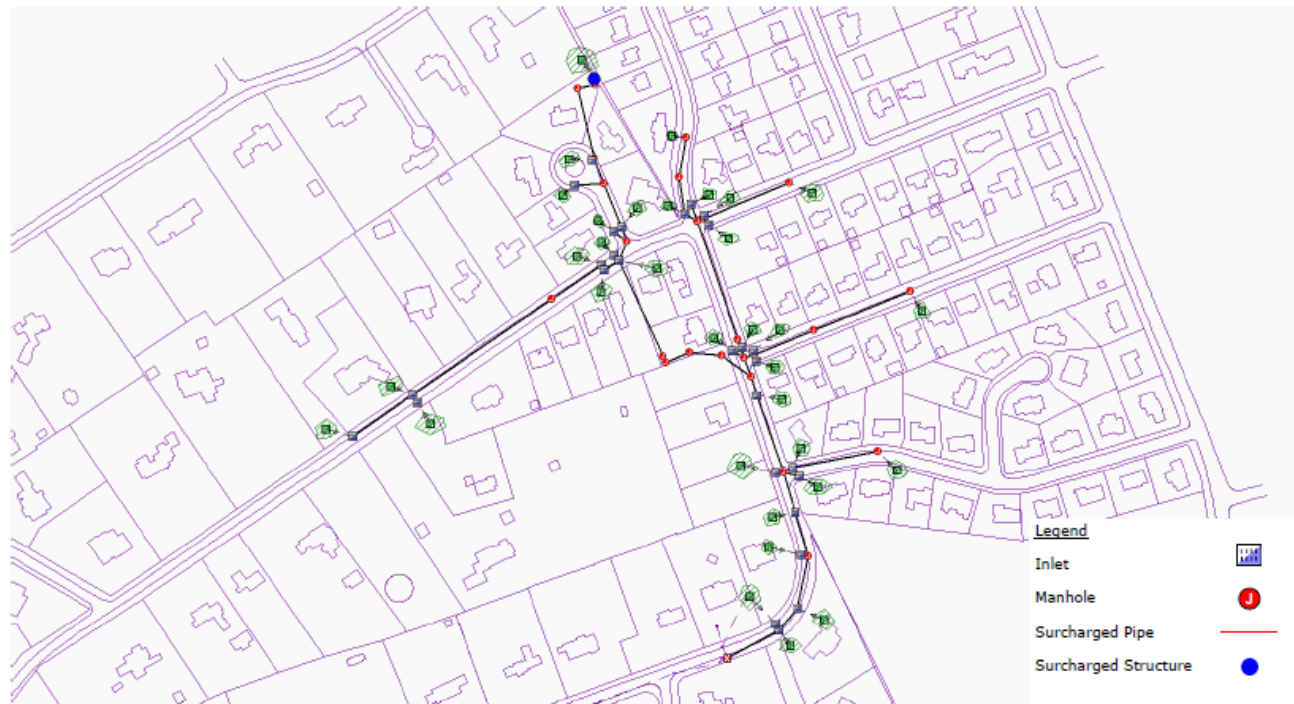
# 2 Year Storm Plan Plot

2 Year Storm Plan Plot  
DA-3 Cushman East - Future Improvement

PROPOSED CONDITION

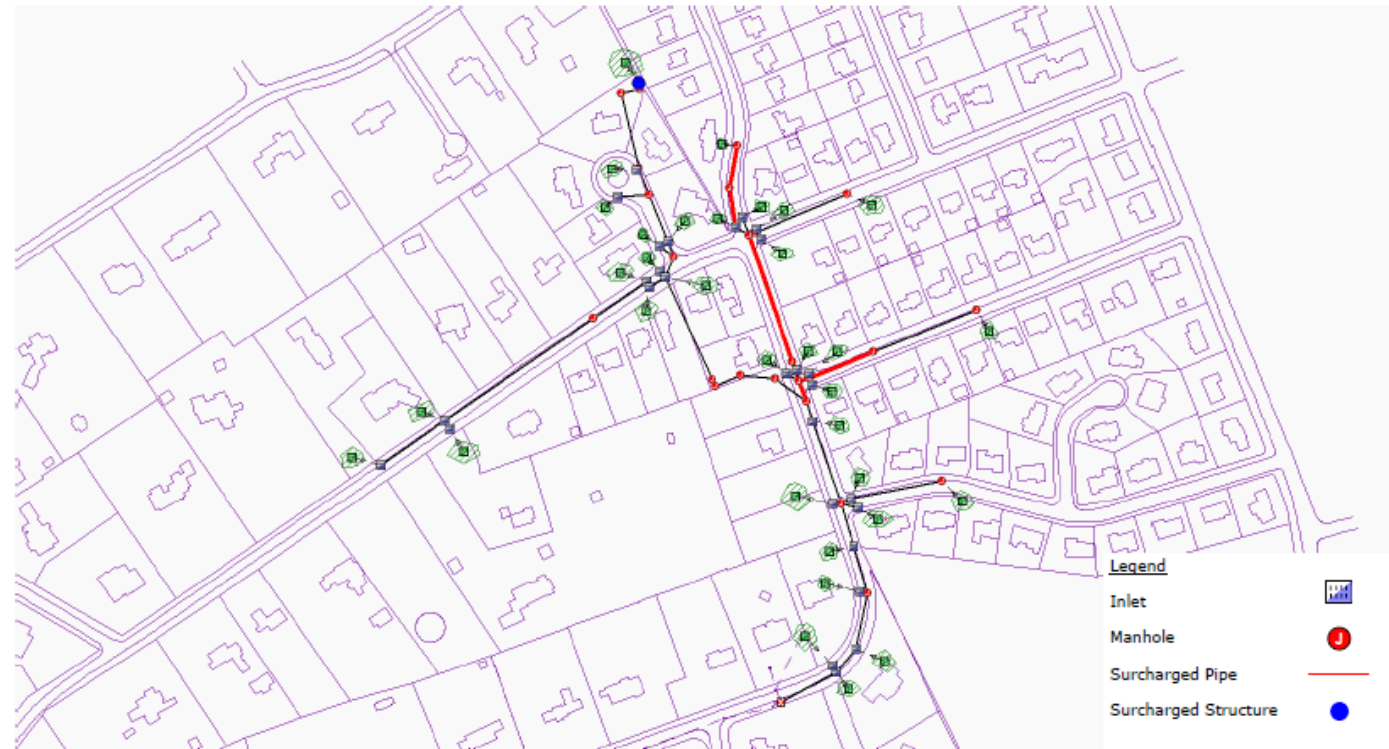
# 10 Year Storm Plan Plot

10 Year Storm Plan Plot  
DA-3 Cushman East - Future Improvement

PROPOSED CONDITION

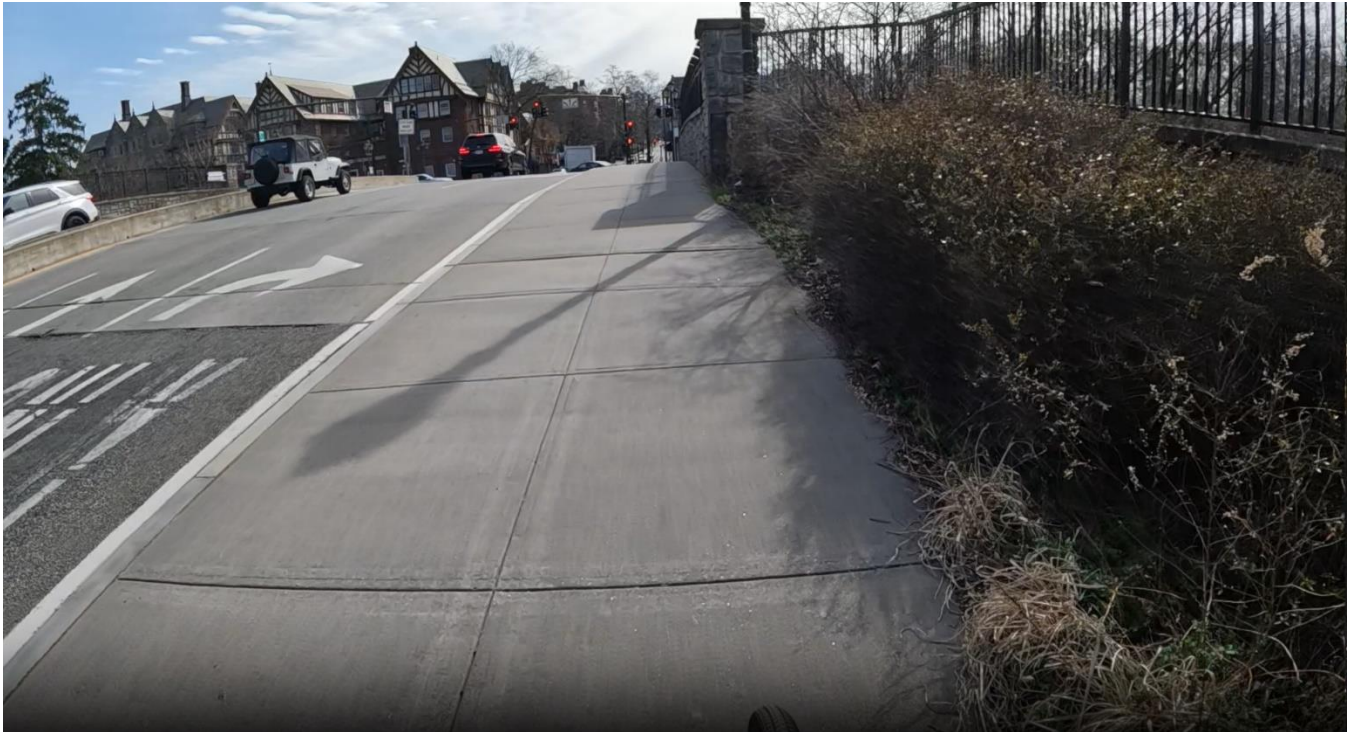
POPHAM ROAD | PCI 93

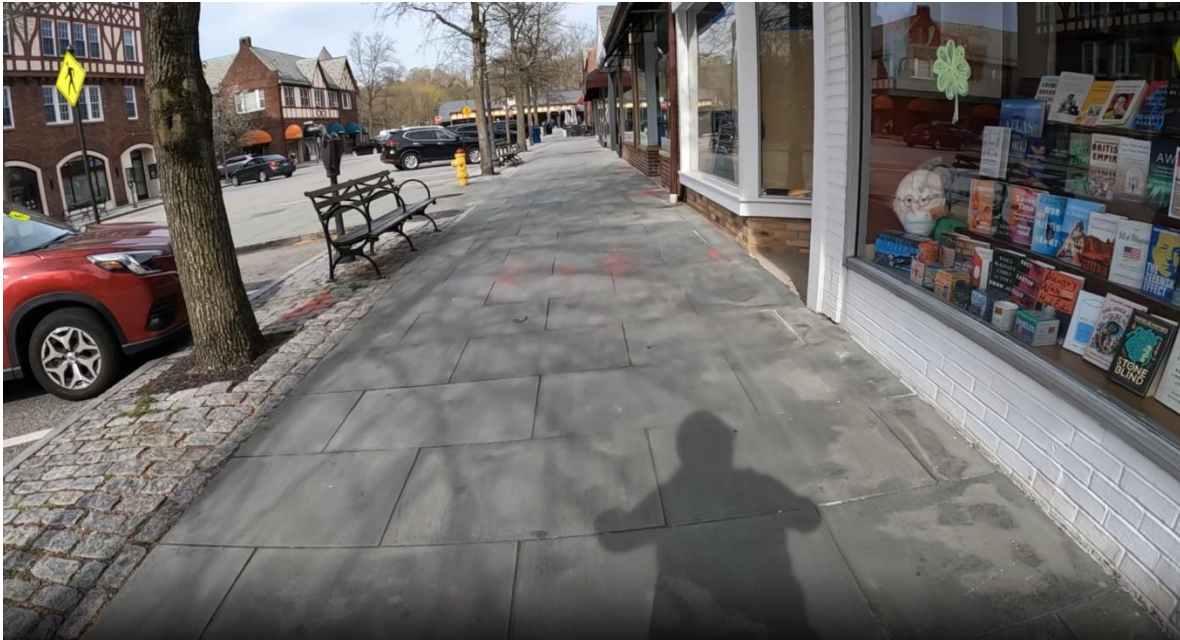
SPENCER PLACE | PCI 88

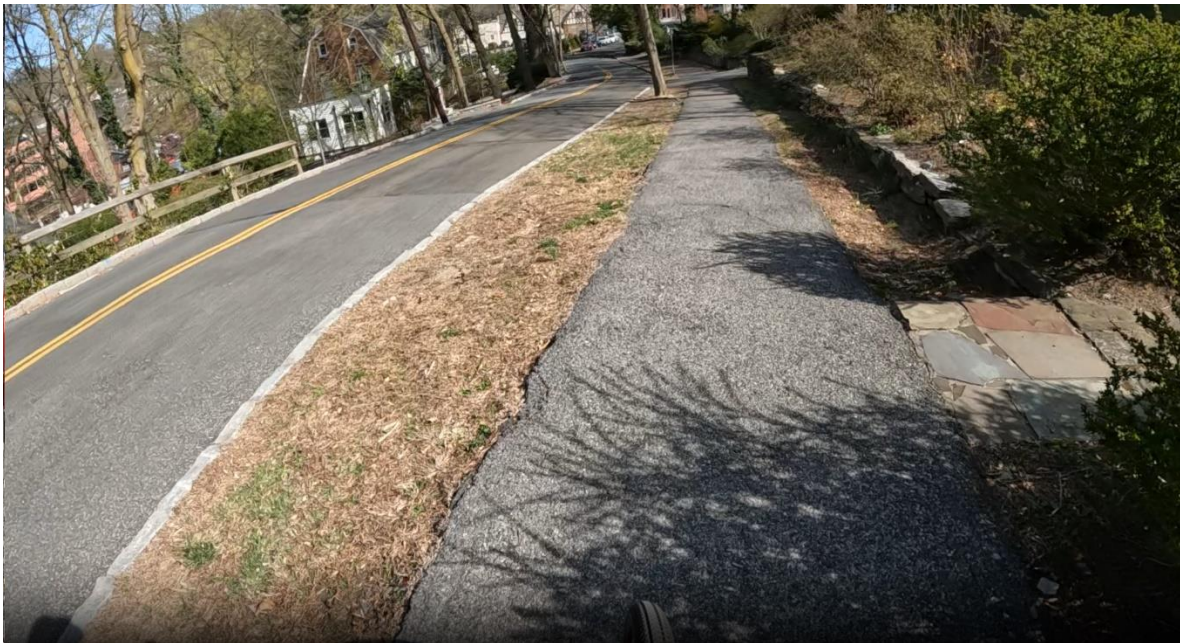
OVERHILL ROAD | PCI 61

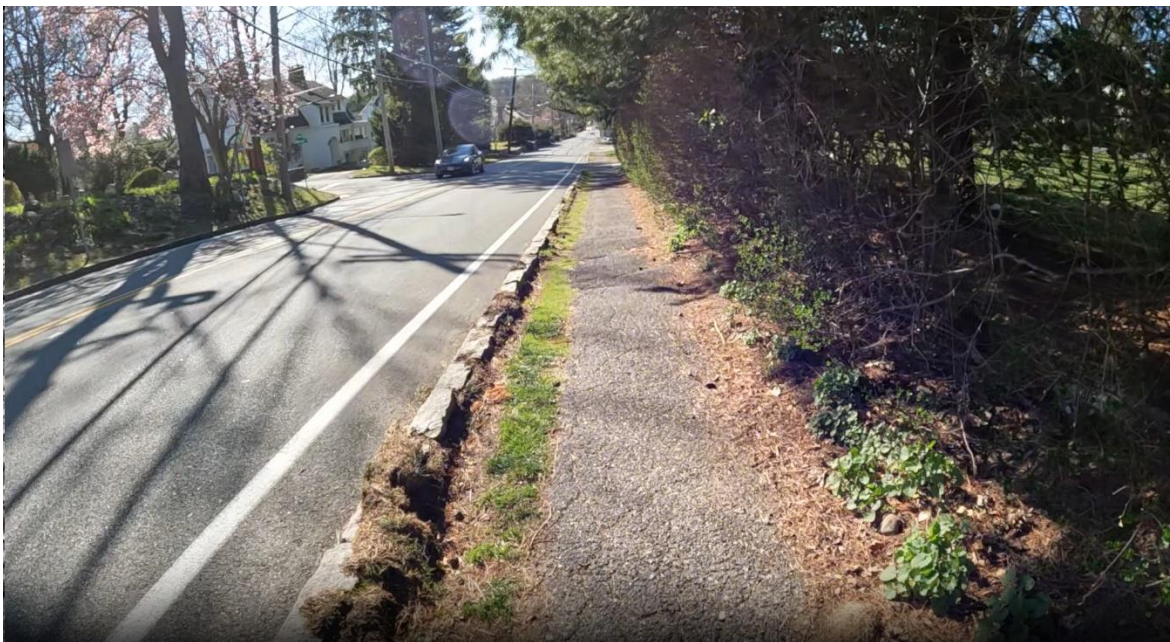
CRANE ROAD | PCI 32
