Village Board of Trustees Work Session Agenda

# Village of Scarsdale Flood Mitigation Projects

# PAVEMENT MANAGEMENT FINAL PROJECT REPORT

Scarsdale, NY - PATHWAYS

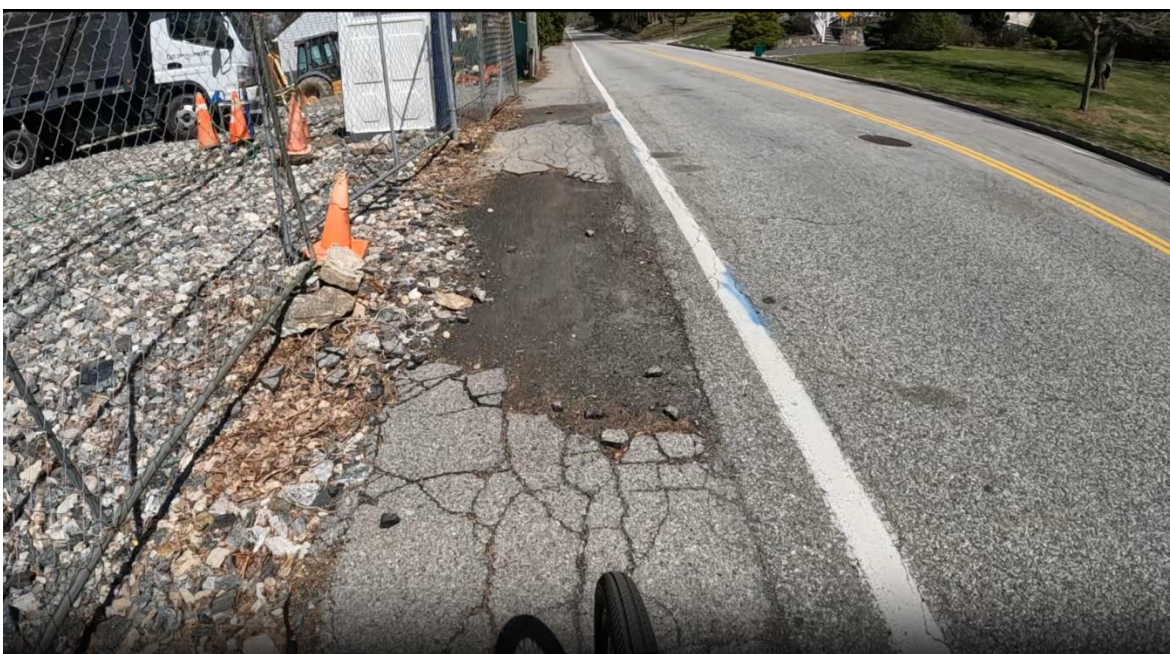
CHURCH LA | PCI 26

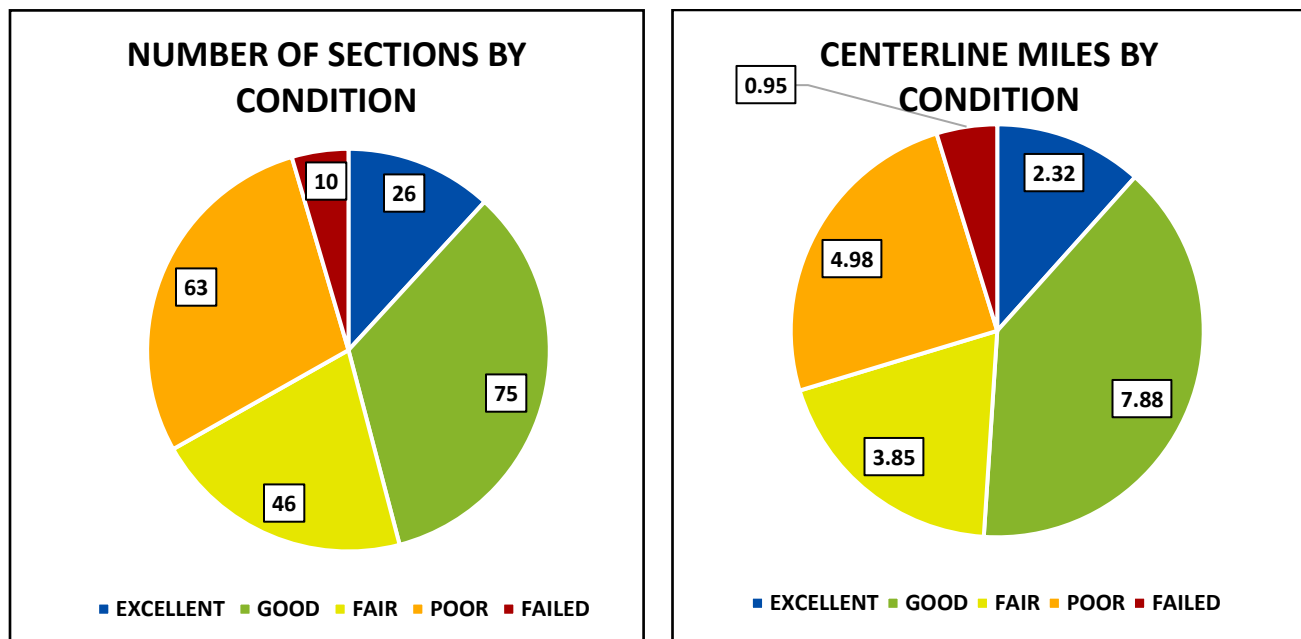
Figure 3. Number of Sections and Centerline Miles by Condition Category

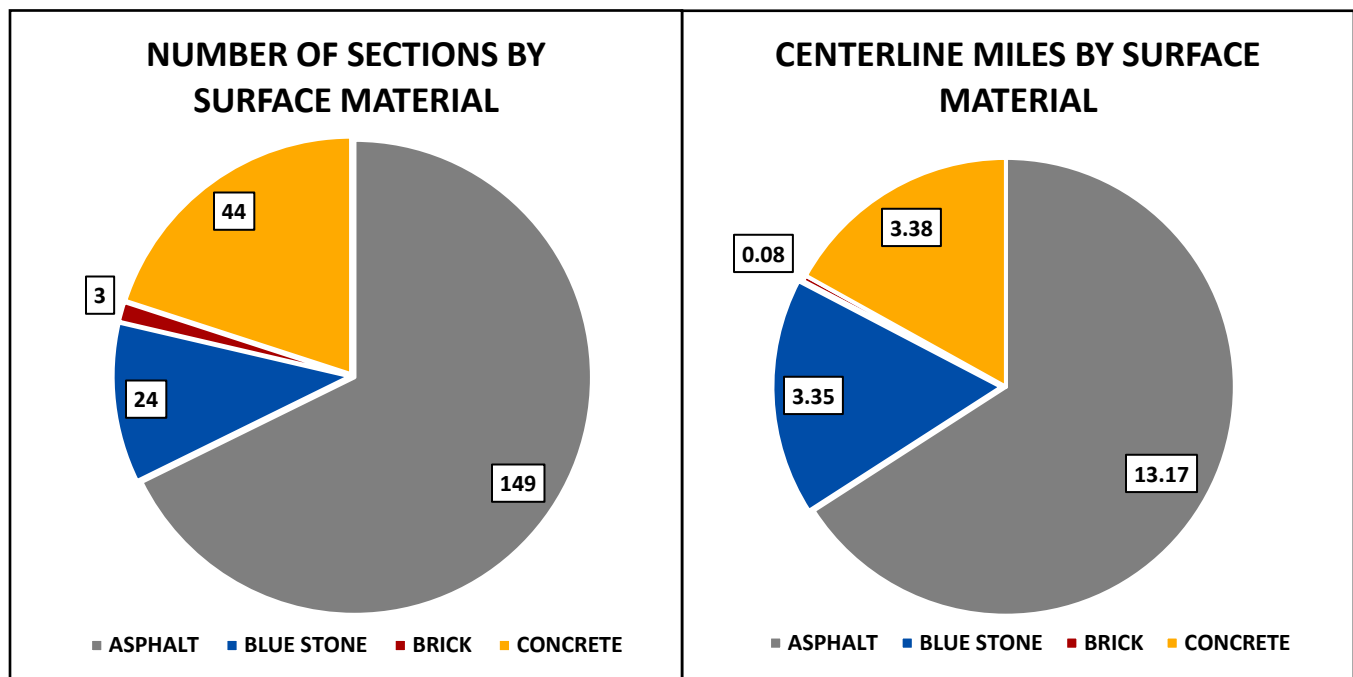
Figure 4. Average Condition, Number of Sections, and Centerline Miles by Surface Material

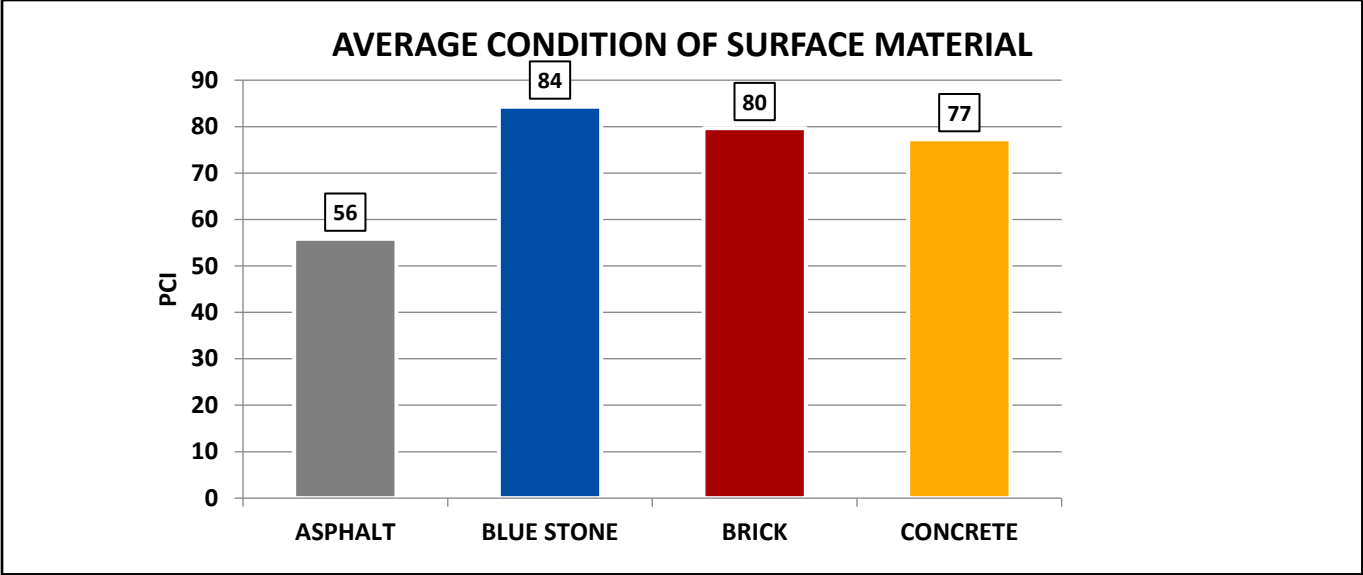
Figure 5. Average Condition, Number of Sections, and Centerline Miles by Surface Material

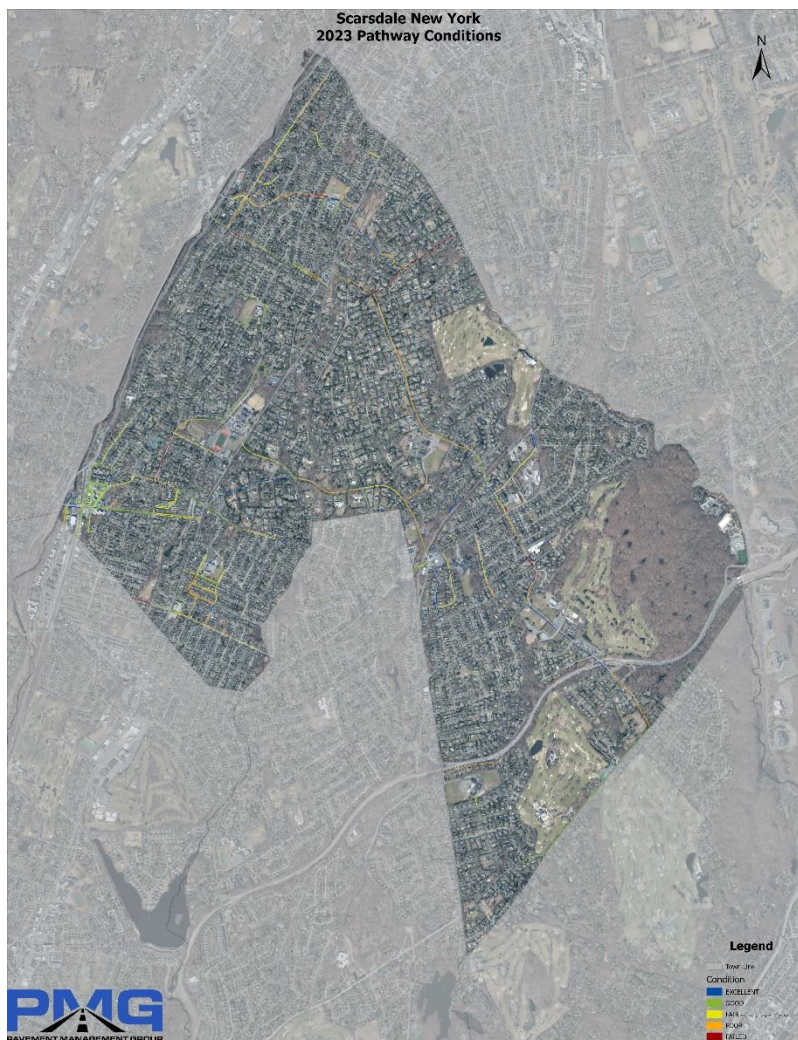
PMG assigned all pavement management data to GIS and will provide the shapefile to the agency. This allows for a wide variety of mapping options within both ESRI's ArcGIS and Google Earth. The following shows an example of a Latest Condition Map that has been created in both GIS and Google Earth for illustrative purposes. An ANCI Size C plot ready PDF version has been provided as a part of the project deliverable.

Figure 6. Pathway Section Latest Condition maps

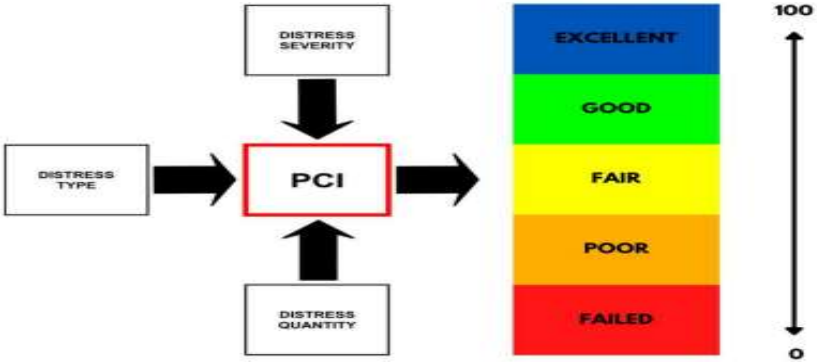
PCI AND CONDITION CATEGORY DEFINITION  
The PCI is on a scale of 0 – 100 with 0 being the worst and 100 being the best. PAVER calculates it through the input of distress type, severity, and quantity information. Figure 2 illustrates the factors that go into the PCI and the 5 condition categories of the PCI.

Figure. 2 Factors Determining PCI Value
