### **BIG CYPRESS BASIN BOARD MEETING AGENDA**

October 27, 2023  
11:00 AM

# Corkscrew Swamp Sanctuary Ecosystem Restoration Project Update

# CANAL BANK STUDY USING NATIVE LOW-GROWING GROUND COVER

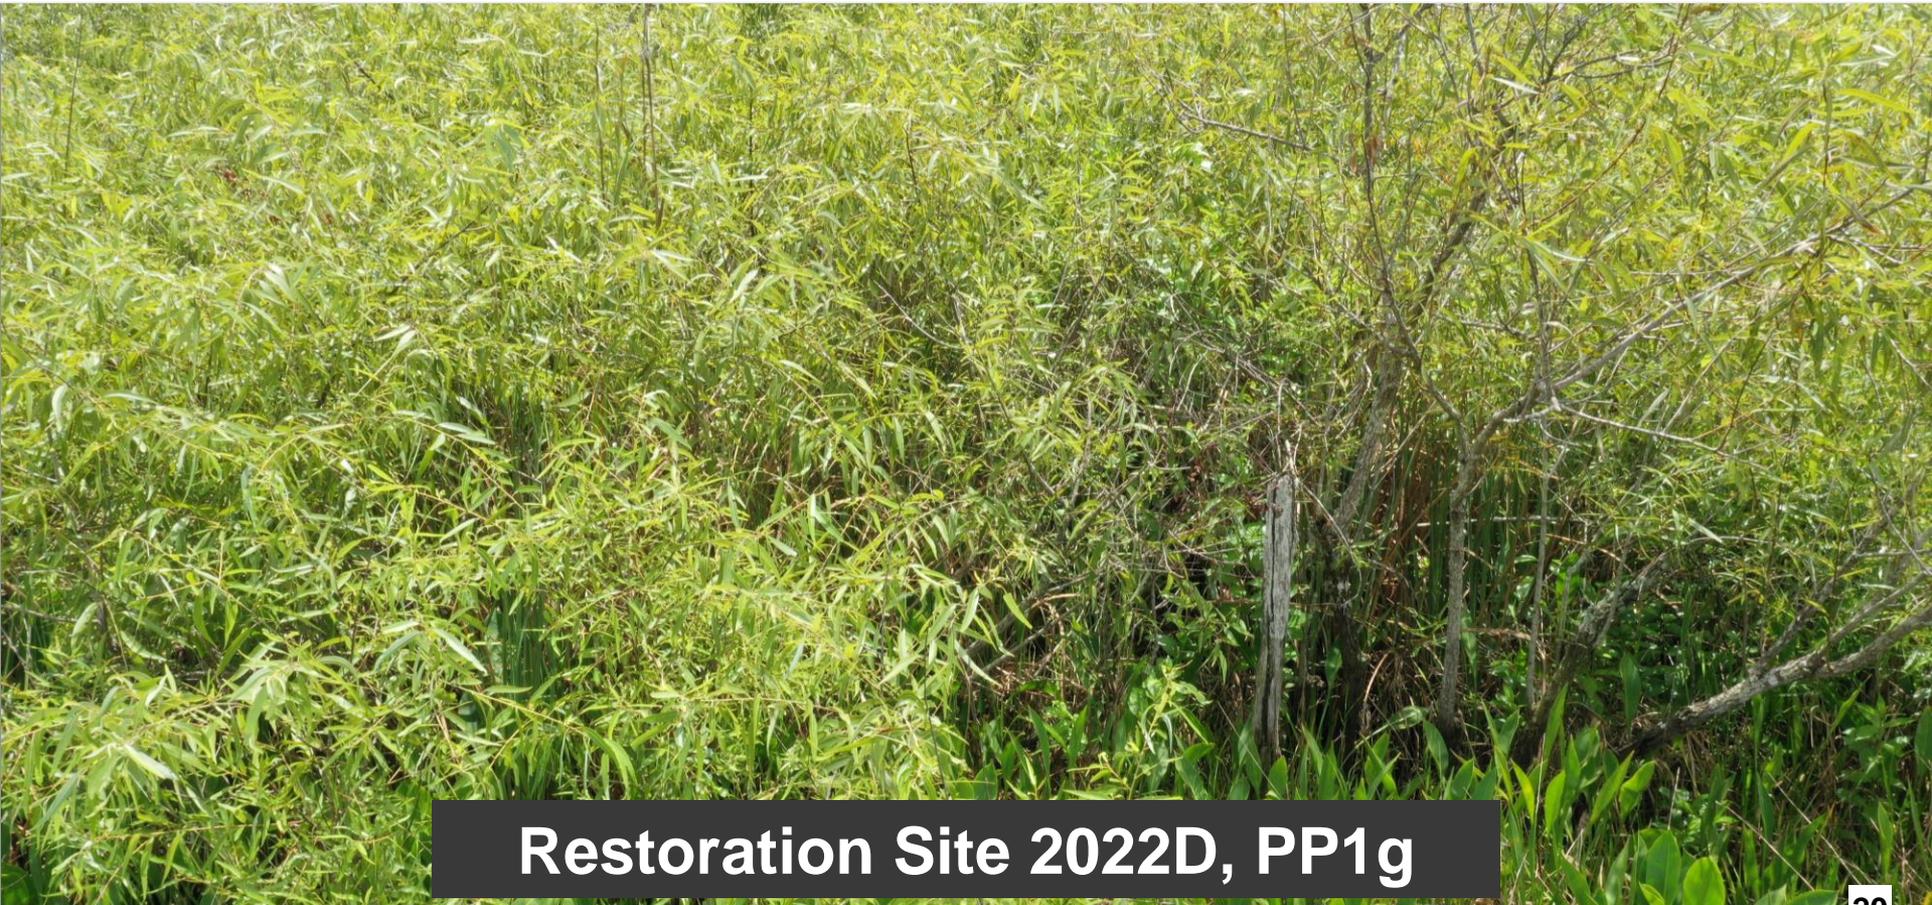
**Restoration Site 2022D, PP1g**

# Pre-restoration (early May 2022)

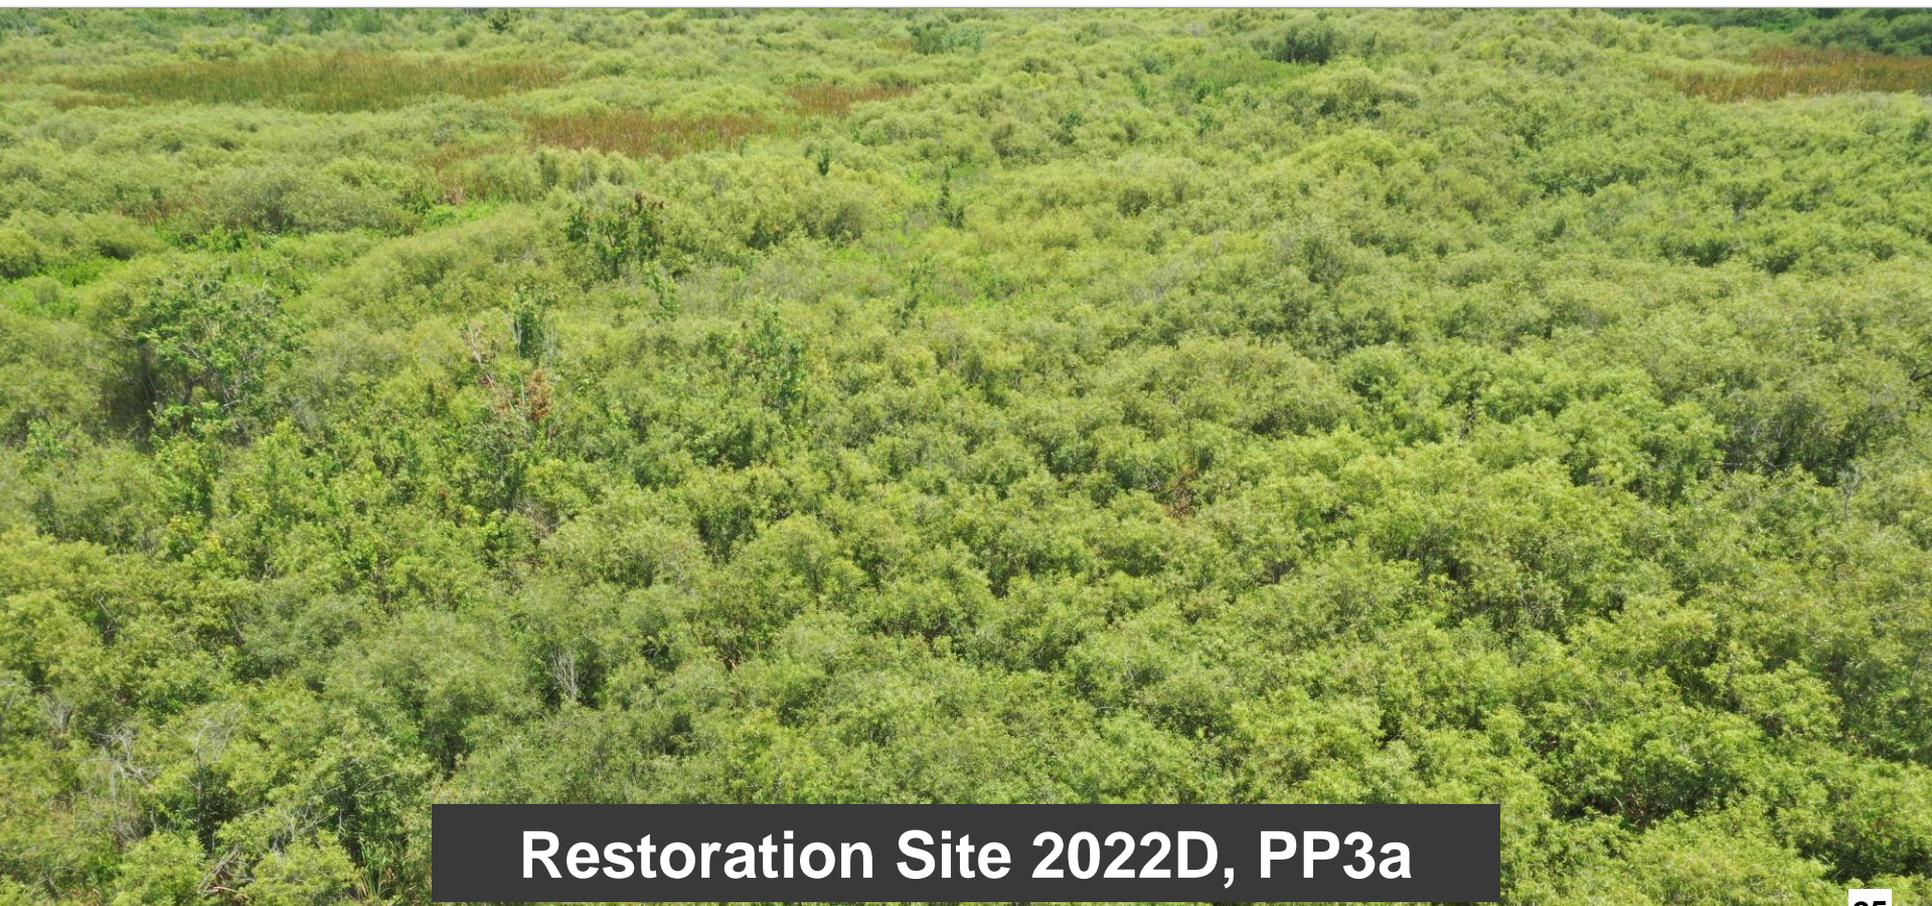
**Restoration Site 2022D, PP3a**

# Pre-restoration (early May 2022)

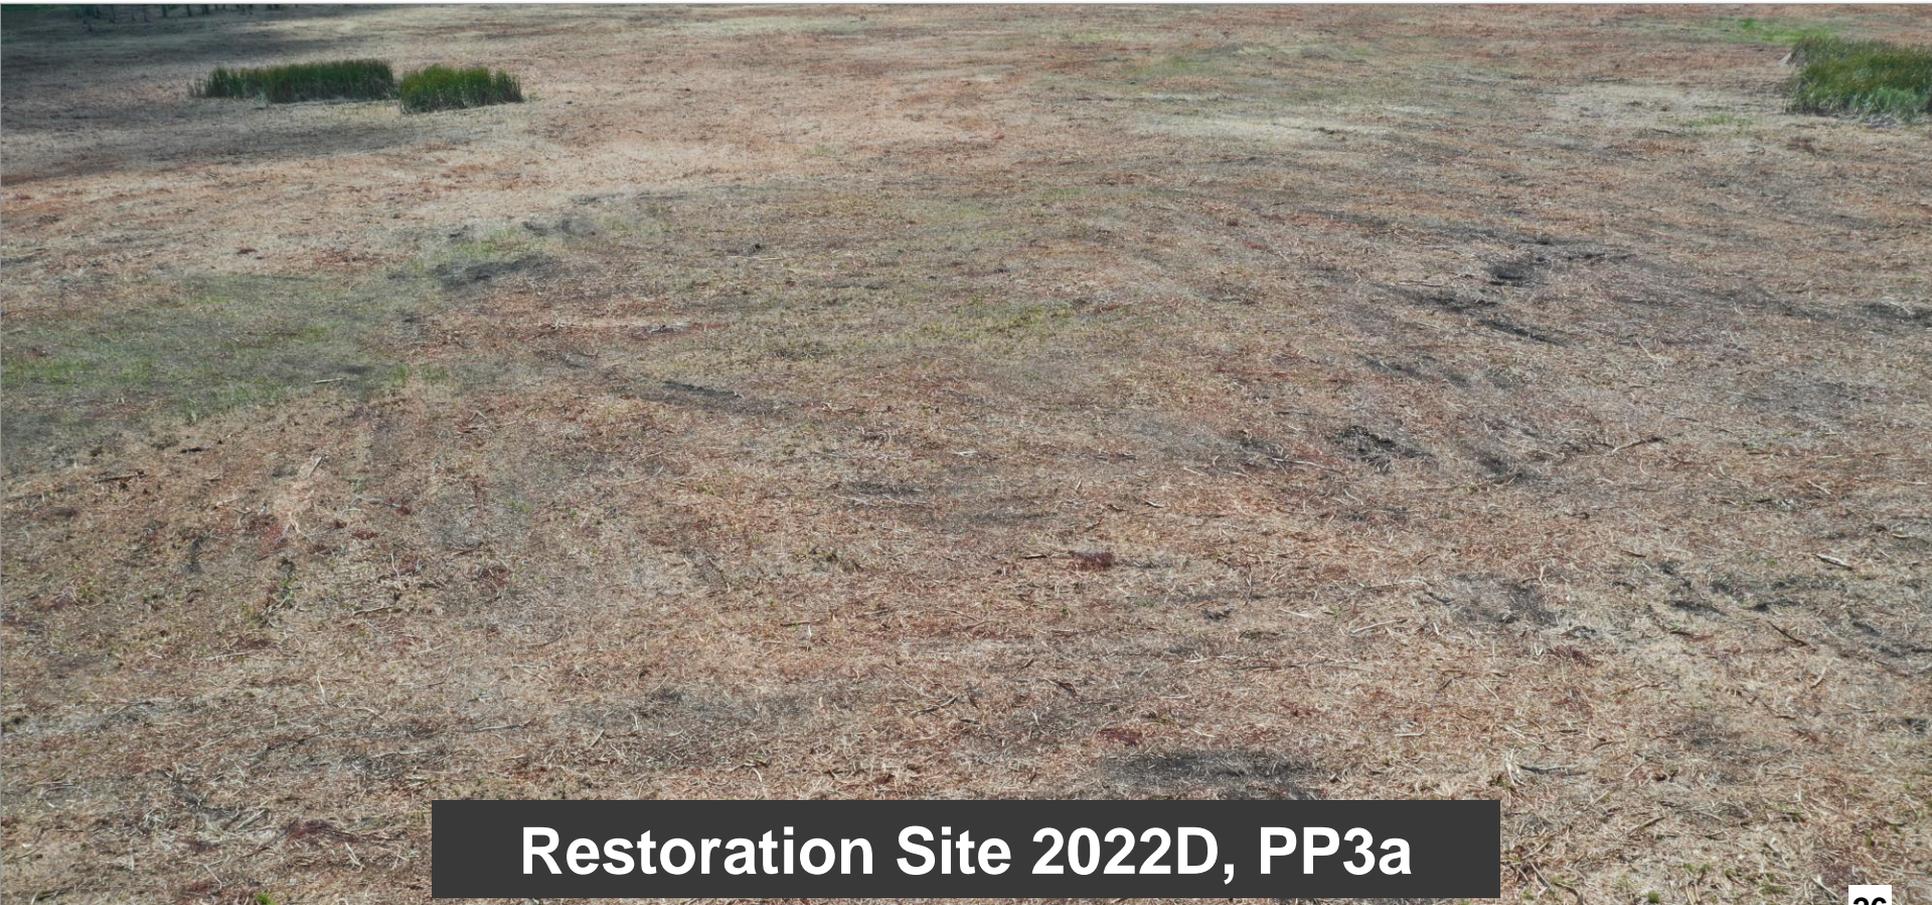
**Restoration Site 2022D, PP3a**

# Post-restoration (late May 2022)

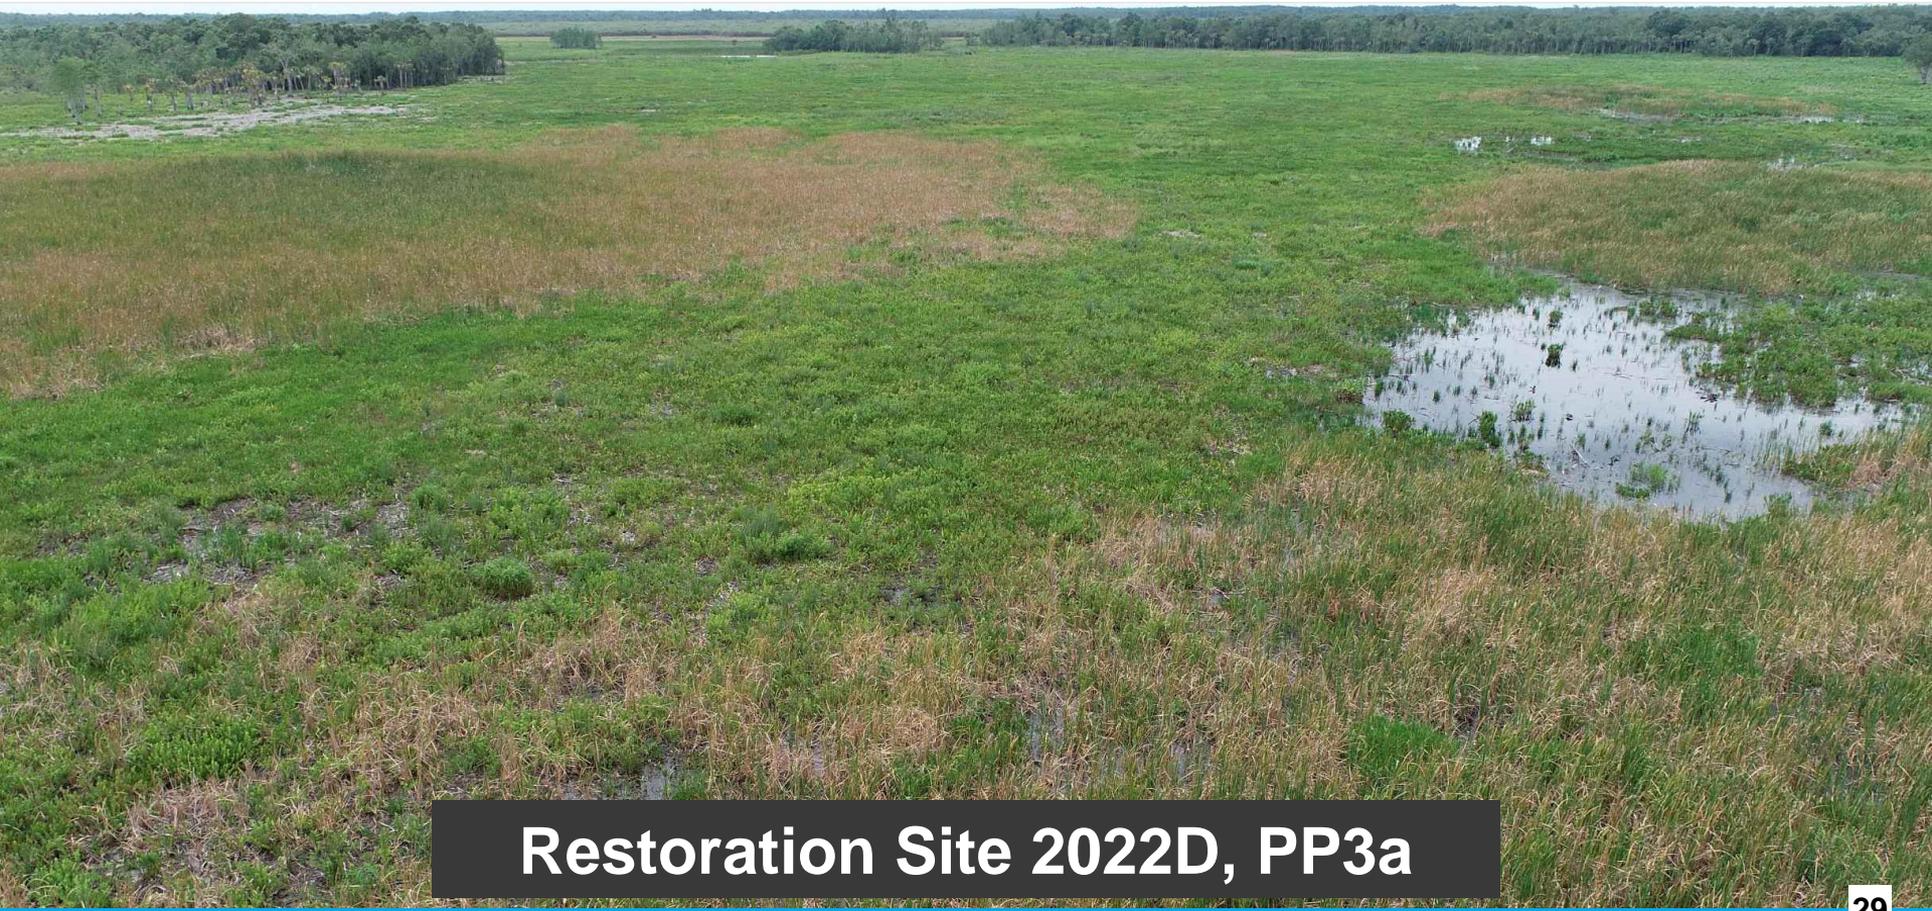
**Restoration Site 2022D, PP3a**

# 12 months post-restoration (May 2023)

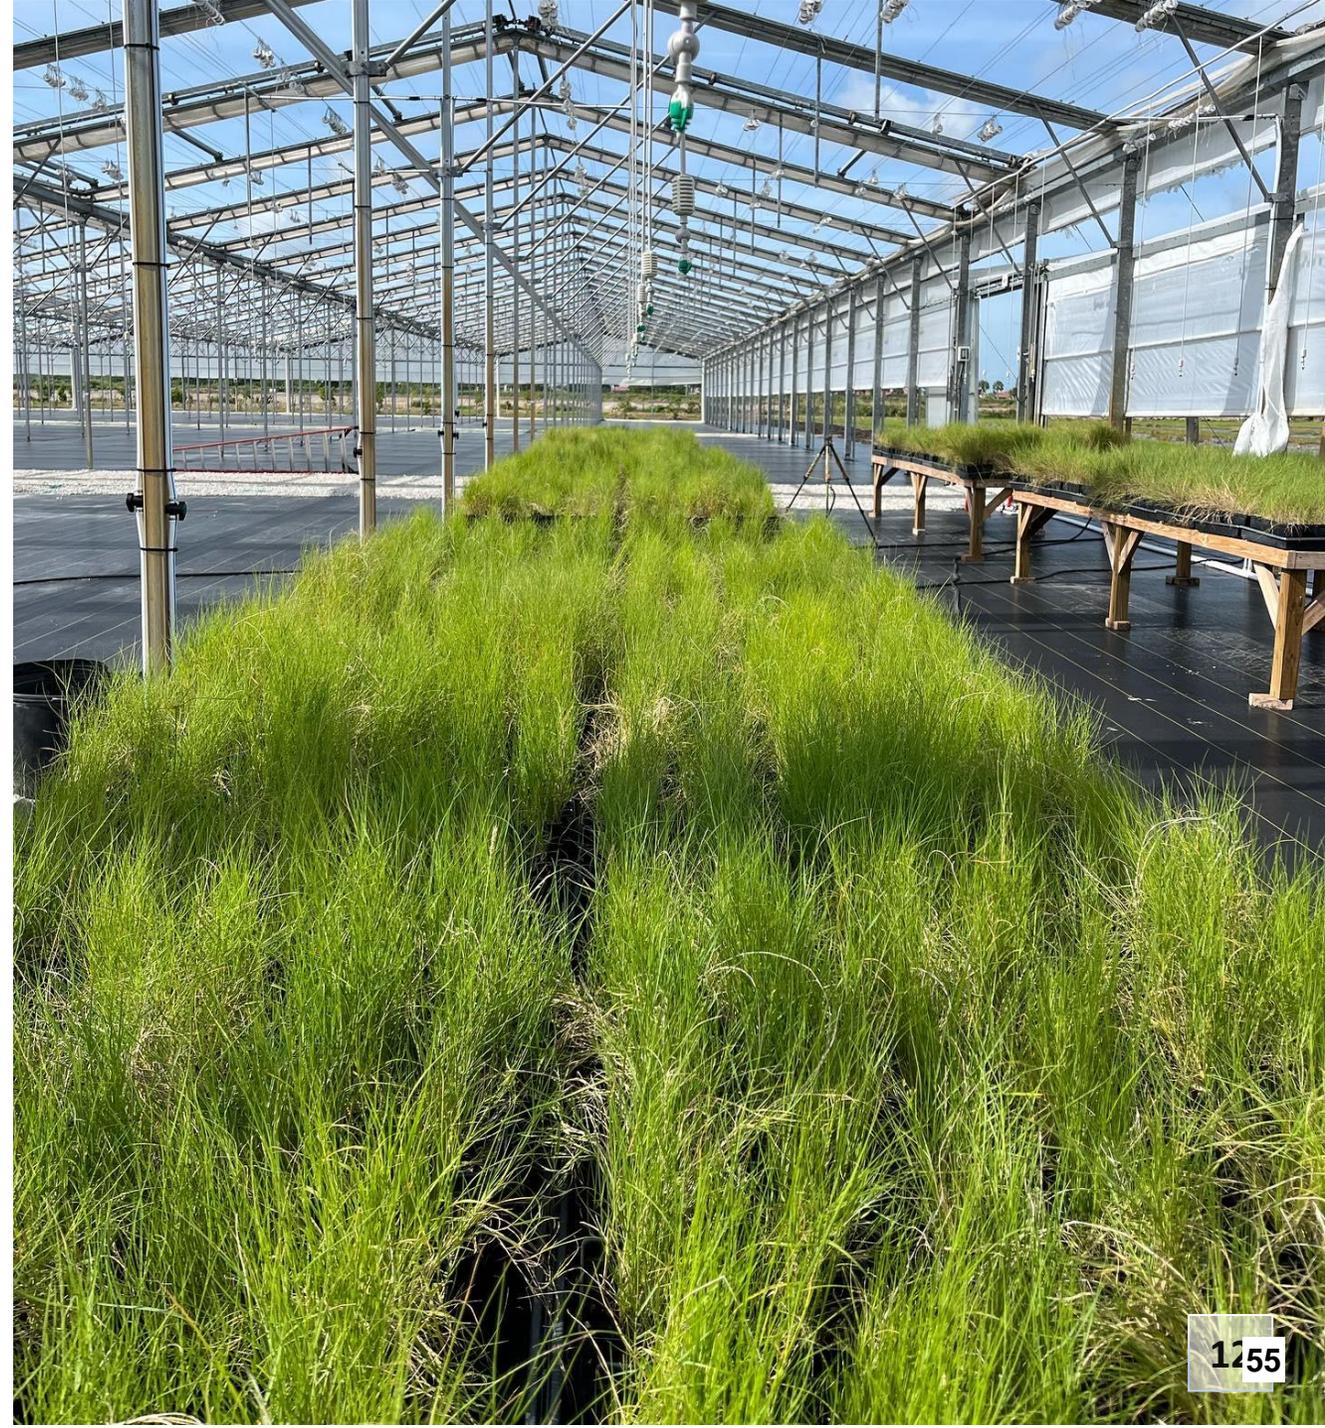
# Plants Growing Operations

- Sod not widely available or unavailable
- 2" Plugs grown out into 4" plants with healthy root systems
- Potential for weeds

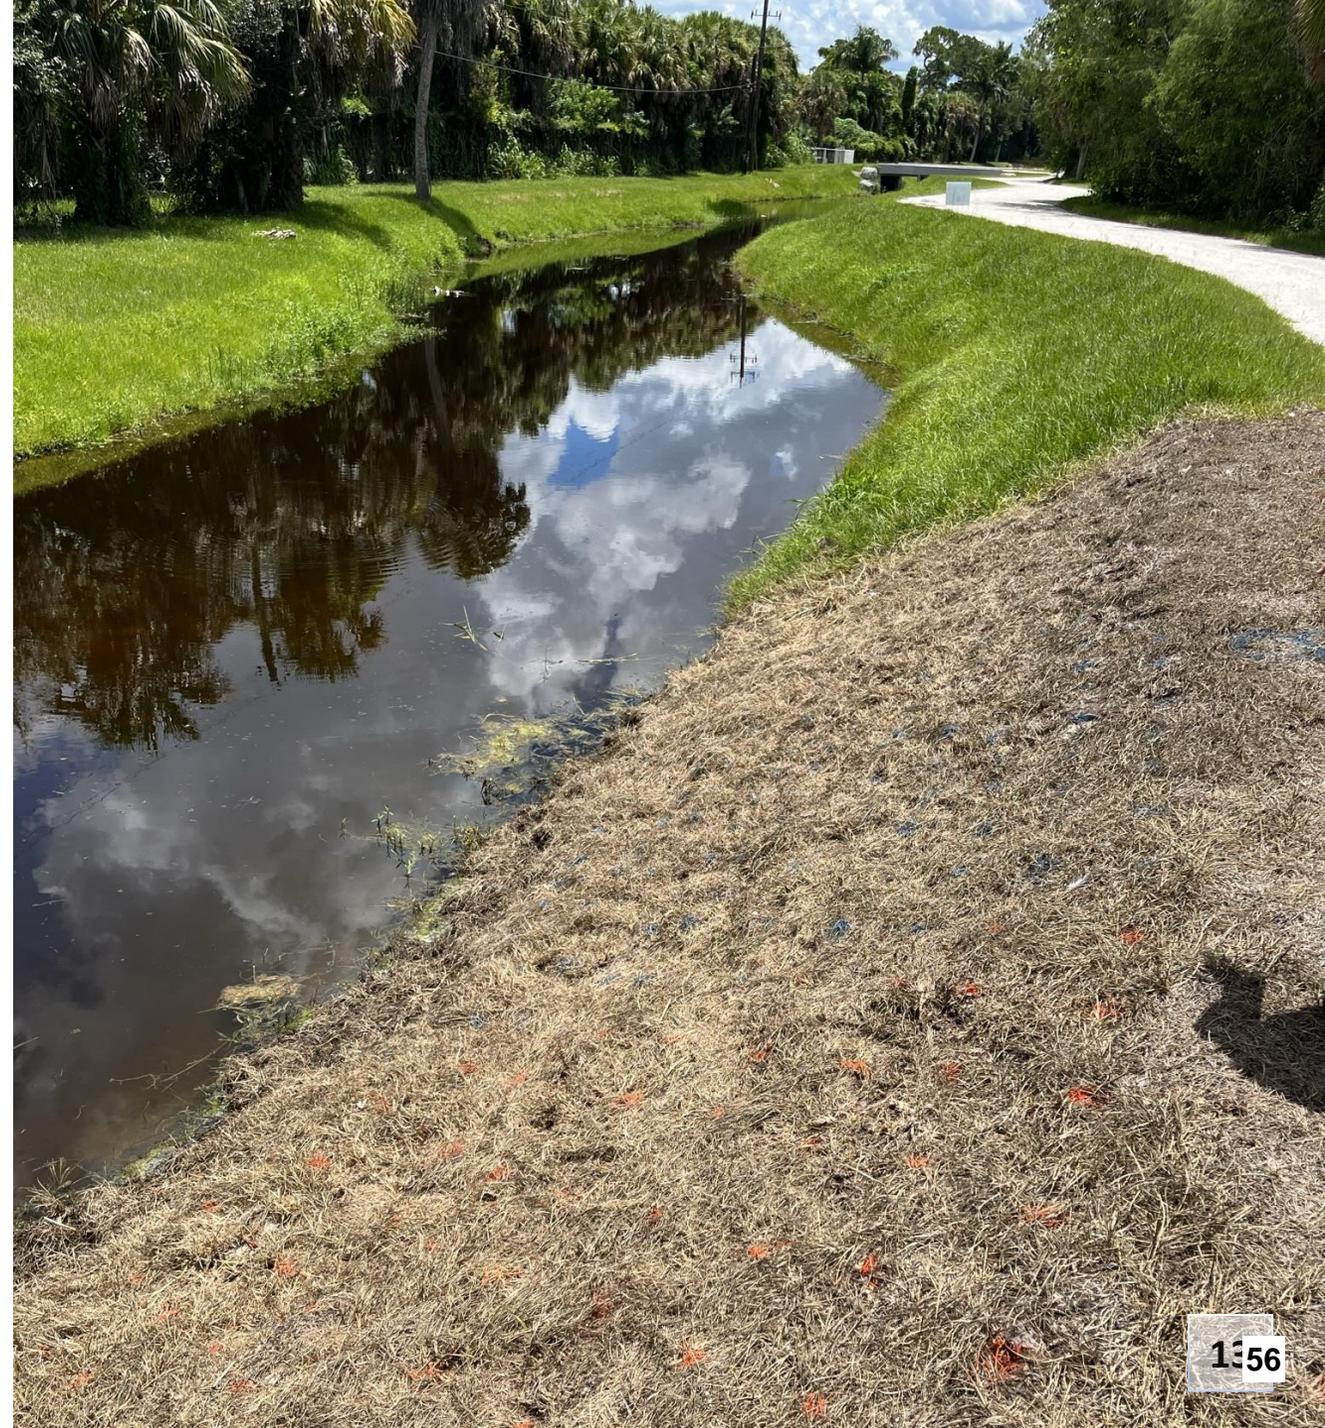
# Site Preparation

- **Bahia grass sod treated with an aquatic-labeled herbicide**
- **Left in place to prevent erosion and reduce weeds**
- **Locations marked**

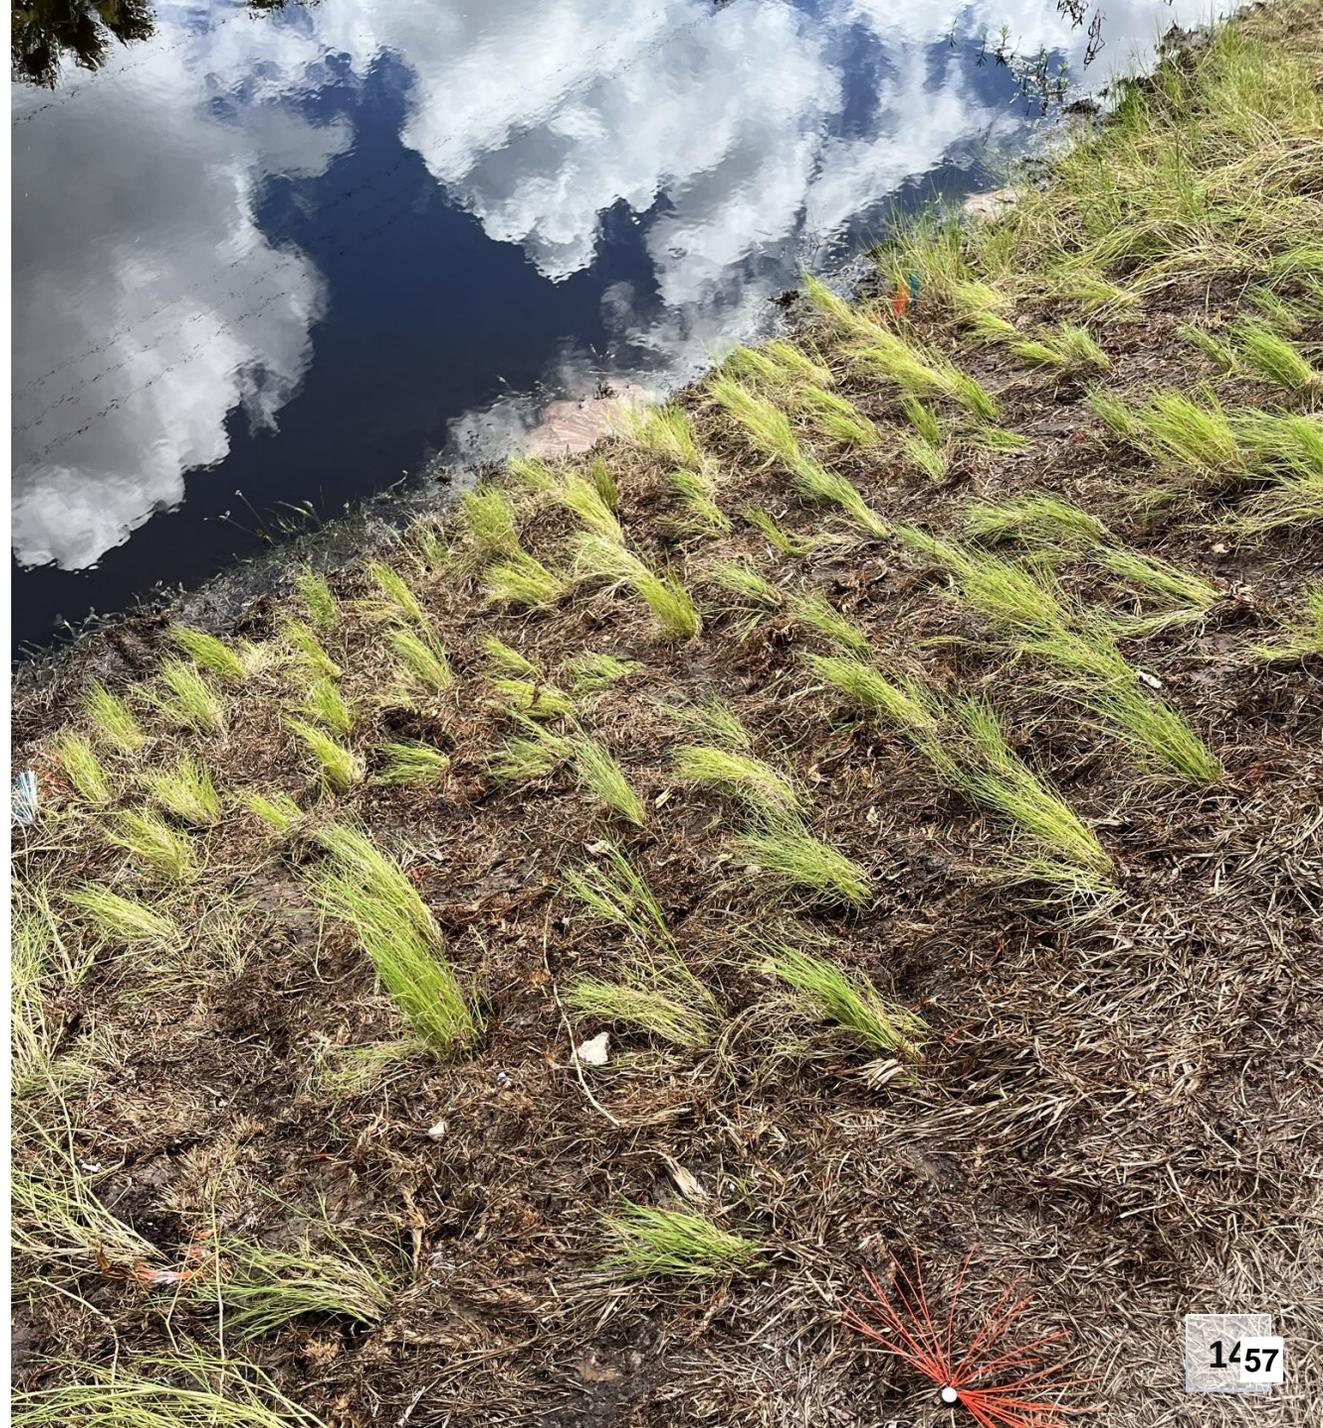
# Layout and Planting

- **Plants laid out according to design**
- **Planted using a drill to minimize impacts to bank**

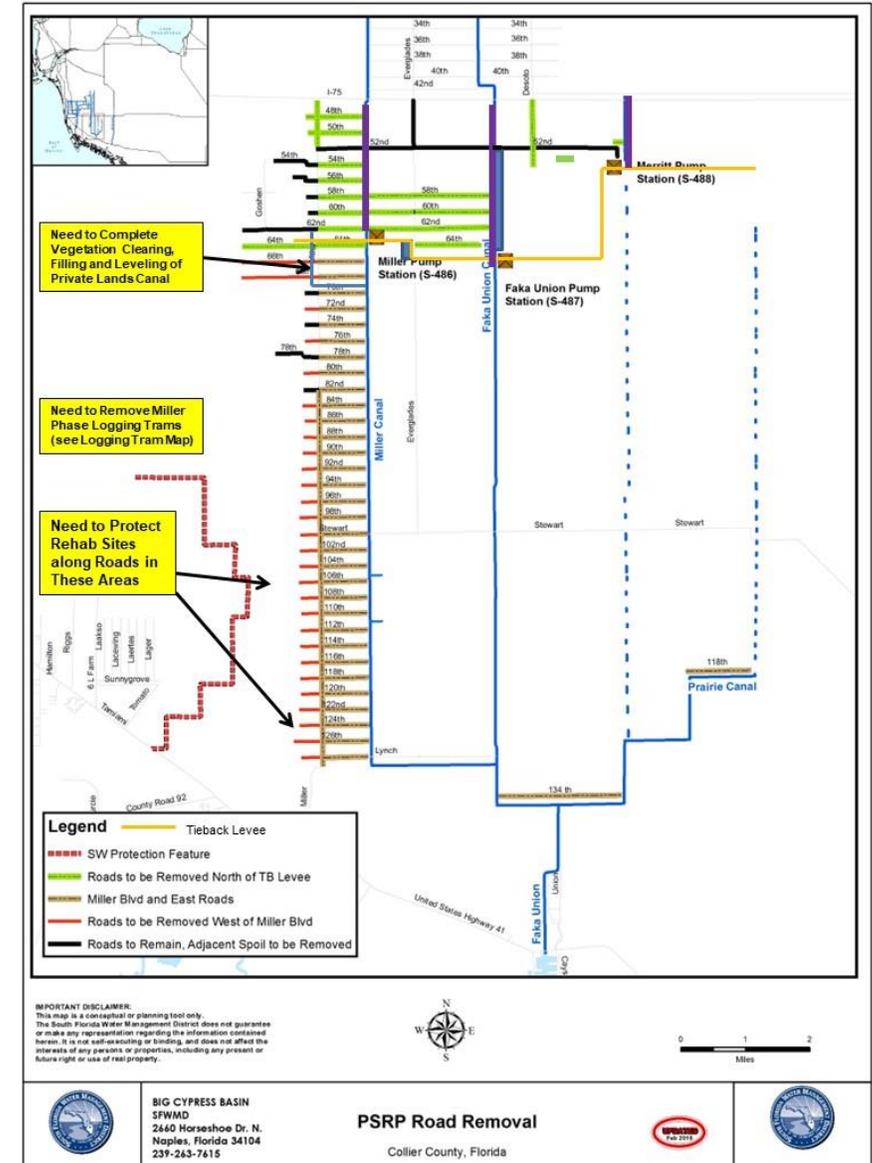
# **PICAYUNE STRAND** **MILLER TRAM AND ROAD REMOVAL**

- Contractor shall remove and regrade all east-west roads (shown on plans), to level undisturbed ground (including logging trams, existing roads and adjacent ditches, swales, and spoil in the area) bounded by Miller Canal to the east, the Tieback Levee to the north, 128th Avenue SE to the south, and to the ends of the roads on the west.
- Miller Boulevard degrade was not included in this contract; however, the spoil and swales along Miller Boulevard shall be leveled to undisturbed ground.

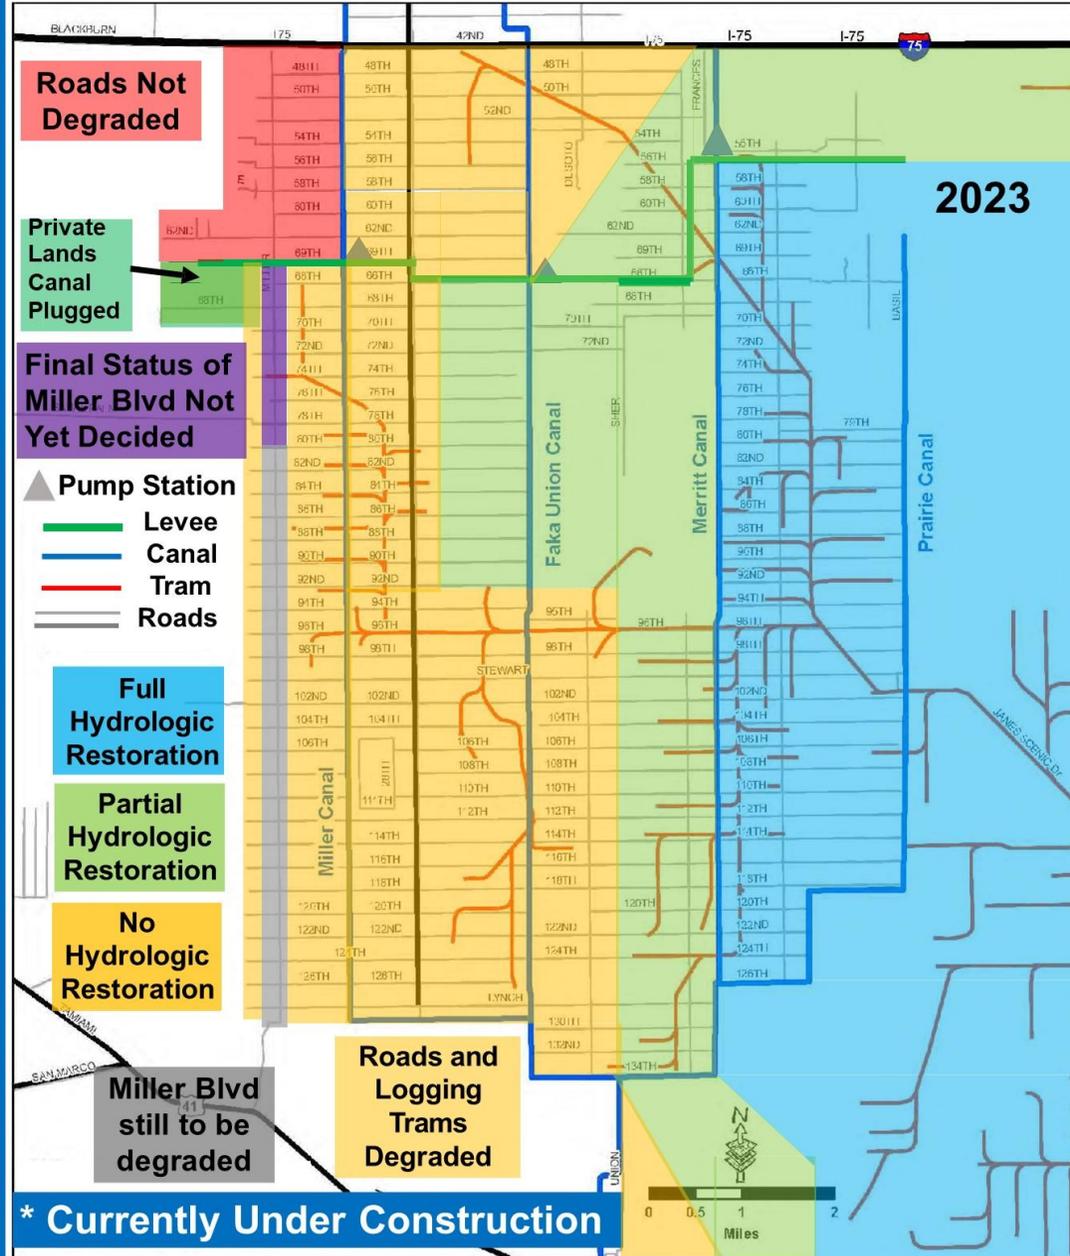
## Status (10 October 2023) Picayune Strand Restoration Project

Roads (99%) and Logging  
Trams (100%) Degraded

Canals 59% Degraded  
Prairie Canal – 7 Miles  
Merritt Canal – 9 Miles  
Stair-Step Canal – 5 Miles  
FU Canal – 3 Miles

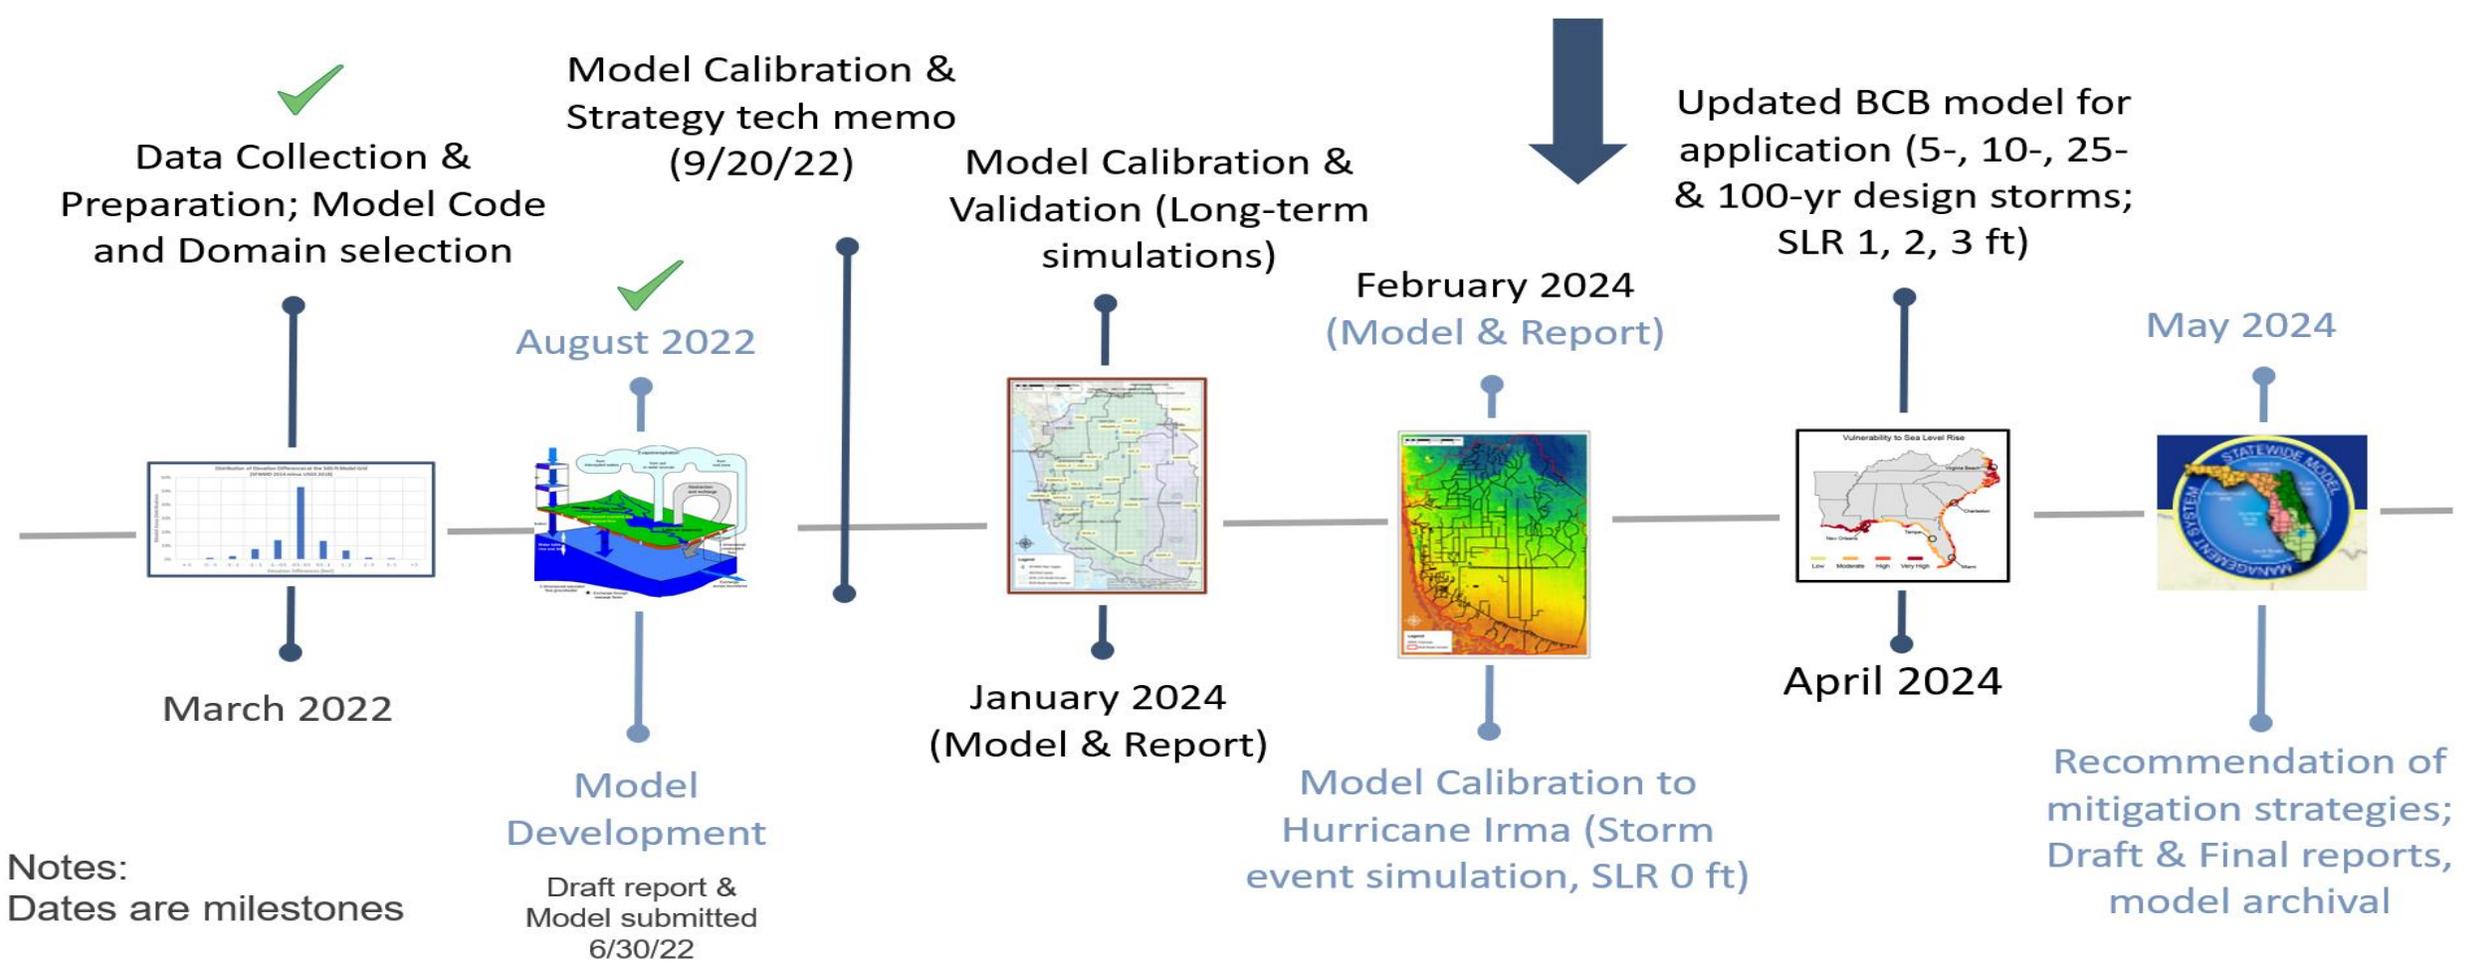
## BCB Model Update: Project Timeline

Notes:  
Dates are milestones

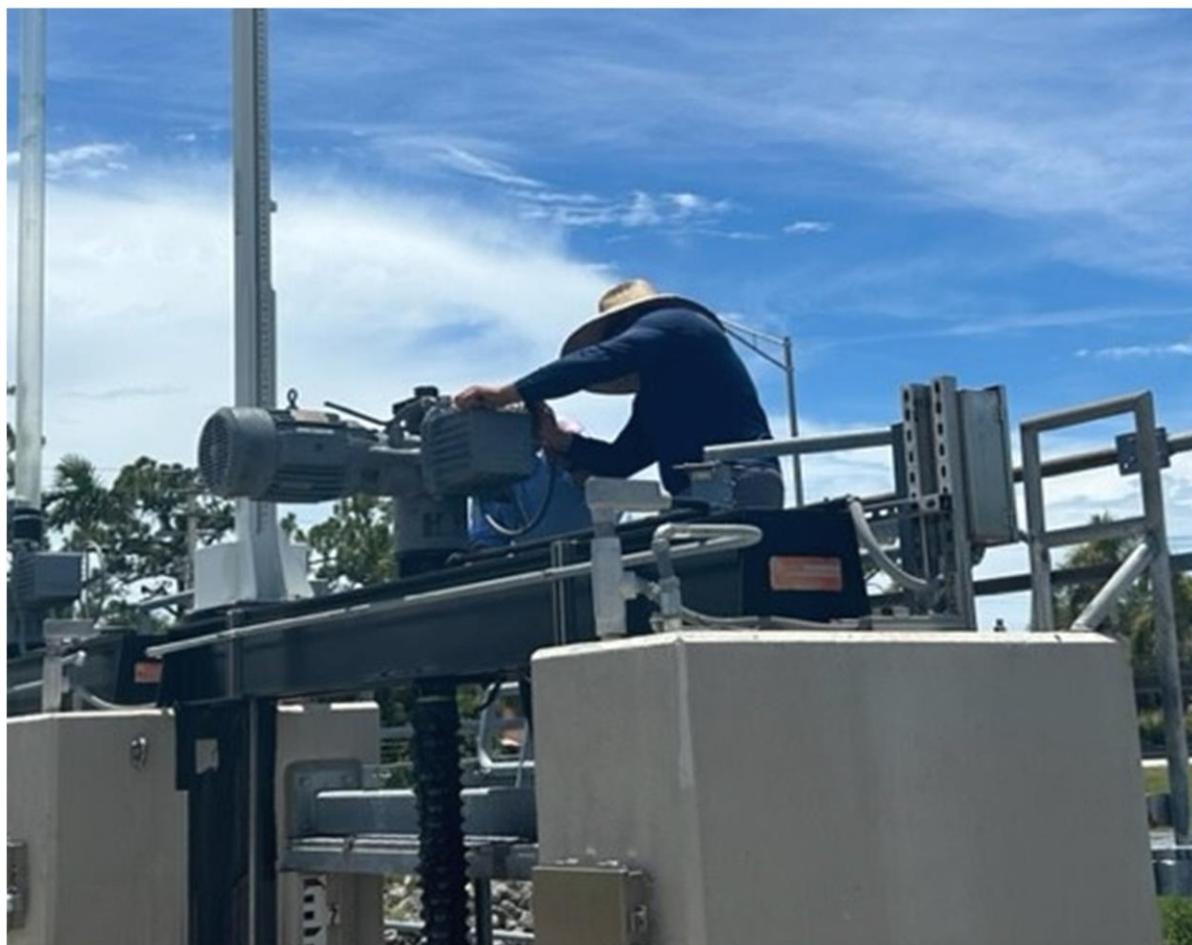
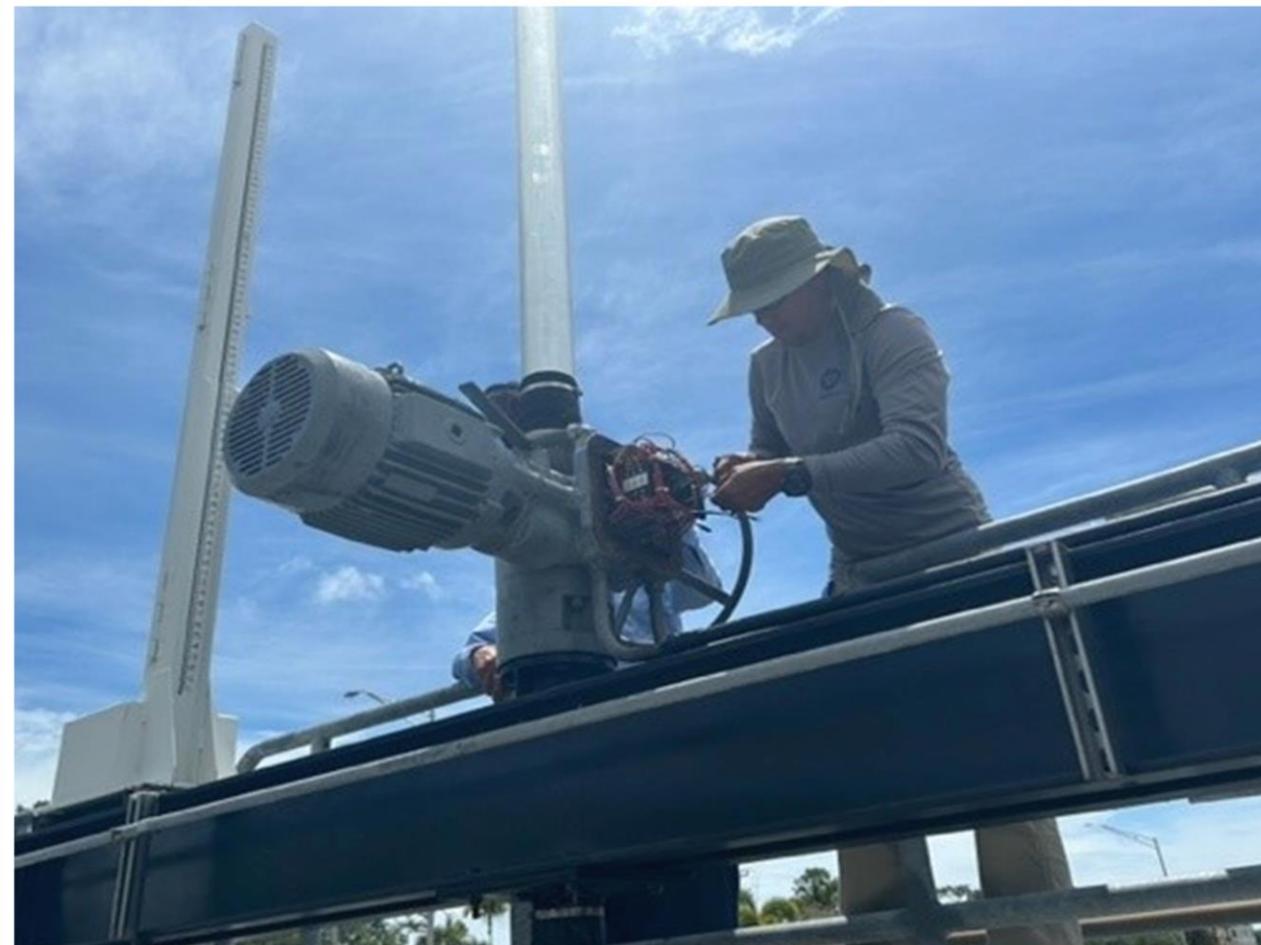
**Gearbox Prev. Main. Coco#1**

**Actuator Repair Coco#2**
