#### CITY COUNCIL WORK SESSION

I.A Castle Creek Bridge and Entrance to Aspen

Appendix A Feasibility Assessment.pdf

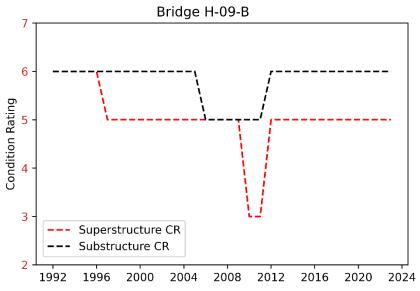
Figure 11. Condition Rating History of the Bridge

Figure 11 illustrates superstructure and substructure condition code history of the bridge based on the NBI database (NBI 2024). During a 2009 inspection, (CDOT 2009) a decline in the superstructure condition code to 3 ("Poor") was noted, necessitating immediate attention. According to CDOT records, extensive repairs and rehabilitation efforts were implemented on the bridge in 2011 to improve the condition code of the bridge. Despite these substantial rehabilitation efforts, they were only sufficient to elevate the superstructure to a "Fair" code.

It should be noted Figure 11 does not include the deck element, which has maintained a code of 6 for over 30 years. Because the deck has an asphalt overlay, inspectors can usually only assess the deck condition from the underside, meaning some issues may be covered by the overlay. City staff have confirmed deck repairs were performed during the 2018 project that milled off the existing overlay to place a new waterproofing membrane and overlay. This project uncovered some areas requiring full depth deck repair and additional reinforcing where corrosion or impact was noted. Replacing the overlay was challenging because of inconsistencies with the existing bridge deck surface.

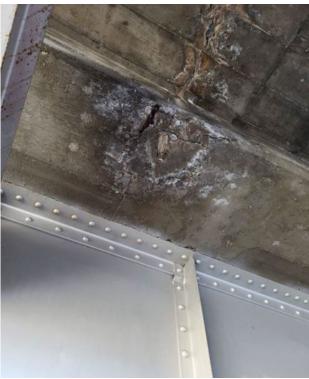
Figure 12. Deck Concrete Spall with Exposed Rebar

In conjunction with a new asphalt overlay, deck repair was performed on the bridge in 2018, which repaired several inspection and maintenance items. The wheel rutting in the overlay noted during the November 2023 inspection can lead to degradation of the deck over time if not properly maintained. A well-performing overlay system is the best defense for maintaining the integrity of the concrete deck underneath and extending its service life. The type of overlay is also important to enhancing the deck's resistance to corrosion. Cementitious and non-cementitious wearing surfaces are available. The concrete deck issues noted will need to be monitored regularly to confirm the 2018 deck repair effort stopped or significantly slowed down the observed deterioration of the underside of the deck. If it is determined deck repairs need to be performed once again, the deck repairs would follow the typical protocol CDOT uses for this situation.

Infiltration of chloride ions into concrete is the most common cause of corrosion initiating in reinforcing steel. Chloride exposure is primarily through the application of deicing salts, such as magnesium chloride. Deck repair and patching or the installation of new membranes and overlays must begin by first identifying the extent of chloride contamination of the deck. Chloride testing consists of taking cores of the concrete deck and analyzing them for chlorides. Depending on the results of the testing, future deck rehabilitation may consist of the replacement of all chloride-contaminated concrete with sound concrete, along with the replacement of the membrane and wearing surface. It may also consist of the installation of a barrier-type overlay on the deck or full replacement of the deck. The test process may significantly impact traffic on the bridge when samples are taken. In addition, the potential deck rehabilitation effort will impact traffic on the bridge and may include full closer of the bridge to complete the repair work.

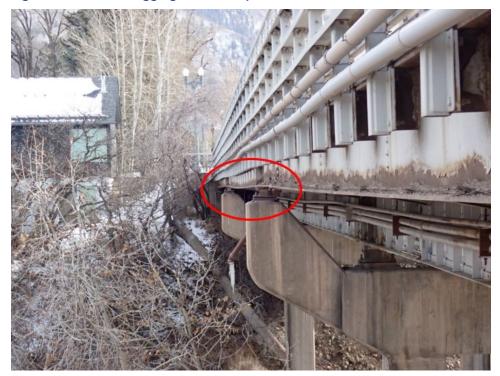
Figure 15. Girder F Sagging Near Mid-span

The steel girders show varying degrees of corrosion. Exterior rolled steel wide flange girders (North exterior Girder A and South exterior Girder F) under each sidewalk show significant corrosion on the bottom flanges and lower webs (refer to Figure 14). Several locations along the girder also have severe localized corrosion in the top part of the web. On average, exterior girders show 20% section loss in the web. Some localized areas show up to 40% section loss. Both exterior girders show a visible sag with approximately 3 inches of downward displacement at mid-span locations (refer to Figure 15).

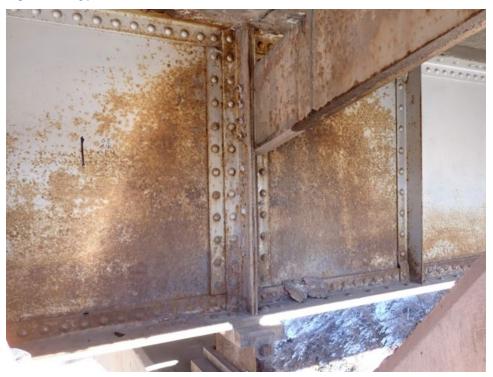
Figure 16. Typical Surface Corrosion of Interior Girder - Girder E South Face at Pier 4

Compared to the exterior girders, the interior girders (B through E) have less corrosion. Surface corrosion and minor pitting are observed at these girders, especially at piers under the deck joints (refer to Figure 16). Girder ends at the abutments exhibited corrosion with negligible section loss.

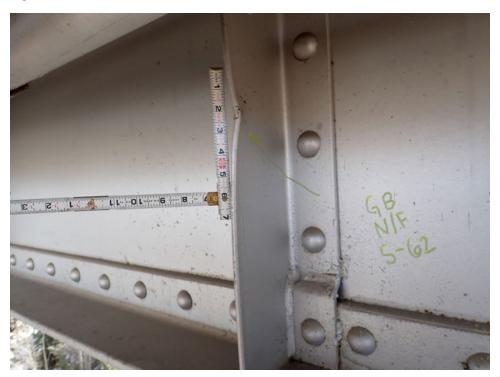
Figure 17. Deflection of Stiffener at North Face of Girder B

One stiffener in Girder B exhibited a noteworthy 1-inch out of plane deflection, emphasizing the necessity for a more in-depth structural evaluation at this stiffener location (refer to Figure 17). Stiffeners in exterior girders follow the same corrosion pattern as that of exterior girders as described in an earlier section. Notably, the vertical web bearing stiffener of Girder F at Abutment 6 has 100% section loss (2-inch diameter hole) at the bottom of the stiffener (refer to Figure 18). The bearing stiffeners of the interior plate girders, located at both the abutments and piers, are constructed using double back-to-back angles. They exhibit pack rust between the faying surfaces with a thickness of up to 1/2 inch. This rust has caused bowing in the stiffener legs at various points, as illustrated on Figure 19. While section loss in these regions is minimal, the accumulation of pack rust poses a potential concern over time. The continued presence of pack rust can induce separation between the angles, leading to further distortion of the angle shape.

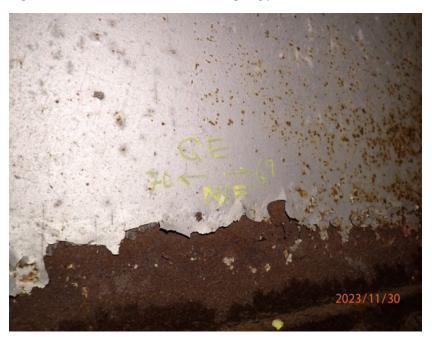
The protective coating on the steel elements has failed in areas because of corrosion, indicating a need for prompt attention. Approximately 80% of coating has deteriorated. This deterioration contributes to the accelerated corrosion of the steel components, emphasizing the urgency of addressing protective coating issues.

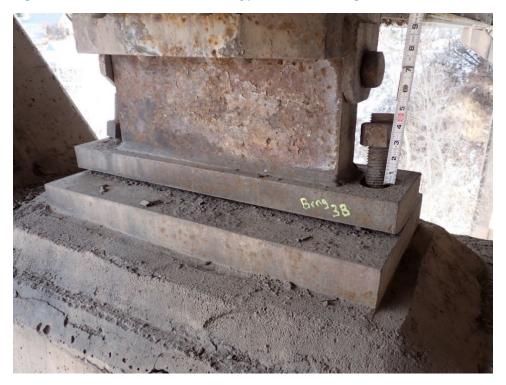
Figure 24. Loose Anchor Bolt Nuts – Typical at All Bearings

The primary girder bearings display surface corrosion without measurable section loss, with some bearings surrounded by soil and debris specifically at Abutment 1 (refer to Figure 21). Loose anchor bolt nuts are observed at all bearings, and pin bolts are backing out at Bearings 1C, 1D, 3E, and 3F. Furthermore, certain fixed bearings on Abutment 6 exhibit surface corrosion, with the grout pad breaking up under several bearings. It is imperative to address these issues urgently to prevent further deterioration and unintended movement. Overall, the bearing condition is generally fair, with surface corrosion and identified problems with anchor bolts. The interior girder bearings, especially the rocker bearings at Abutment 1, are in the expansion position, which is opposite of what is expected in the colder weather conditions during the inspection in November.

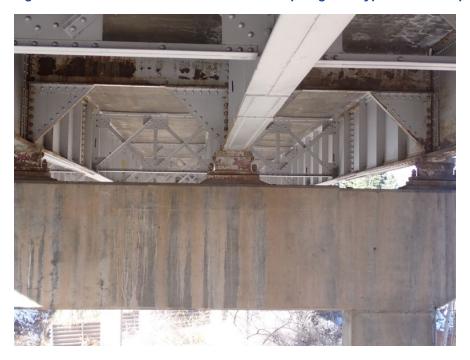
Figure 25. Surface Corrosion of C-Channel Diaphragms – Typical at All Diaphragms

The steel diaphragms exhibit satisfactory overall condition, except for surface corrosion identified in the C-Channel diaphragms at the piers. Notably, the C-Channel diaphragms between the exterior and interior girders at piers show corrosion with 10% to 30% section loss of the webs.

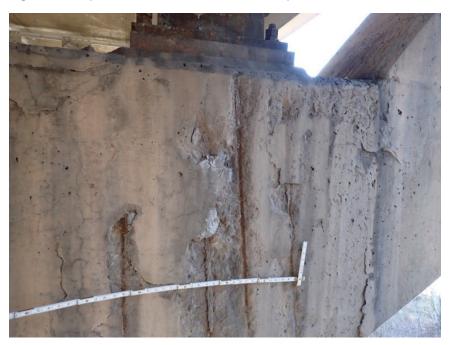
Figure 26. Exposed Corroded Rebar on Pier Cap at Pier 2

Pier caps exhibit moderate to heavy water staining, light scaling, delamination, and various severity of cracks. Specific issues include a 4-square-foot spall with exposed, corroded rebar on Pier 2, rear face under Girder E. Pier 3 cap shows delamination and cracks with efflorescence, while Pier 4 cap displays delamination, shallow spalls, and horizontal and diagonal cracking below Bay 3C. Pier 5 cap is starting to delaminate on the right side under Bay 4D.

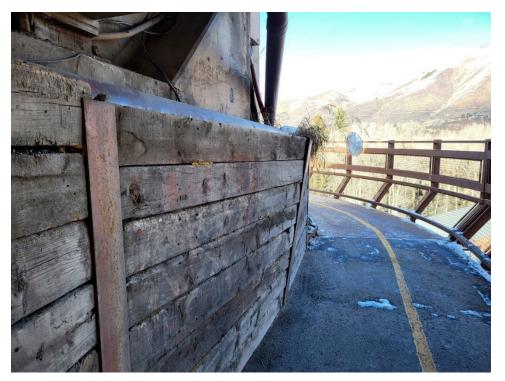
According to the CDOT inspection report for 2022, maintenance personnel in Aspen have reported the need to annually adjust or reposition the timber wall supporting the bike path to a vertical orientation at Abutment 1. This recurring issue has prompted the City to initiate a rehabilitation project aimed at addressing the structural concerns associated with the timber wall. Mitigation of the retaining wall and bike path helps the continued protection of Abutment 1.

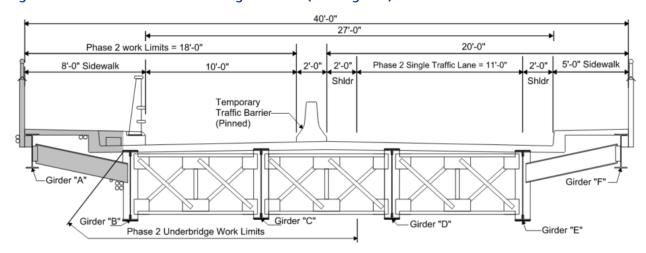
Figure 33. Rehab Construction Phasing - Phase 2 (Looking East)

In the proposed construction phasing, Phase 1 will involve the replacement of the exterior girders on the southern side. This includes the replacement of bearings for Girders D, E, and F at both abutments. Additionally, all other bearings on Girders D, E, and F will be cleaned, the bearing grout pads will be regrouted where necessary, and any instances of deck spalling will be patched. The subsequent phase will mirror this rehabilitation process, focusing on the northern side of the bridge. Additionally, Phase 2 will involve the replacement of Bearing Pedestal for Girder A at Abutment 6.

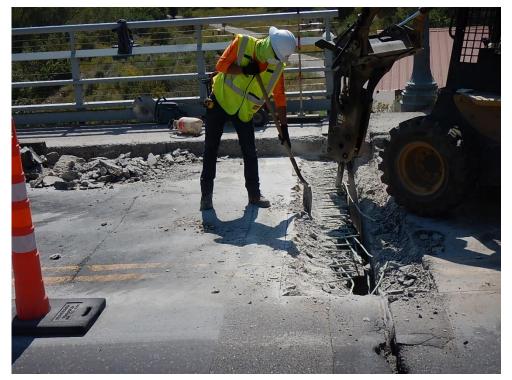
Active Construction at Abutment 1 on Joint

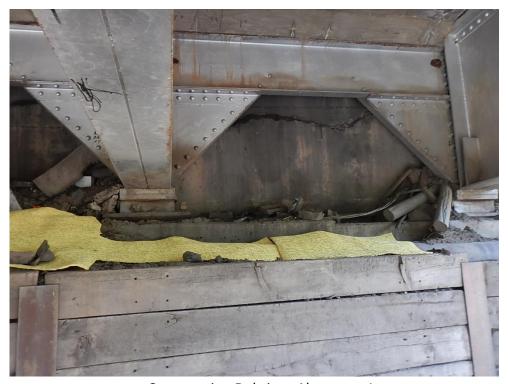
Construction Debris at Abutment 1

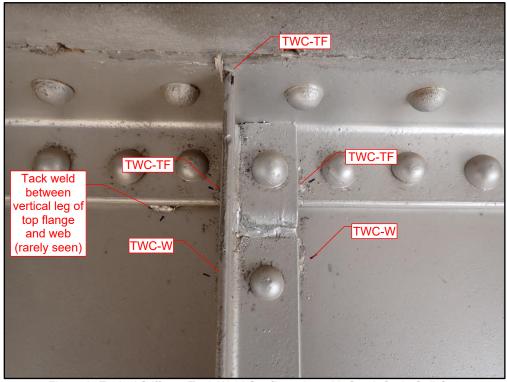
flange angle, and very rarely another tack weld between the vertical leg of the top flange angle and the girder web. See the image to the right for an illustration of tack weld locations, accompanied by a code legend below. See also Figure 9 for an annotated photograph showing a typical stiffener and associated tack welds. The codes that have been used in the legend and graphic shown here have been used throughout the report and drawings in order to more quickly identify the location of a tack weld within the cross section of the girder.

Figure 9 : Typical Stiffener Tack Weld Configuration with Crack Code Call-Outs

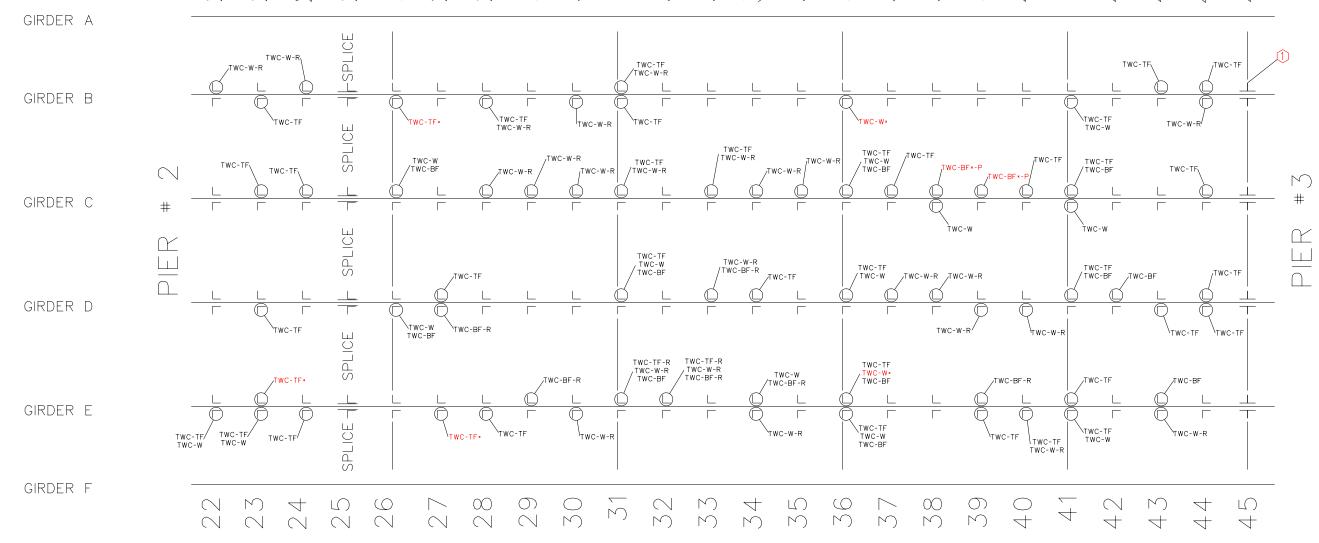
1 PACK RUST BETWEEN FAYING SURFACES OF ANGLE LEGS, UP TO 1/2" THICK, TYP. AT BEARING STIFFENER LOCATIONS.

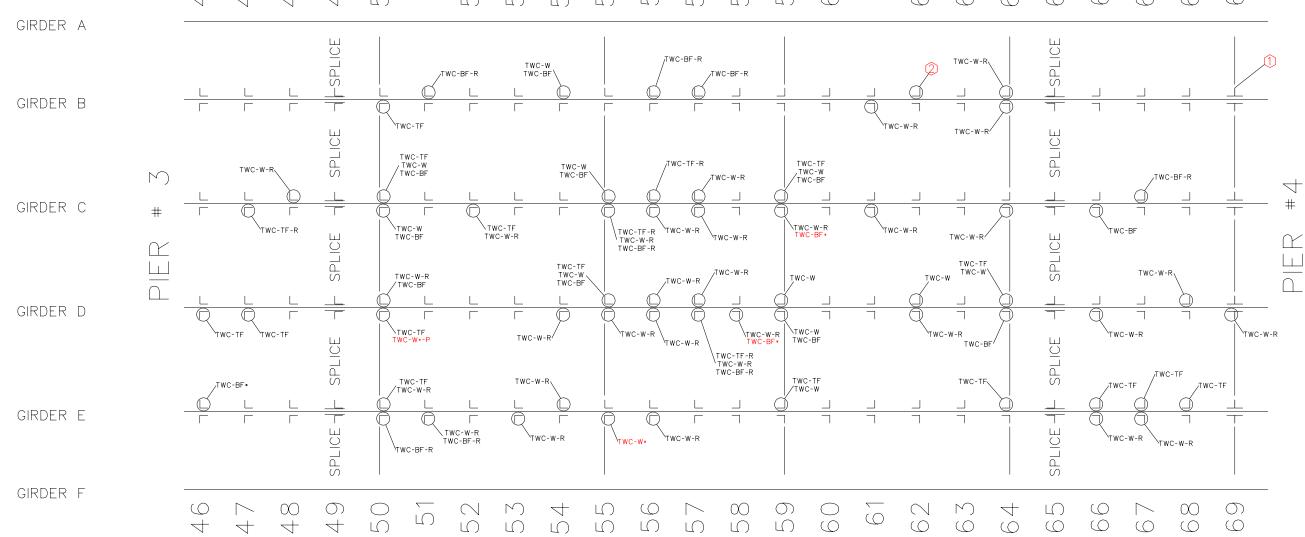
- ① PACK RUST BETWEEN FAYING SURFACES OF ANGLE LEGS, UP TO 1/2" THICK, TYP. AT BEARING STIFFENER LOCATIONS
- STIFFENER DEFLECTED, UP TO 1" OUT OF PLANE OVER 6" HEIGHT, NEAR BOTTOM 1/3 POINT
