# **Notice of Meeting of the Main Street Advisory Board of the City of Georgetown, Texas September 17, 2026**

- 1.A **Call to order**  
Call to order - Evan Cuyler, Board Chair
- 1.B **Main Street Facade Grant request for 102 E University Ave**  
Consideration and possible action on a Main Street Facade Grant request for 102 E University Ave – Rachel White, Downtown Development Manager

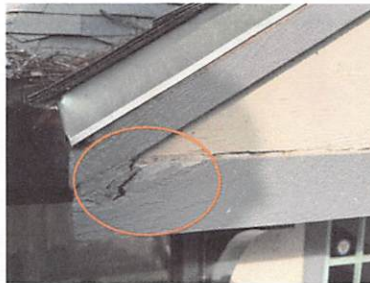
left side porch

Loose and damaged exterior cladding components were observed, including sections of window trim, soffit areas, crawlspace vent trim, and other wood trim elements showing signs of deterioration and moisture-related damage. These conditions are consistent with deferred maintenance and may allow further moisture intrusion if not addressed. Repair and ongoing maintenance is recommended to help preserve the exterior envelope.

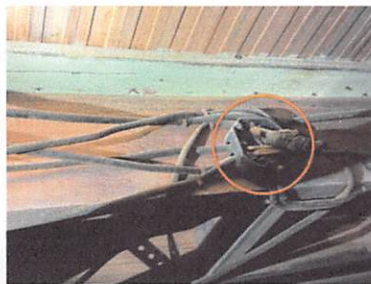
Exposed wiring connections within crawlspace

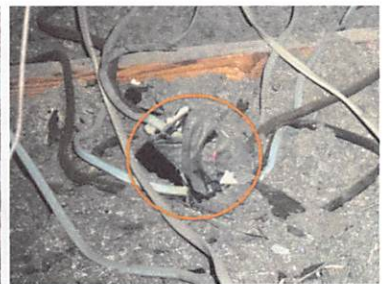
Exposed wiring connections in attic

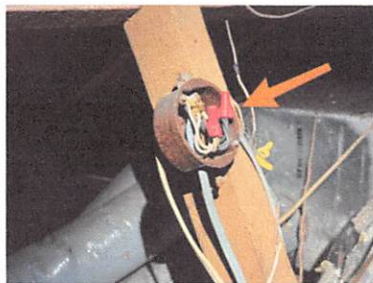
Exposed wiring connections in attic

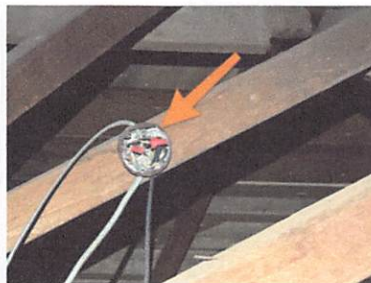
Exposed wiring connections in attic

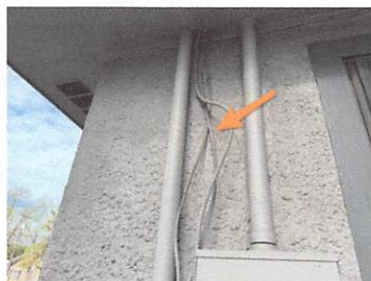
Branch circuit wiring should be securely installed and not exposed or routed on exposed surfaces, especially in storage or appliance service areas. In this case, the affected wiring, not rated for direct exposure or outdoor use, is also exposed to outdoor elements. To protect this wiring better, appropriate conduit, a box, or a raceway should be used.

Exposed and unprotected wiring

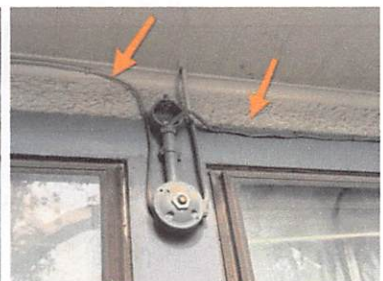
Exposed and unprotected wiring

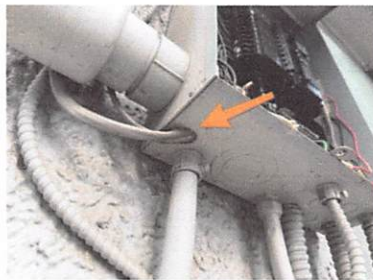
Cables unprotected at point of entry into panel

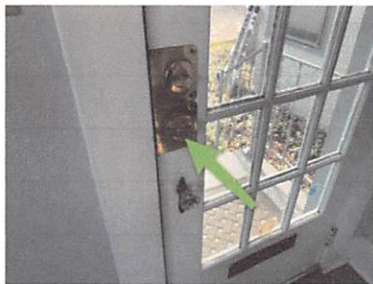
Left side door

Keyed deadbolt locks were observed on one or more exterior doors that are not designated as primary egress doors. While this is generally acceptable for non-egress locations, occupants should be aware that keyed deadbolts require a key to unlock from the inside, which may delay exit in an emergency if the key is not readily accessible.

For improved safety, consider using thumb-turn deadbolts or ensuring that keys are always kept nearby and easily accessible.

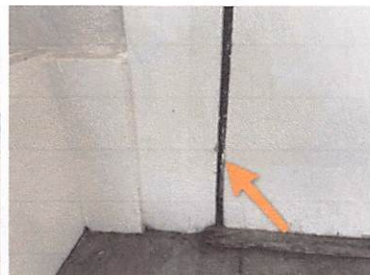
Right side exterior door

Damaged / missing weatherstripping materials can result in energy loss, pest intrusion and / or moisture intrusion. For garage pedestrian doors, this can also result in possible garage fumes within the living space.

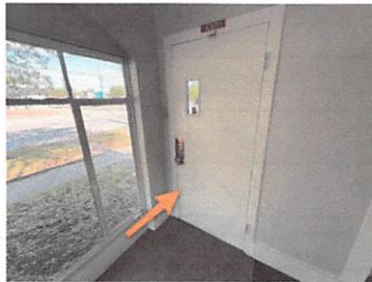
Right side exterior door

**2: Door rubs or catches when operated**

Adjustment / repair is recommended as necessary for improved operation.

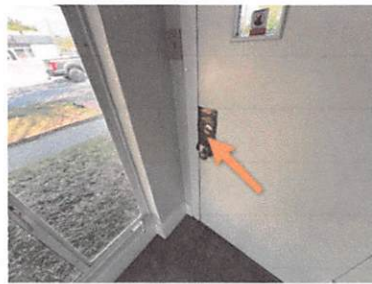
Right side door

### 3: Poor deadbolt lock operation

Adjustment / repair is recommended as necessary to ensure proper security and lock operation.

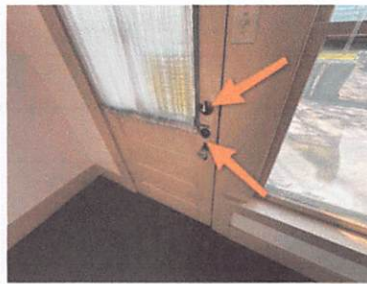
Back door. Bottom deadbolt inoperative. Top deadbolt difficult to operate

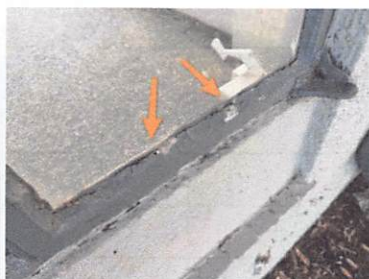
The older windows at the right side of the house were observed to have deteriorated and previously repaired glazing compound. These conditions may allow moisture intrusion and were consistent with evidence of past moisture penetration at interior areas. Repair and ongoing maintenance is recommended to help reduce the potential for continued water intrusion.

poor window glazing compound

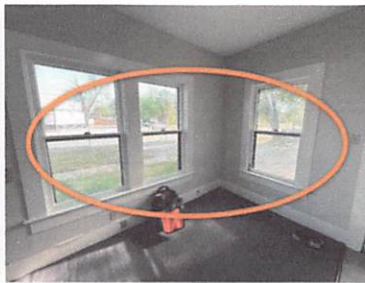
Affected windows would not operate or open using normal force. Repair is recommended for improved operation; particularly in bedroom areas where window emergency egress is required.

Windows appear painted shut. Living  
room
